ROOF

OCT 17, 2024

^E
BRAD MULKURN

INSPECTION

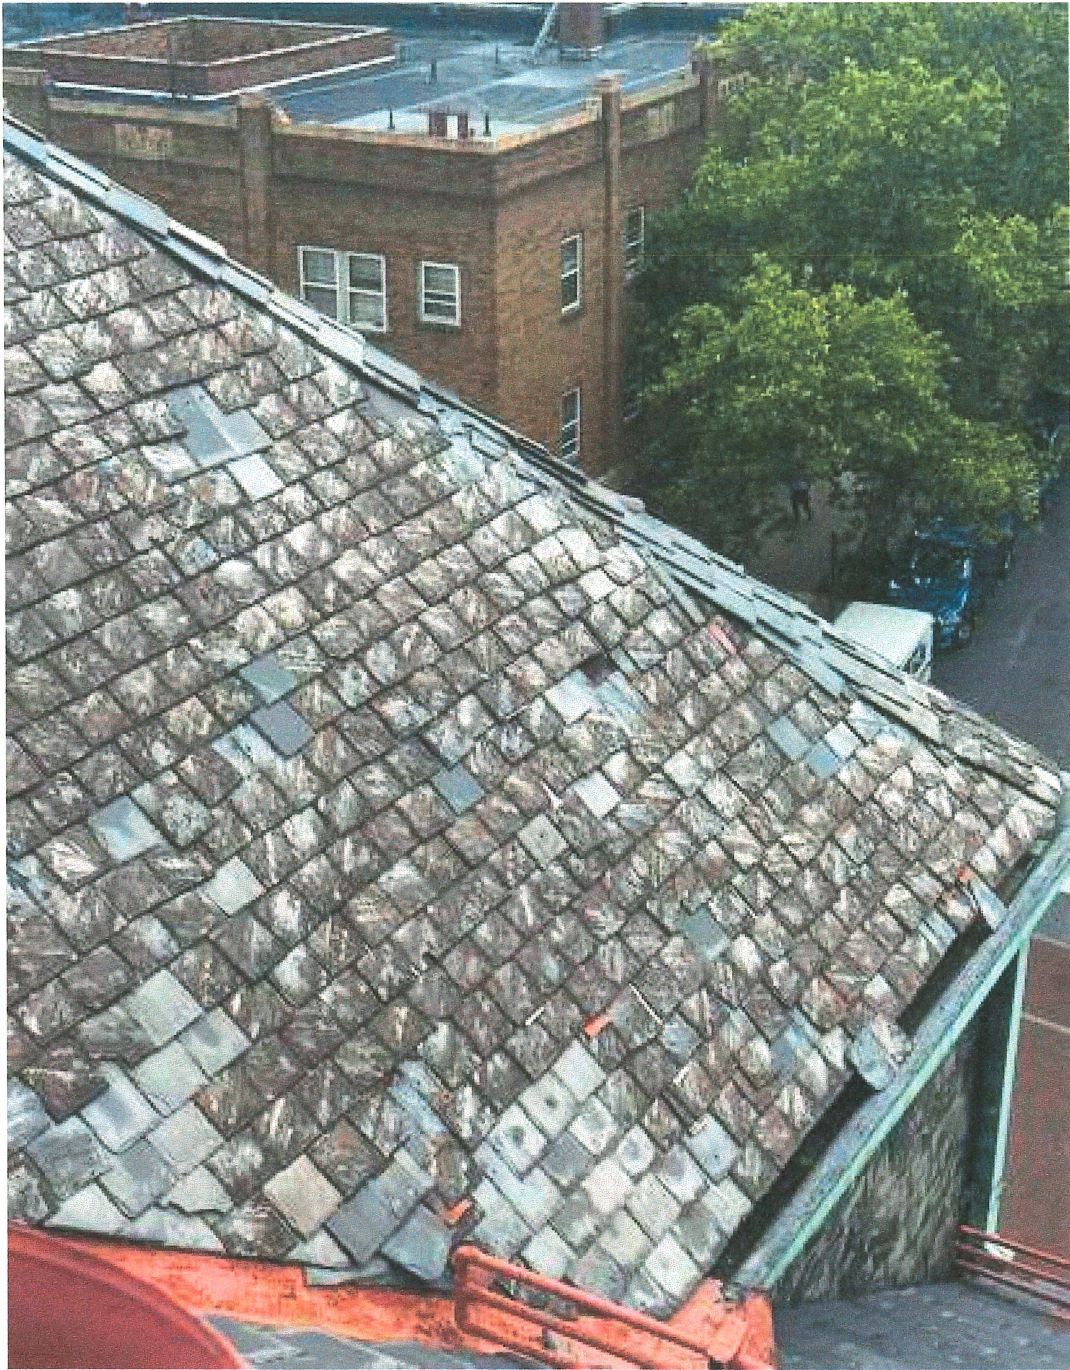
Loose slate tiles and severe de lamination

Front section of roof to be replaced due to slate nails backing out, causing slate tiles to pull away from roof. Severe delamination of slate causing premature failure of slate tiles. Slate roof is in bad condition, needs to be addressed as soon as possible. Roof condition may cause severe interior water damage and or structural damage to wood and other components. It's concerning that a Slate tile will fall from such height causing damage to cars parked near by and or unfortunately hitting a pedestrian walking underneath.

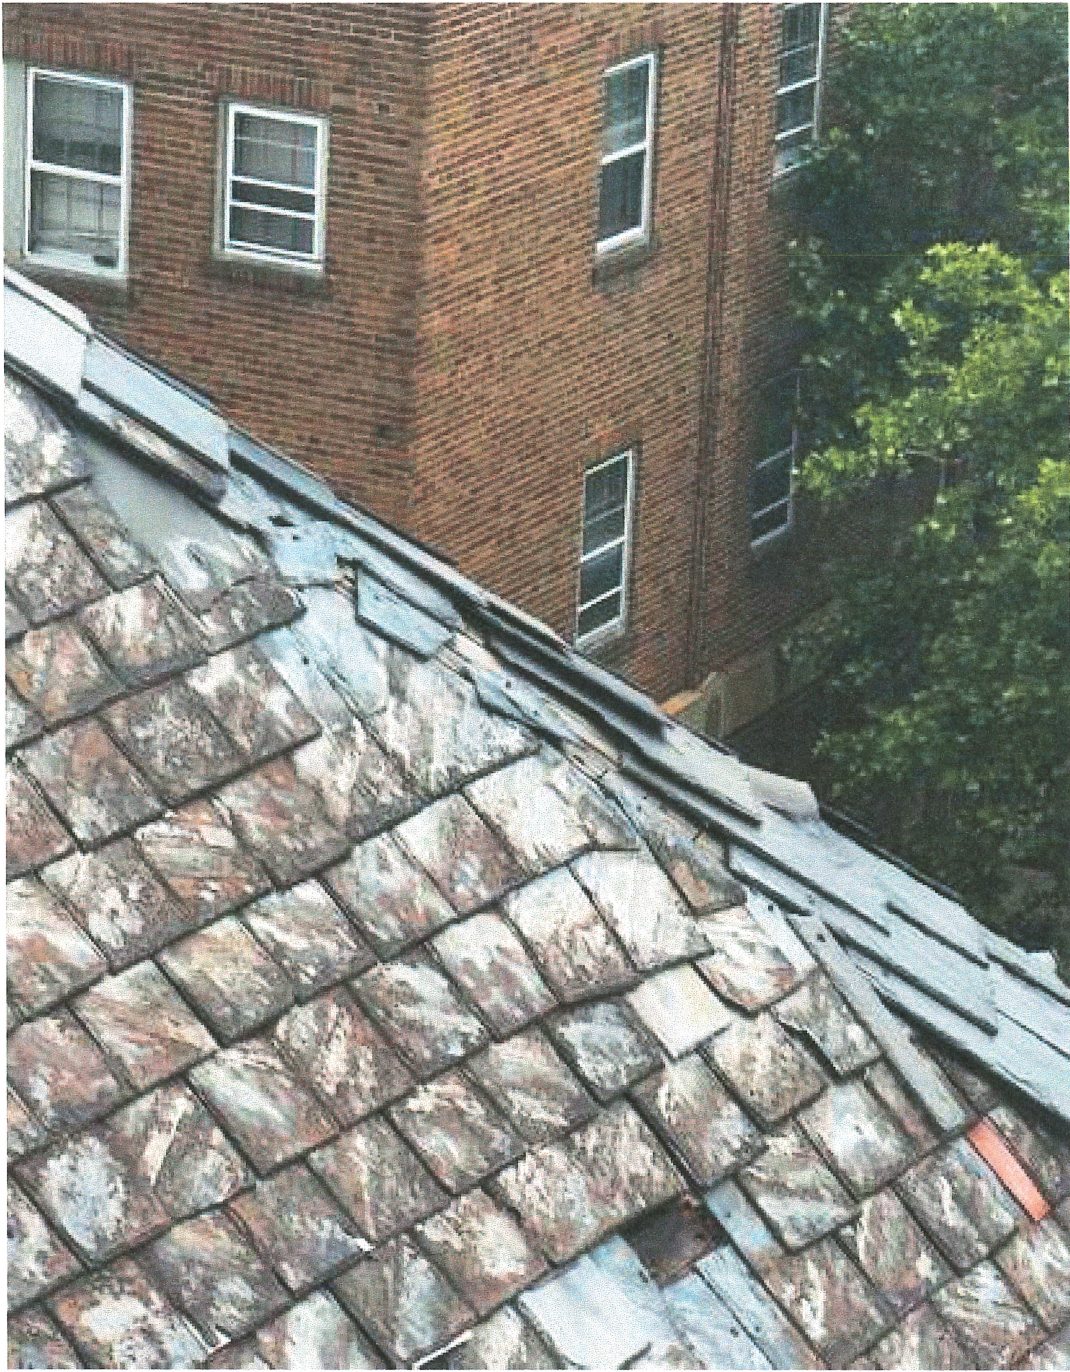
Loose Slate tiles

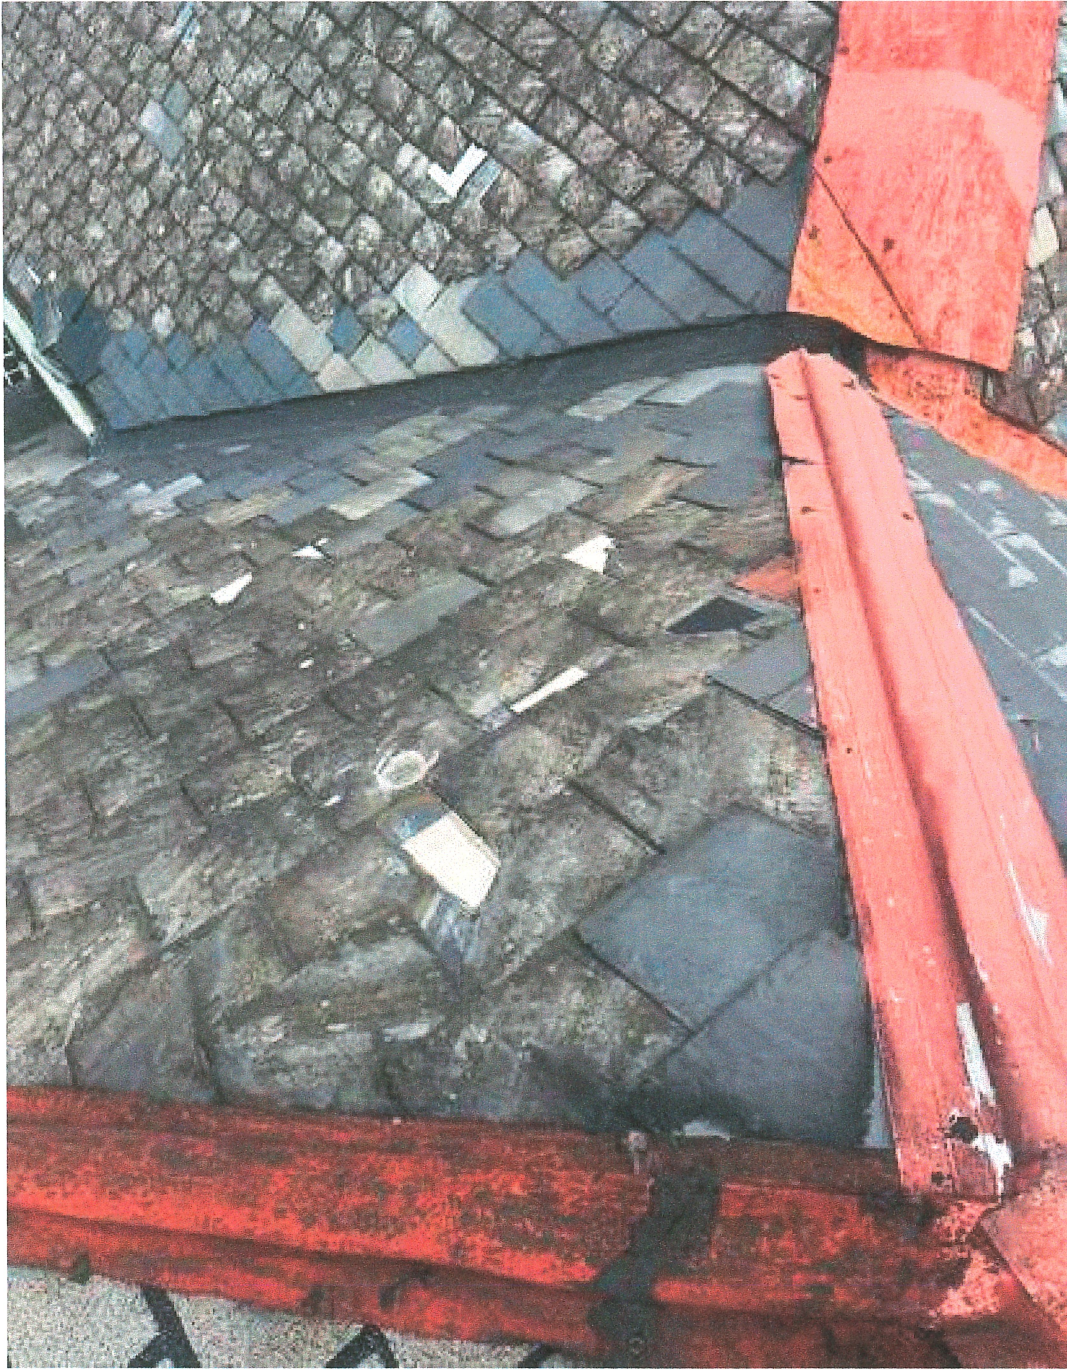
Roof was previously tried to be repaired unsuccessfully

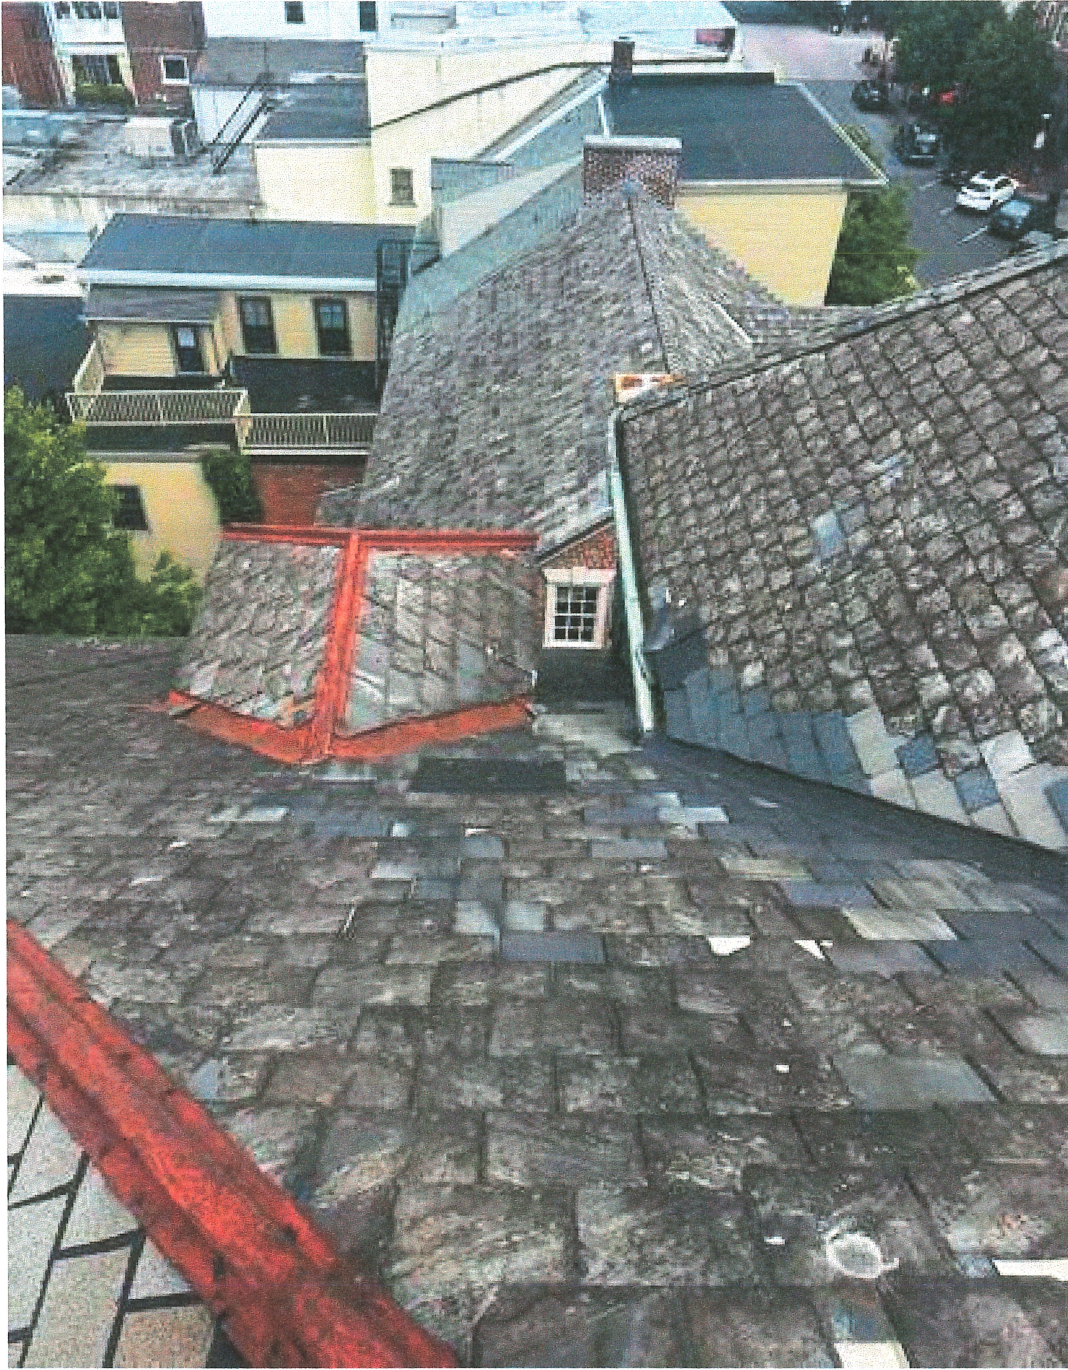
Slate tiles falling from roof due to nails backing out

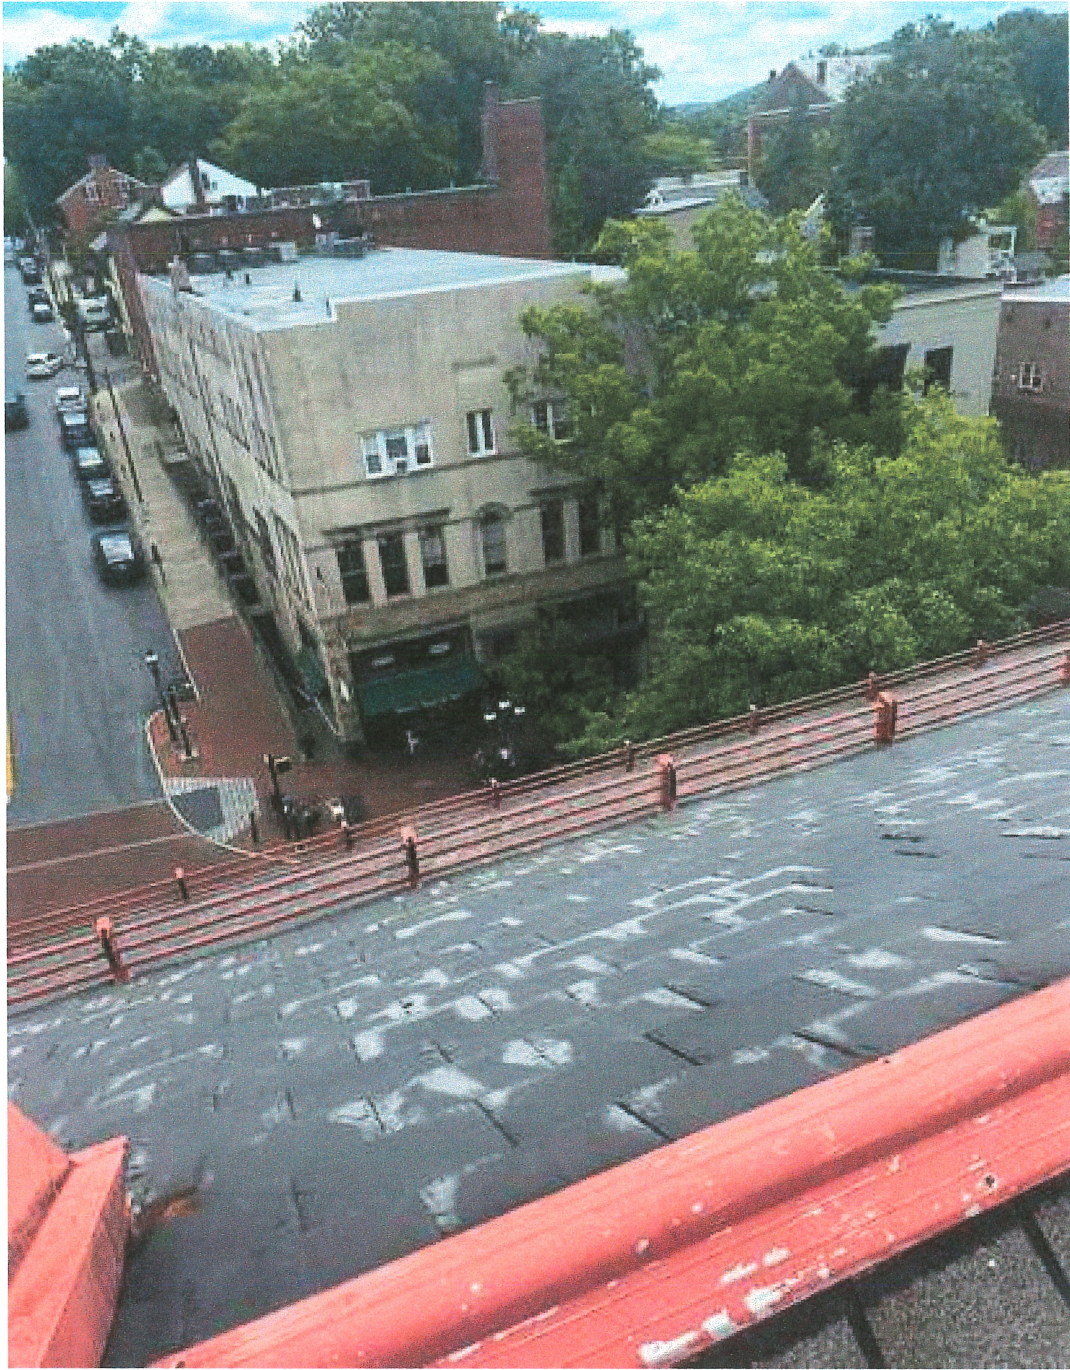
Flashing needs to be install around metal base frame

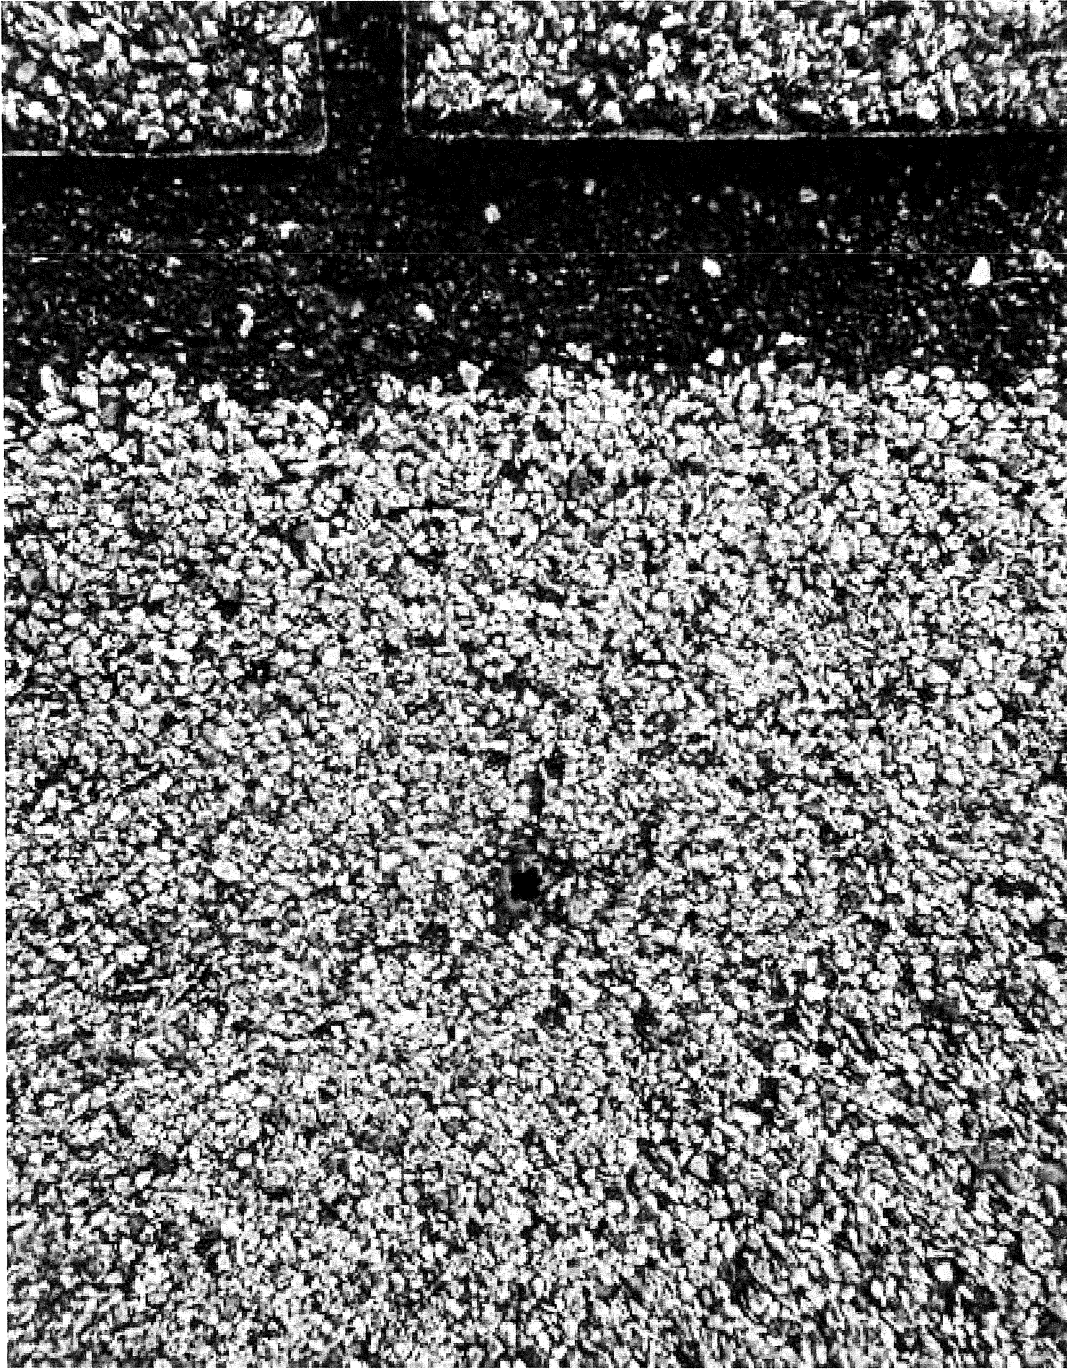
• Nail hole, cause by nails backing out

Roof must be replaced, rear section of roof (shingles) were installed incorrectly previously. Does not have a solid nailing surface under shingles, (space decking) causing nails to back out of shingles. Causing future leaks and shingles blow off. New aluminum step flashing around dormers and wall line. Also removing and resetting air conditioning unit on the back to install new shingles. Valleys will be done by performing the California cut method.

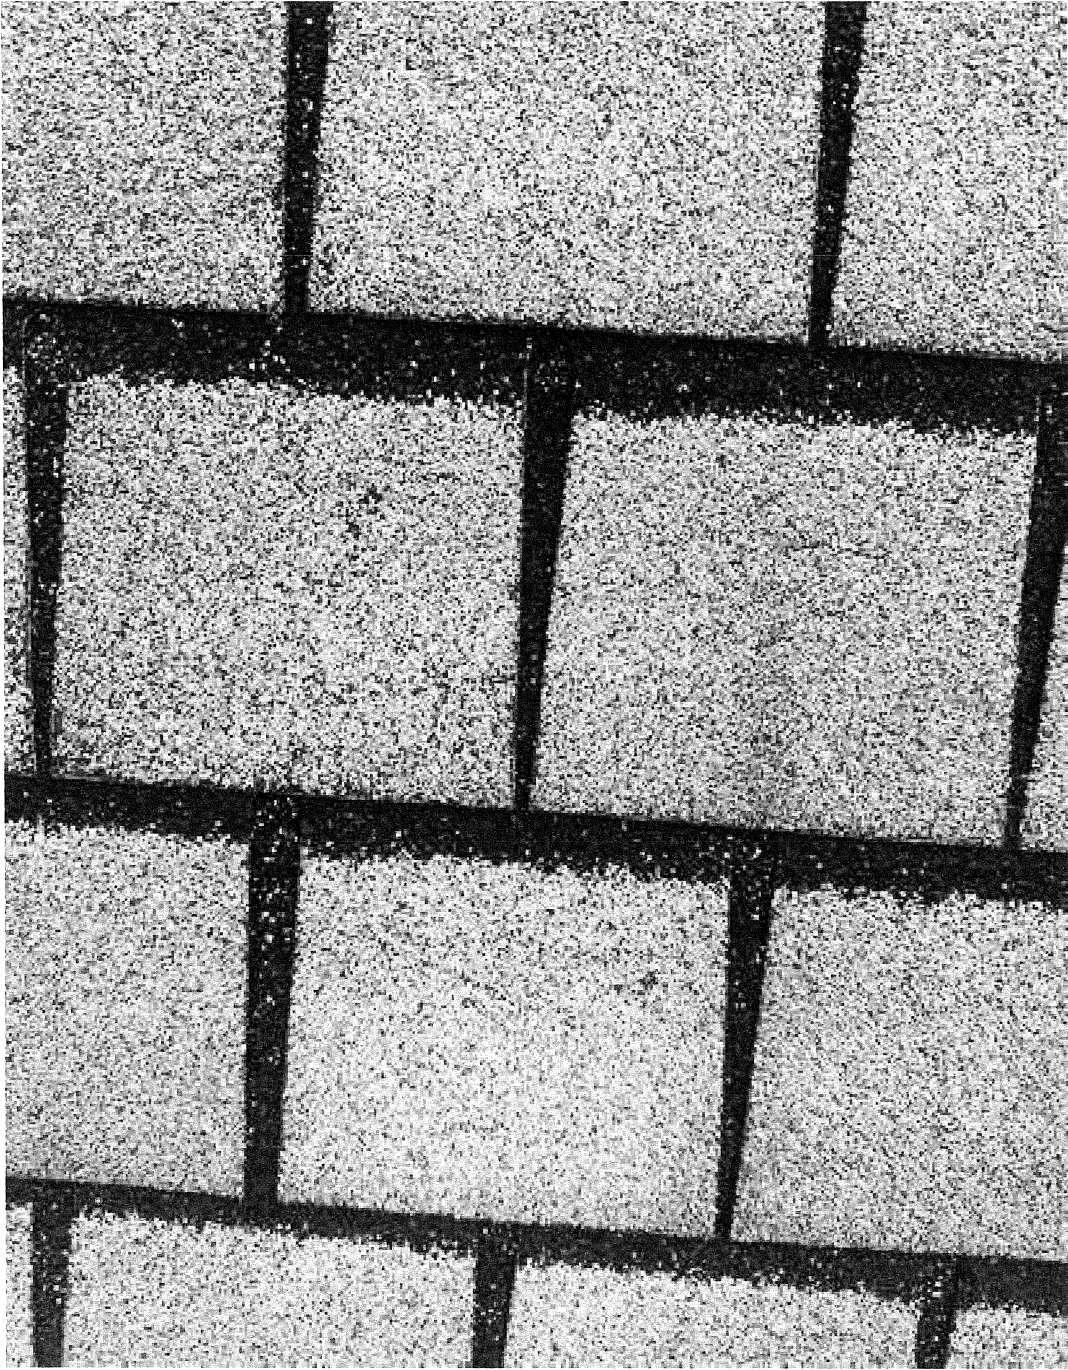
More damage shingles by nails backing out

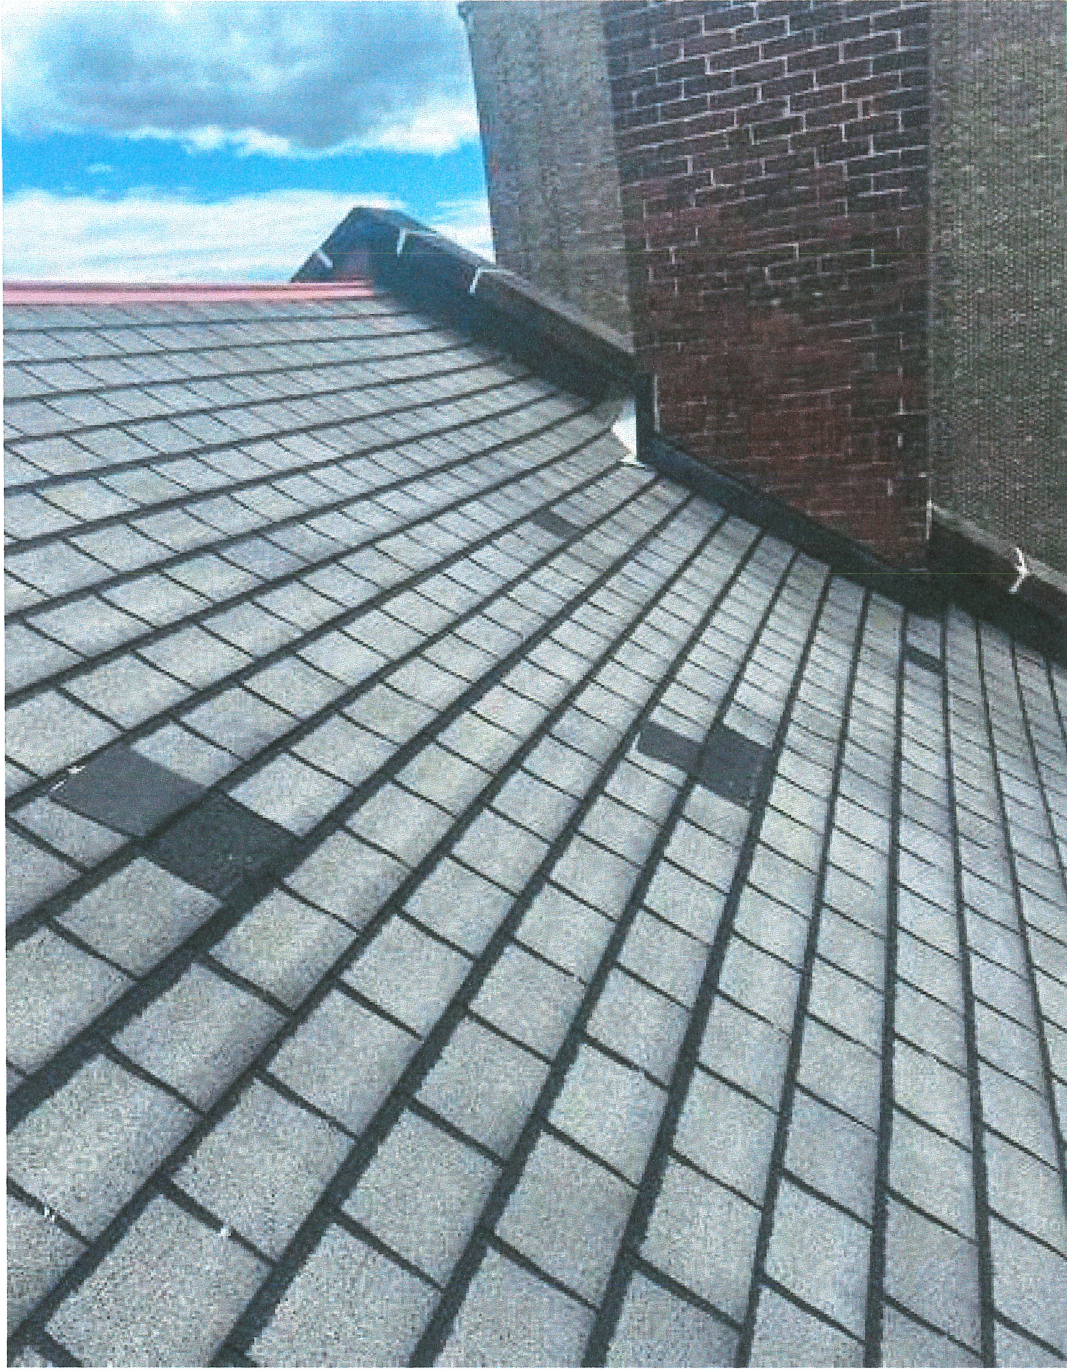
Shingle blow offs, needs new chimney flashing and step flashing around wall line.

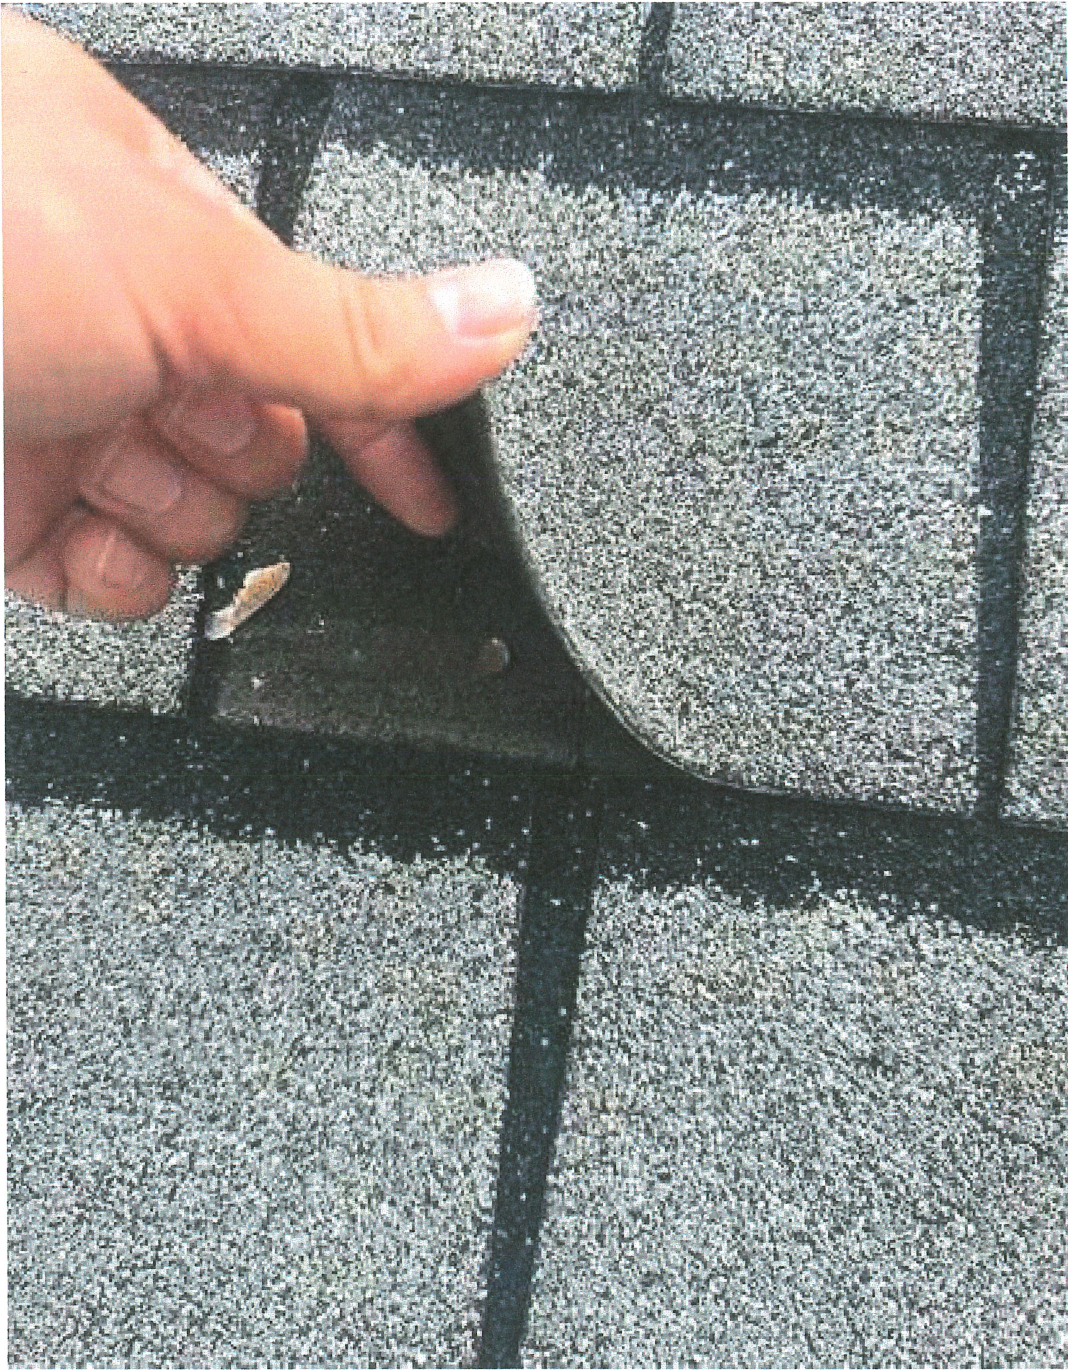
Nail backing out
