Date: 11/23/2020
Project #: 1075820.000
Service Task: 00OBS00

To: Mr. Joseph C. Posh
From: Ross C. Sotak, PE
RE: **14-18 3RD STREET – STRUCTURAL OBSERVATION**
Bethlehem, Pennsylvania

Field Observation Report

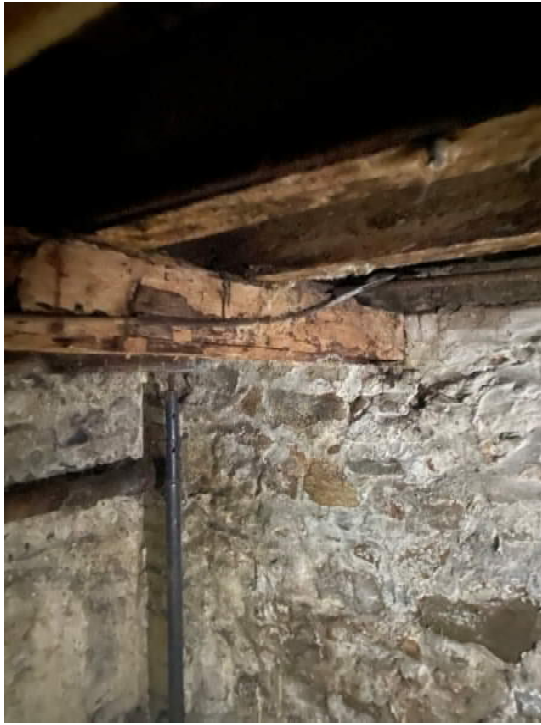
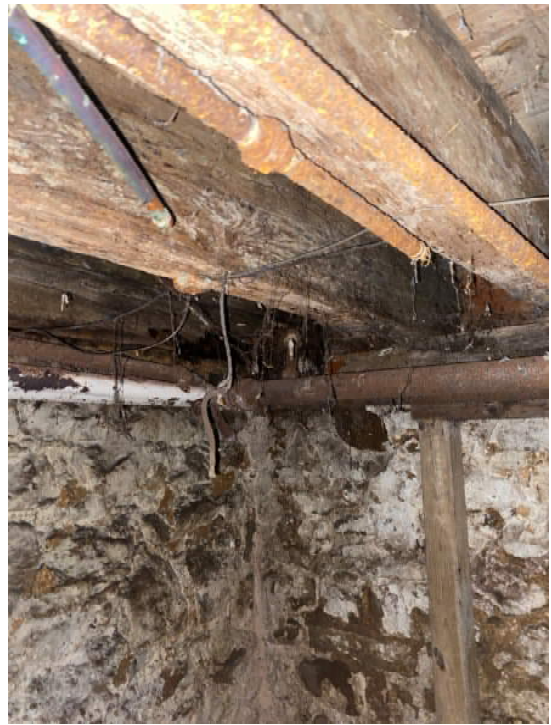
While much of the structure is concealed by finishes, the portions that could be observed are in poor condition. In the basement of the 18 building many of the floor joists are either dry-rotted or rotted from water infiltration (Photos 1 and 2). There are framing members with noticeable deflections and a portion of the first floor has failed where water has deteriorated the joists (Photos 3 and 4).

Photos 1 and 2 – Deteriorated floor framing.

structural capacity of the wall. This wall will need to be completely rebuilt and/or have a new supplemental permanent structure installed. In addition to the walls and foundations, much of the wood framing will need to either be reinforced or replaced due to the deterioration outlined above.

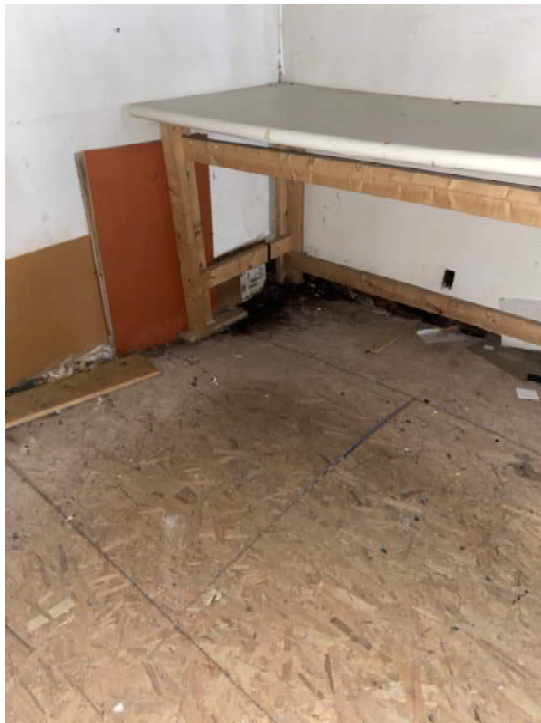
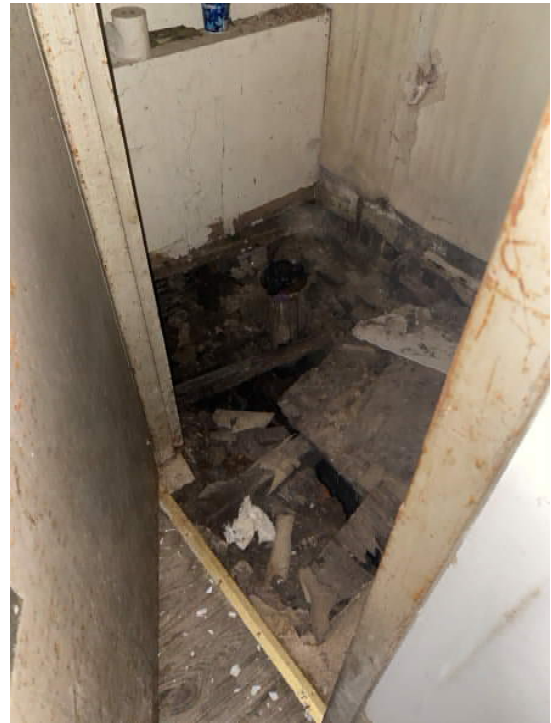
Photo 3 and 4 – First floor failures.

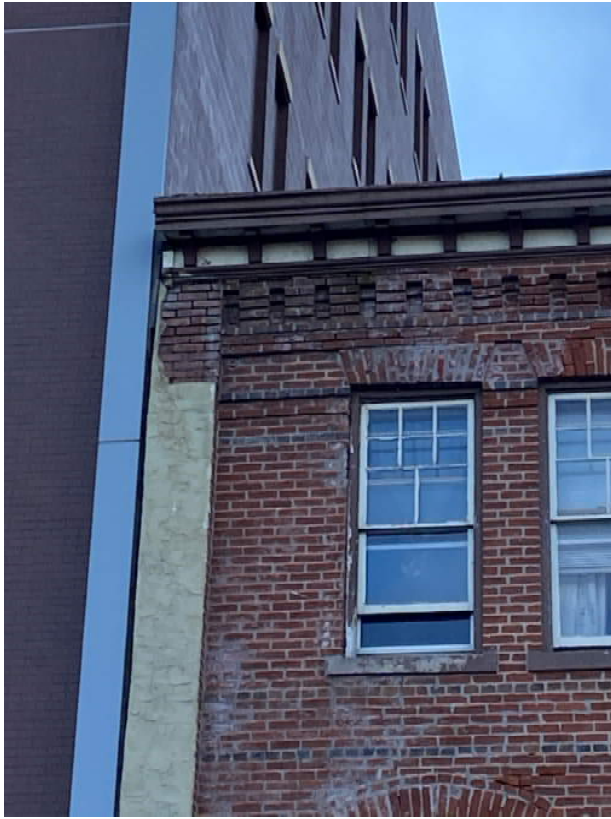
On the north façade there is evidence of water damage within the wall on the eastern side as is evident by the efflorescence and the spalling of some of the brick (Photo 5). There is a crack in the façade where the two buildings meet, with the crack appearing to grow wider toward the top which could suggest the 18 building is settling and moving away from the 14 Building (Photo 6).

Photo 5 – Water infiltration on north facade

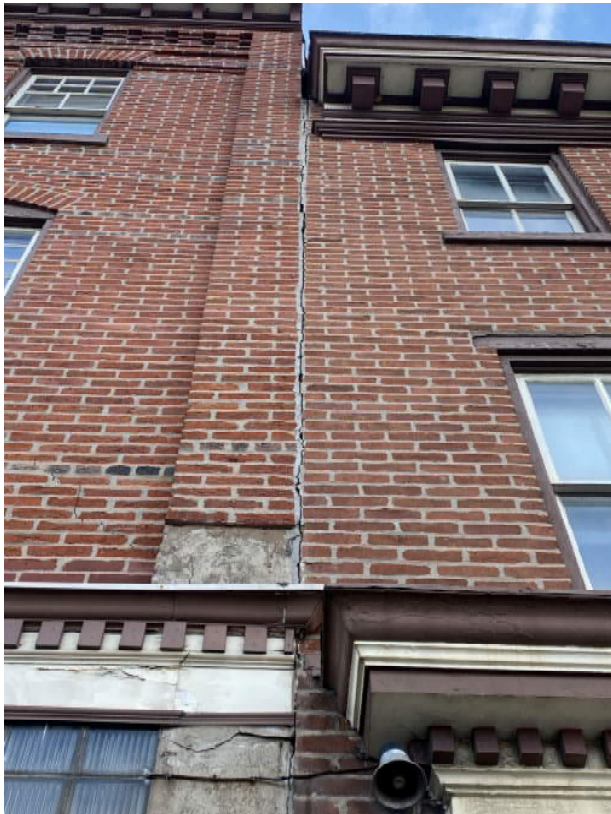
Photo 6 – Crack in north façade – widening toward the top.

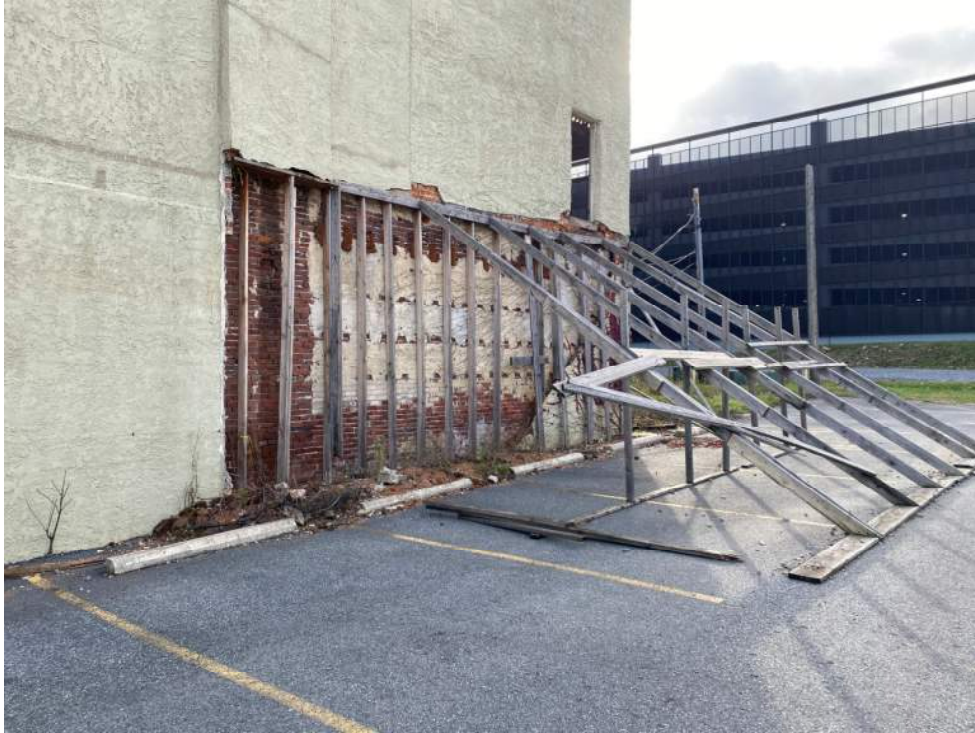
It is understood that several years ago the west wall of the building was impacted by a vehicle, necessitating the installation of the wood shoring on the exterior. This wood shoring has now deteriorated due to constant exposure to the elements (Photo 7). The wall was noticeably damaged by the impact as it's no longer plumb and straight as seen from the outside and there is a bulge on the wall on the inside (Photo 8).

Photo 7 – Shoring on west wall.

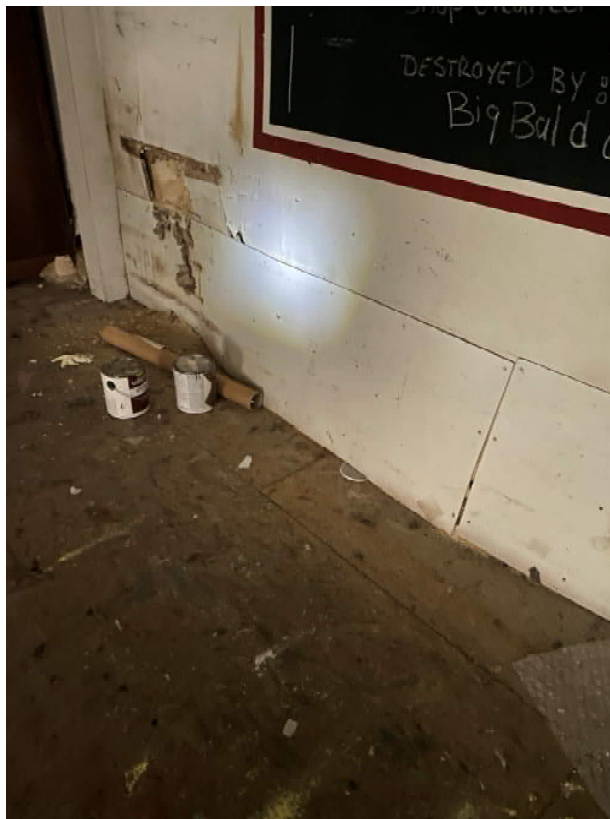
It's understood that the proposed project for this site is a six-story mixed use building with retail on the first floor and apartments above. The existing structure would not be capable of supporting that type of vertical expansion. The unreinforced brick walls and foundations do not have enough capacity to support three additional floors. Of particular concern is the west wall in the area of the vehicle impact, in that location the mortar joints have been broken, significantly reducing the

Photo 8 – Interior of west wall.

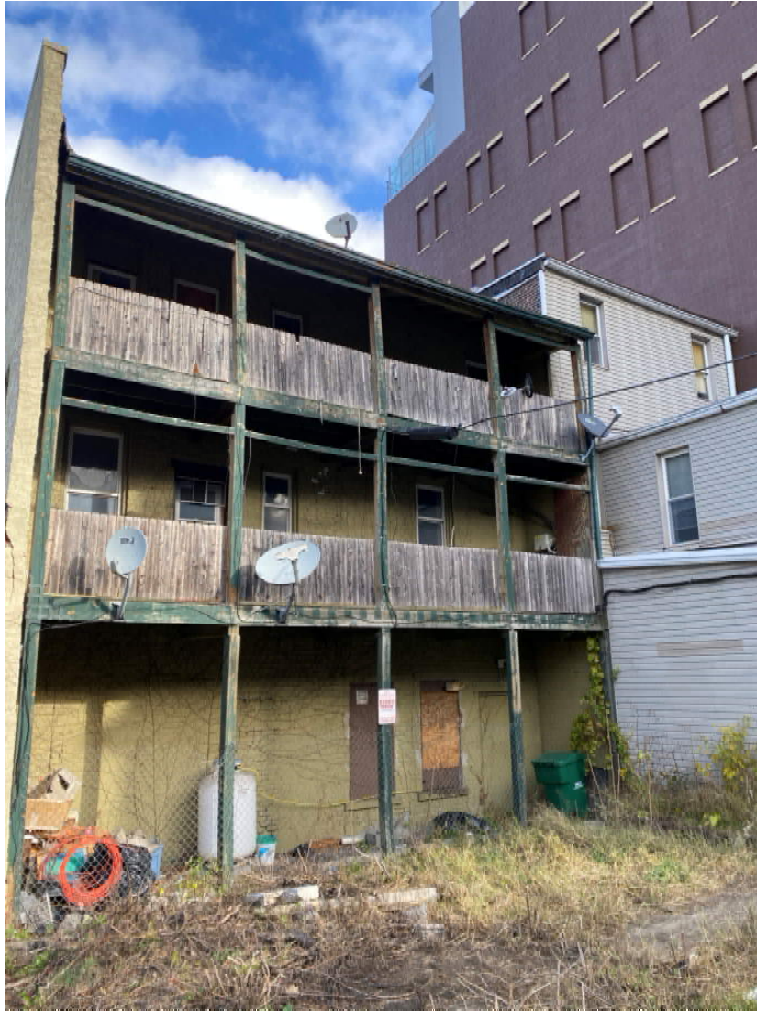
The south elevation consists of exterior wood framed patios which are in poor condition due to prolonged exposure to the elements and would likely need to be rebuilt (Photo 9).

Photo 9 – Patios on south elevation.
