407-409 VINE STREET

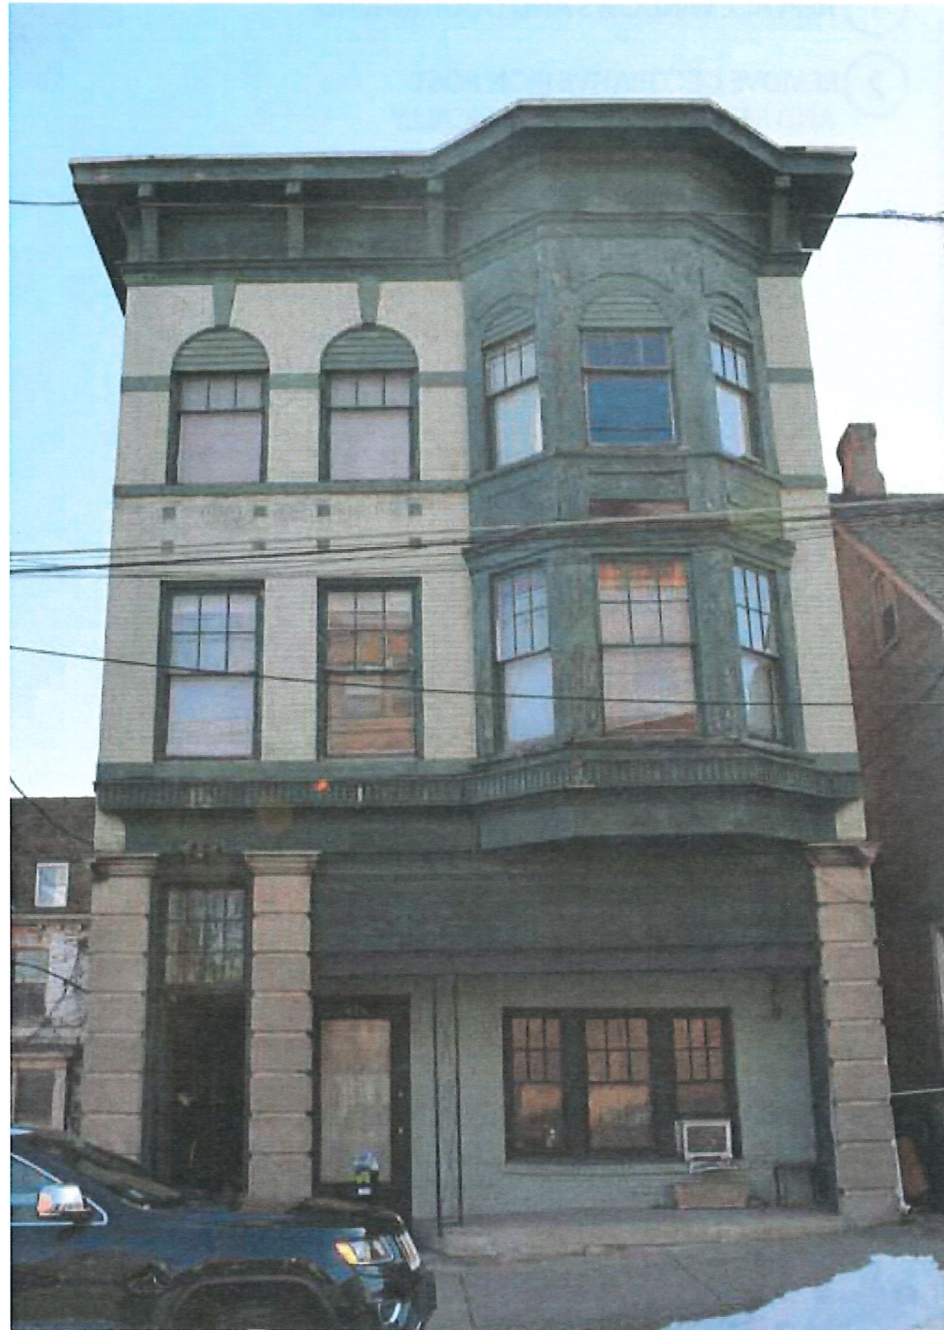
View of Existing Primary (East) Facade, Looking West

Recessed street level wall of 409 Vine Street was determined to be structurally deteriorated and needs to be reconstructed. Shingle siding at transom is not original, although the transom element was likely original above a storefront window

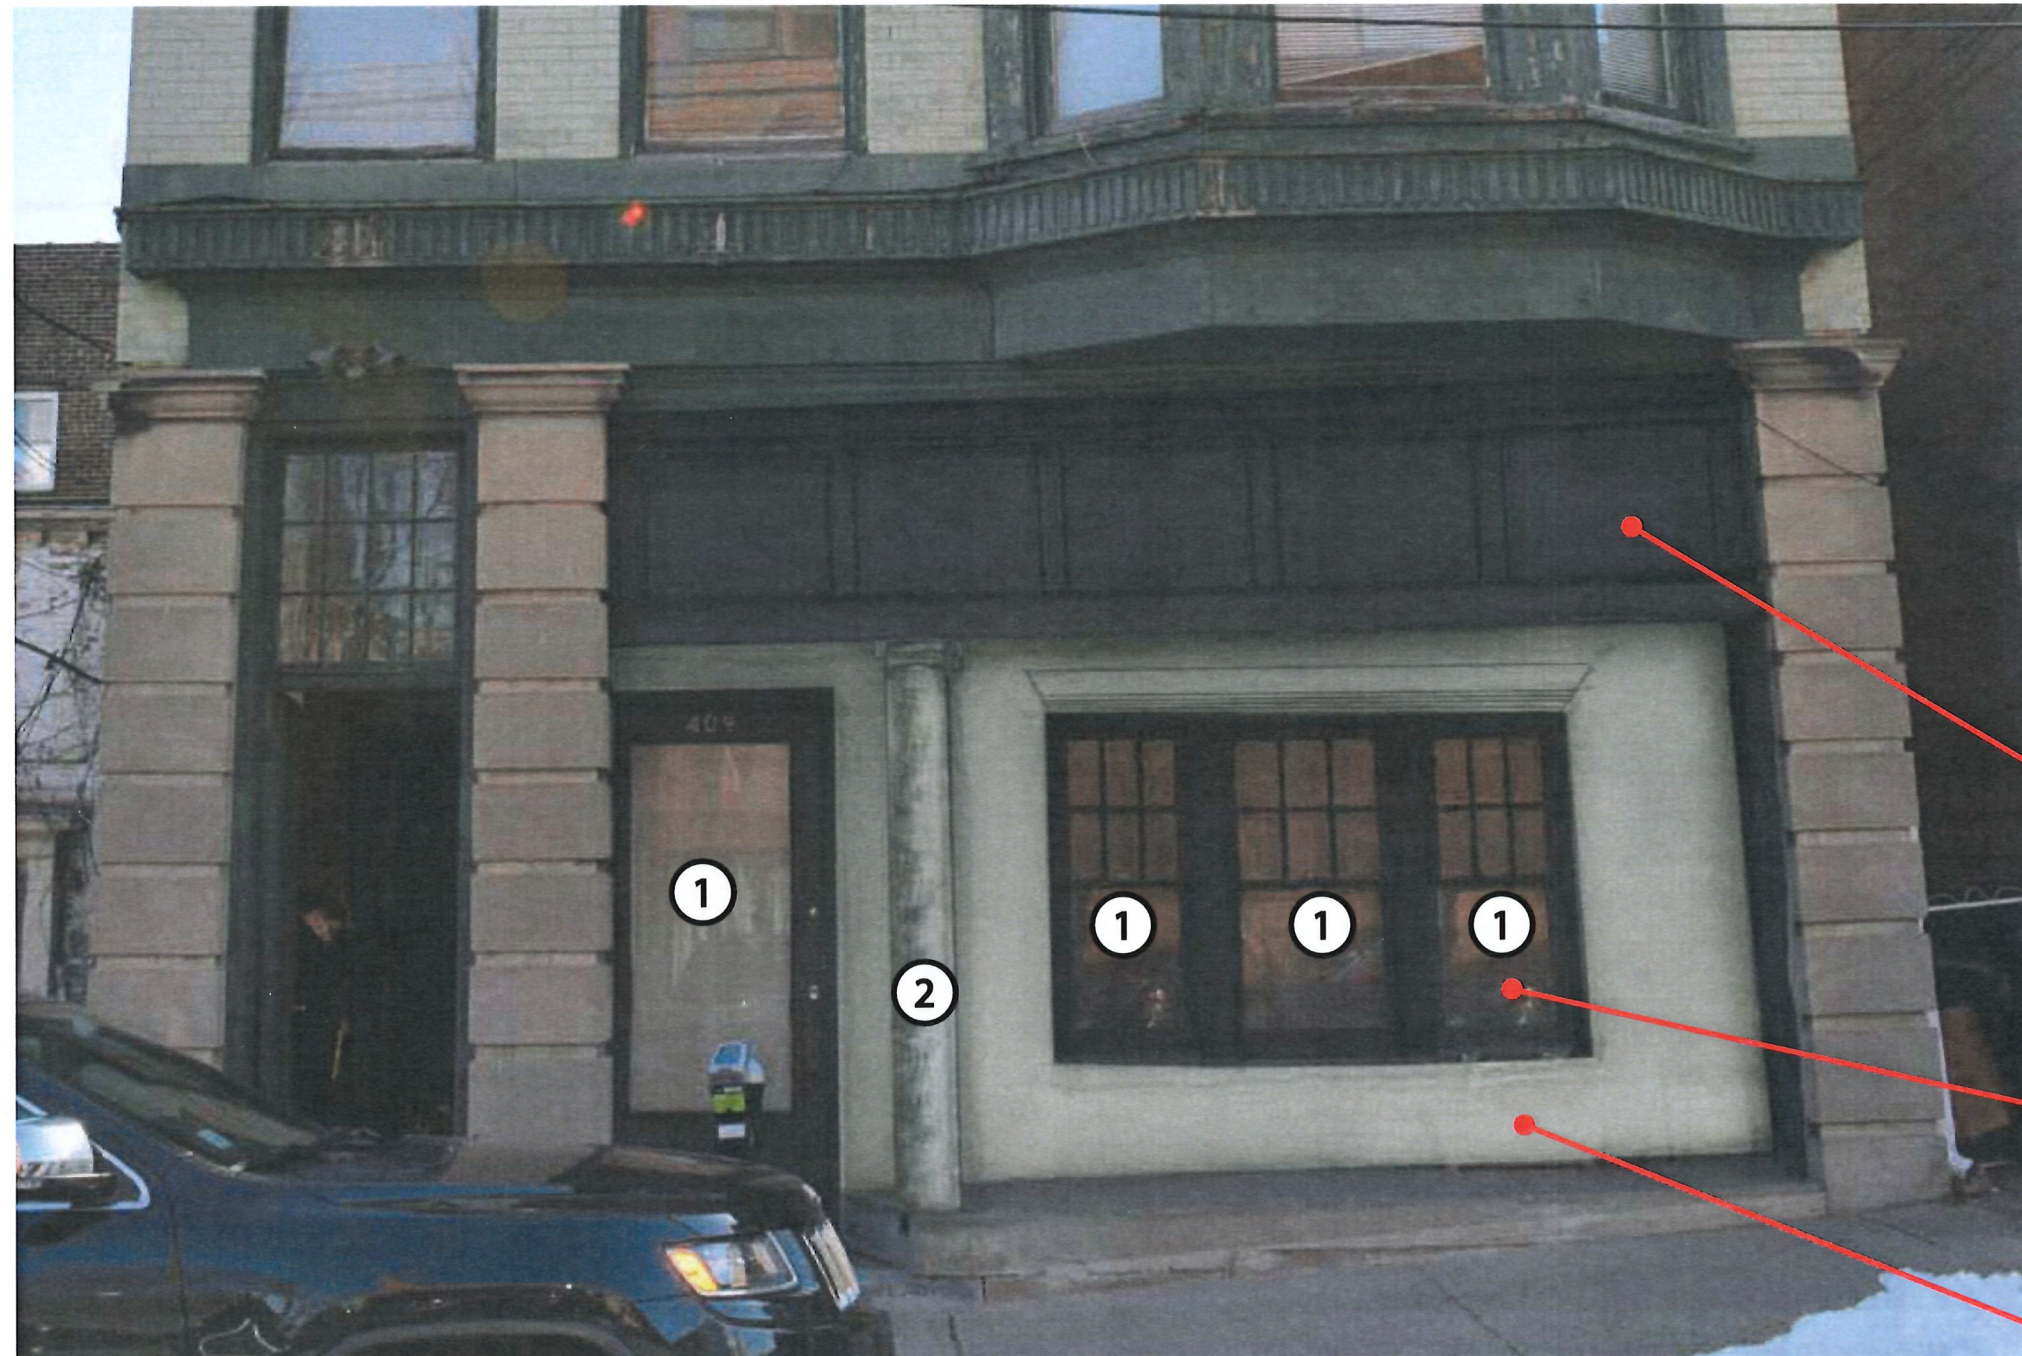
Enlarged View of Proposed Primary (East) Facade at Street Level

DETERIORATED WALL TO BE RECONSTRUCTED (STRUCTURALLY COMPROMISED) AND BRICK TO BE REPLACED WITH STUCCO AT EXTERIOR; NEW WOOD FRAMING AT INTERIOR TO BE REBUILT IN EXIST. LOCATION

- ① REPLACE WINDOWS AND DOOR IN-KIND
- ② REMOVE DECORATIVE IRON POST AND REPLACE WITH HISTORICALLY APPROPRIATE DORIC POST (FIBERGLASS OR COMPOSITE)

REMOVE SHINGLES ON TRANSOM AND REPLACE WITH WOOD PANELING AND RAISED WOOD TRIM TO RECALL LIKELY ORIGINAL RHYTHM OF TRANSOM WINDOWS ABOVE A STOREFRONT

REMOVE AC UNIT AND WOOD PANEL. NEW WINDOWS TO BE ALUM. CLAD WOOD W/ SDL UPPER SASHES. SIZES TO MATCH EXIST. AS CLOSELY AS POSSIBLE WITH WIDE MULLION BETWEEN WINDOWS (COLOR TO BE DARK GREEN TO MATCH EXIST.
