Project or Contract Reference: Amendment of Consulting and Engineering Services for Structural Evaluations at City Hall, Project No. MS-19-W01

Project Title: Structural Evaluations at City Hall Complex

RE: Bethlehem City Hall Complex
Additional Deficiencies Discovered During Garage Investigation

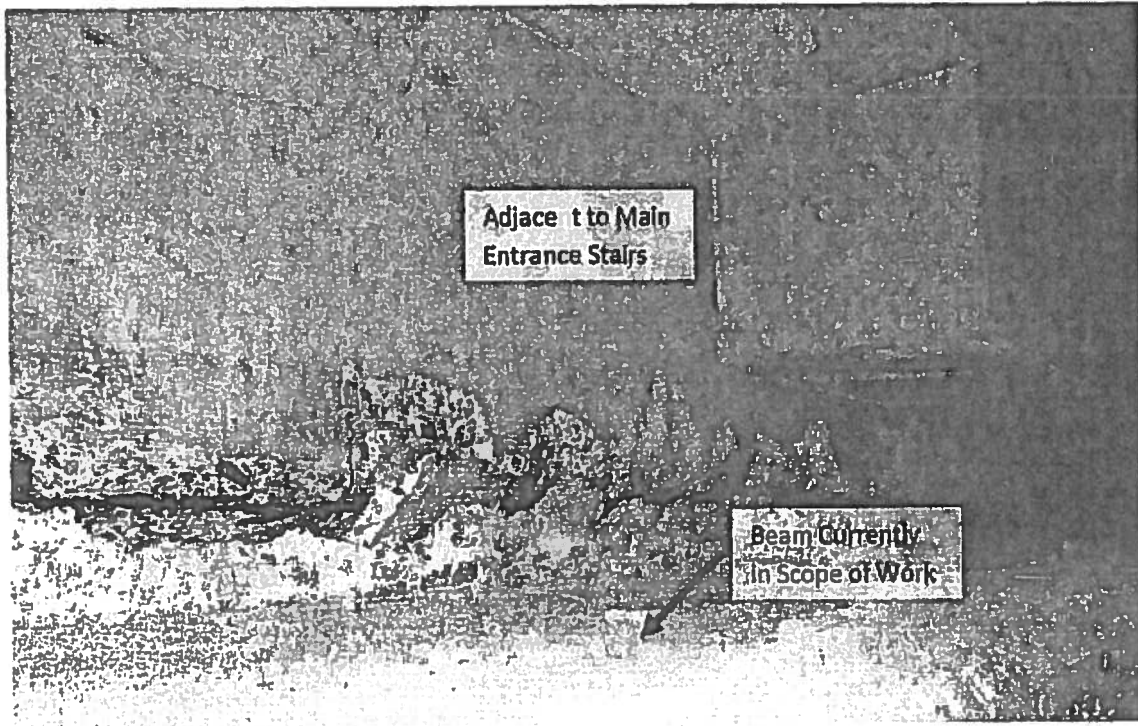
1. An approximate 65' long section of concrete wall was observed to have severe concrete spalling and damage to the bottom of the wall (Reference Photos 1-3 and SK-1). The wall is located directly under the library's main entrance steps and directly above the damaged plaza beam that is currently included in the scope of our repairs. From our review of the existing drawings, this wall appears to be an extension of the east wall of the library colonnade. The wall supports the granite benches and vertical panels around the perimeter of the library plaza/colonnade. It is our opinion that expanding the current scope of repair work to include the plaza wall will likely be the most cost-effective option.

Photo 1: Item #1- Bottom of Library Wall spall damage located under Library Main Entrance Stairs

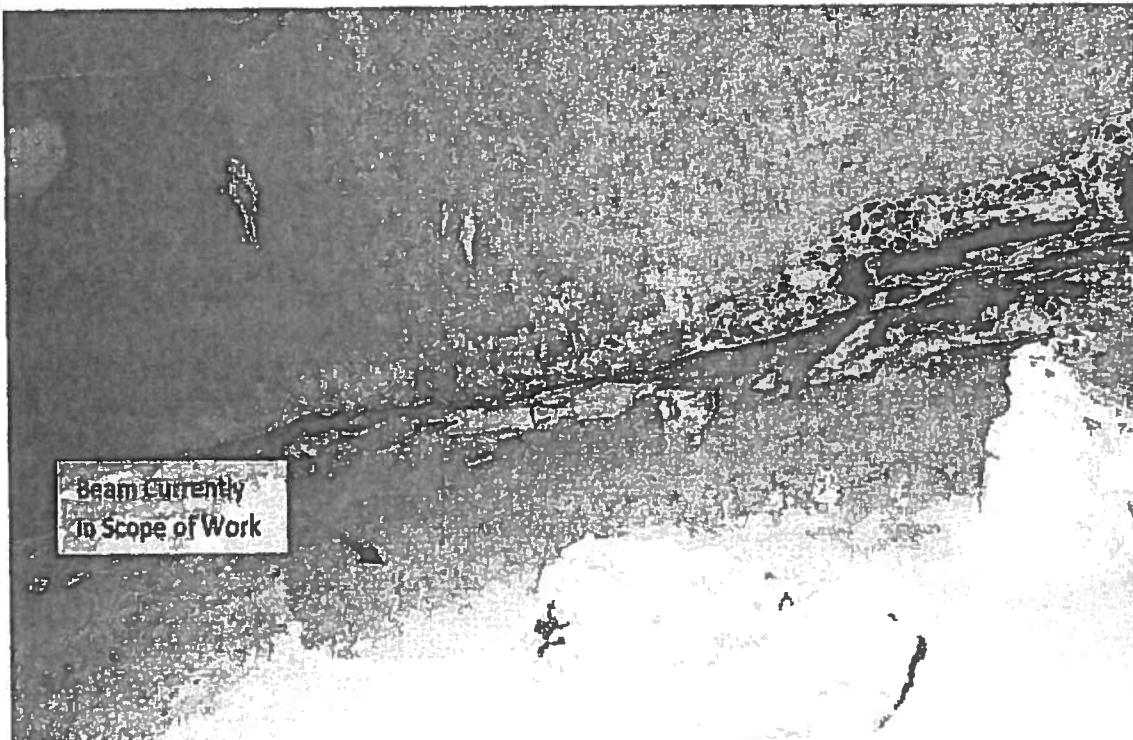
Photo 2: Item #1- Bottom of Library Wall spall damage located West of the Library Main Entrance Stairs

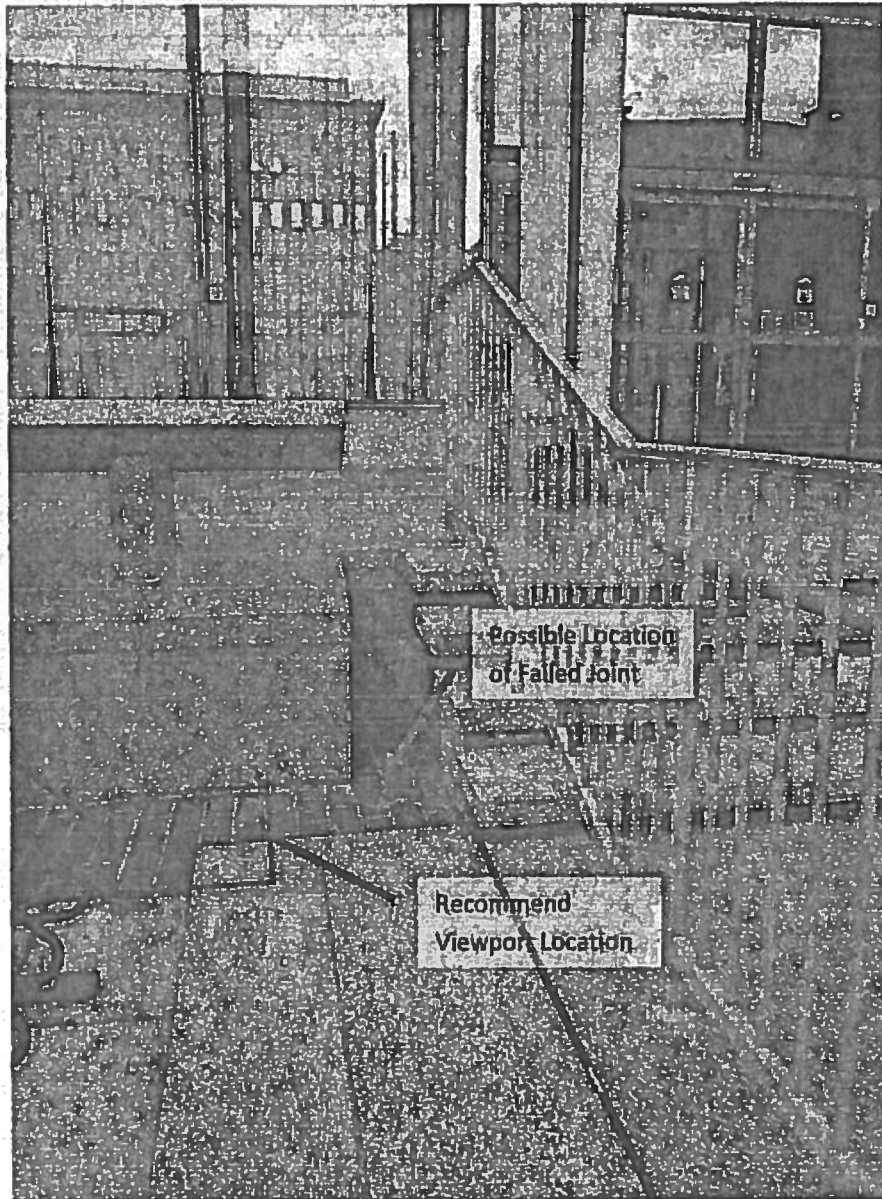
From review of the existing drawings, it appears that a 1-1/2" wide expansion joint is located adjacent to the exterior face of the plaza wall. Based on the observed damage to the concrete plaza wall and plaza beam, this expansion joint has likely failed and is allowing water to infiltrate. We recommend that exploratory viewports be opened in order to examine the condition of the expansion joint and confirm the cause of the damage to the wall and beam below. The viewports would involve the removal of brick pavers adjacent to the library steps at several locations (Reference SK-1 and Photo 3). We recommend addressing this issue prior to repairing the concrete plaza beam to allow the beam repairs to be done concurrently and to reduce costs. If the water infiltration is not addressed, the lifespan of the current repairs will likely be reduced due to further damage.

Photo 3: Item #2- Failed Expansion Joint at Library Colonnade Wall

We recommend further investigation for items 1 and 2 in order to determine the condition of the concealed expansion joints. We recommend a minimum of two (2) exploratory viewports at each expansion joint for a total of four (4) viewports at the plaza level. This will allow for a better analysis of the source of water infiltration and the development of appropriate repair details. Pennoni can provide a proposal for observation of exploratory viewports and to develop repair designs for the expansion joints based on observations at the viewports.

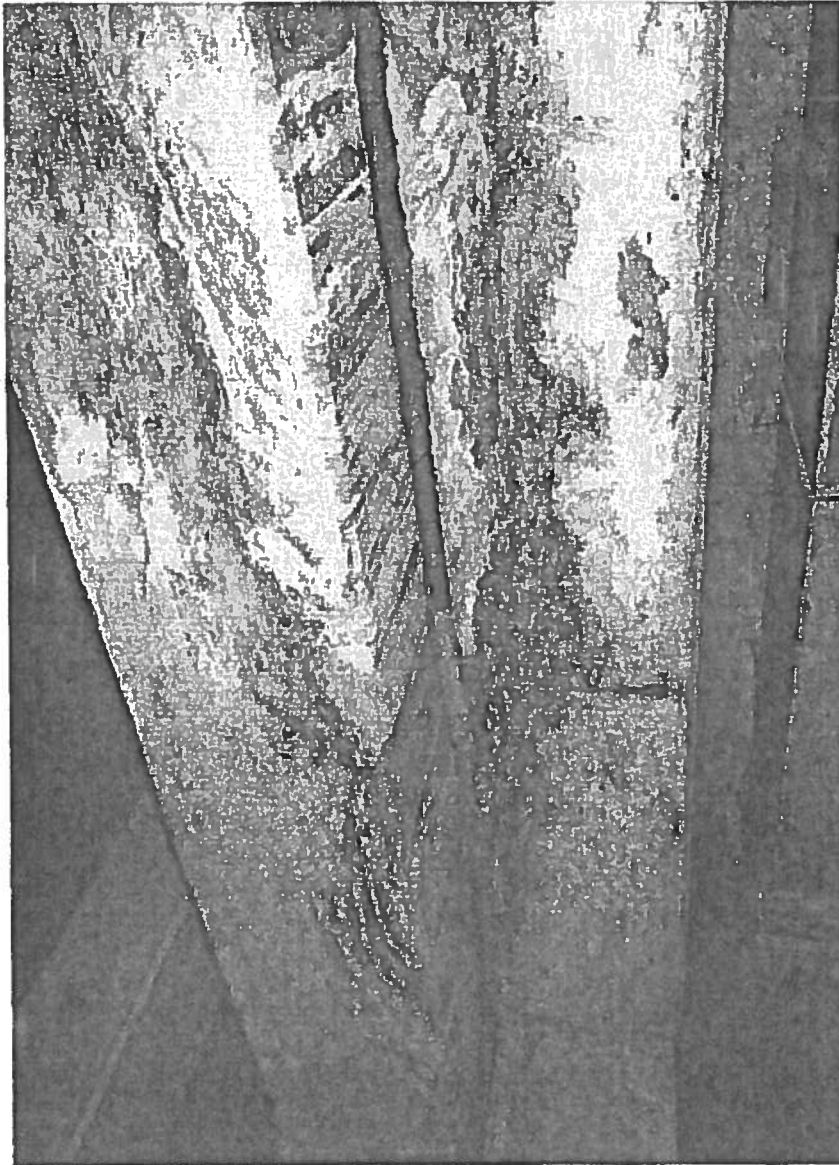
2. An approximate 40' section of the 1-1/2" expansion joint located at the center of the plaza, near the southeast corner of the library colonnade (Reference Photos 4-6 and SK-2). The failure has resulted in significant water infiltrating the garage area below the joint location. The water infiltration appears to have contributed to the parking garage slab deterioration below this area. We recommend that exploratory viewports be opened in order to investigate the condition of the expansion joint and determine possible repairs. The viewport would likely involve the removal of brick pavers at several locations (Reference Sk-2 and Photo 5).

Photo 4: Item #2- Water infiltration due to failed expansion joint near the center of the plaza

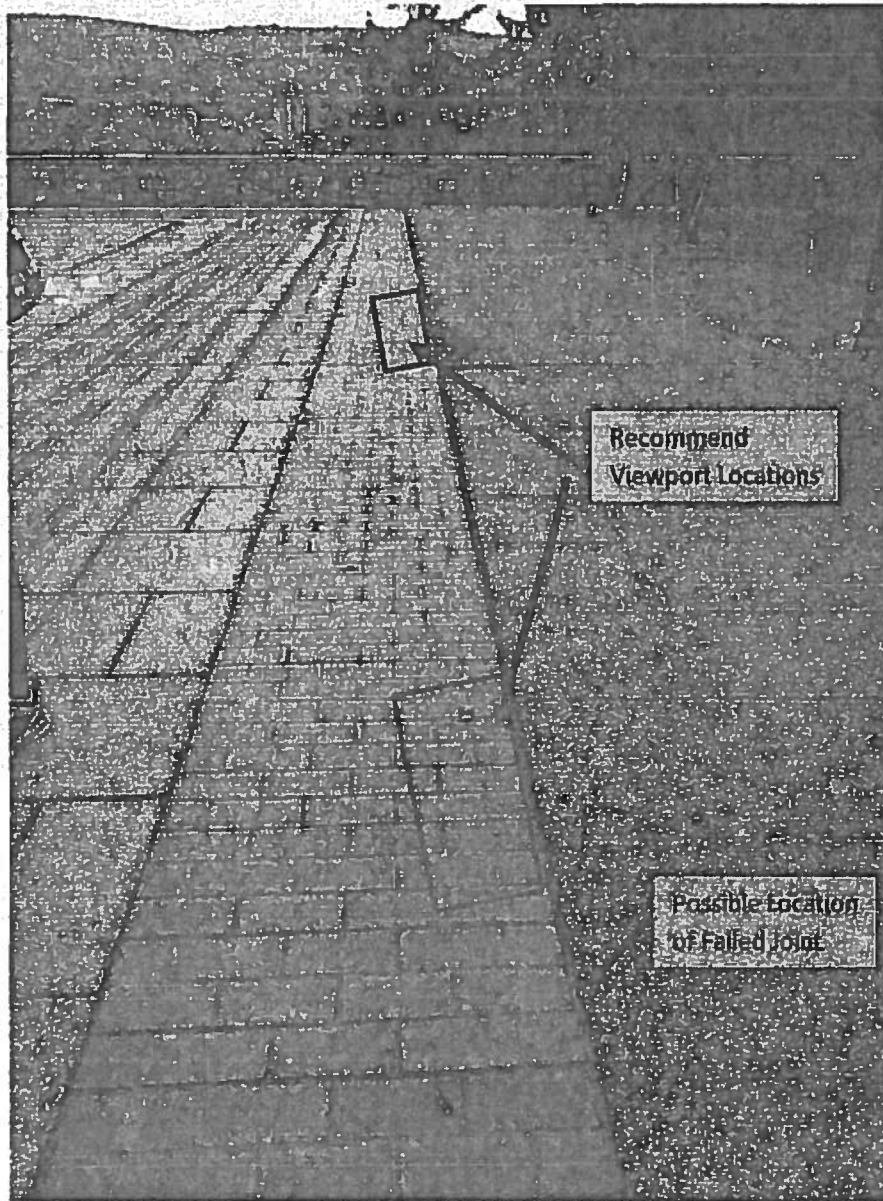
Photo 5: Item #2-Failed Expansion Joint - Approximate Location

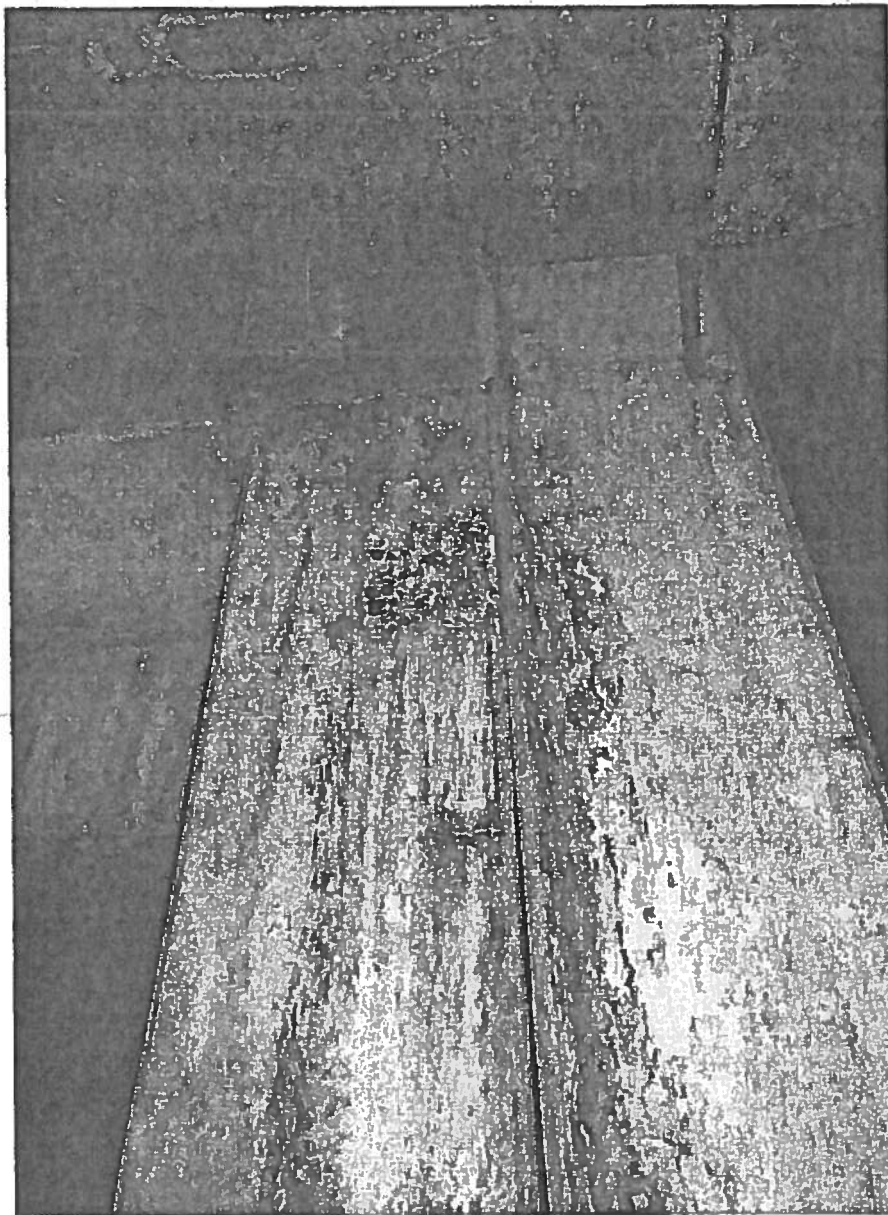
Photo 6: Item #2-Water infiltration due to failed expansion joint at columns/spalled concrete

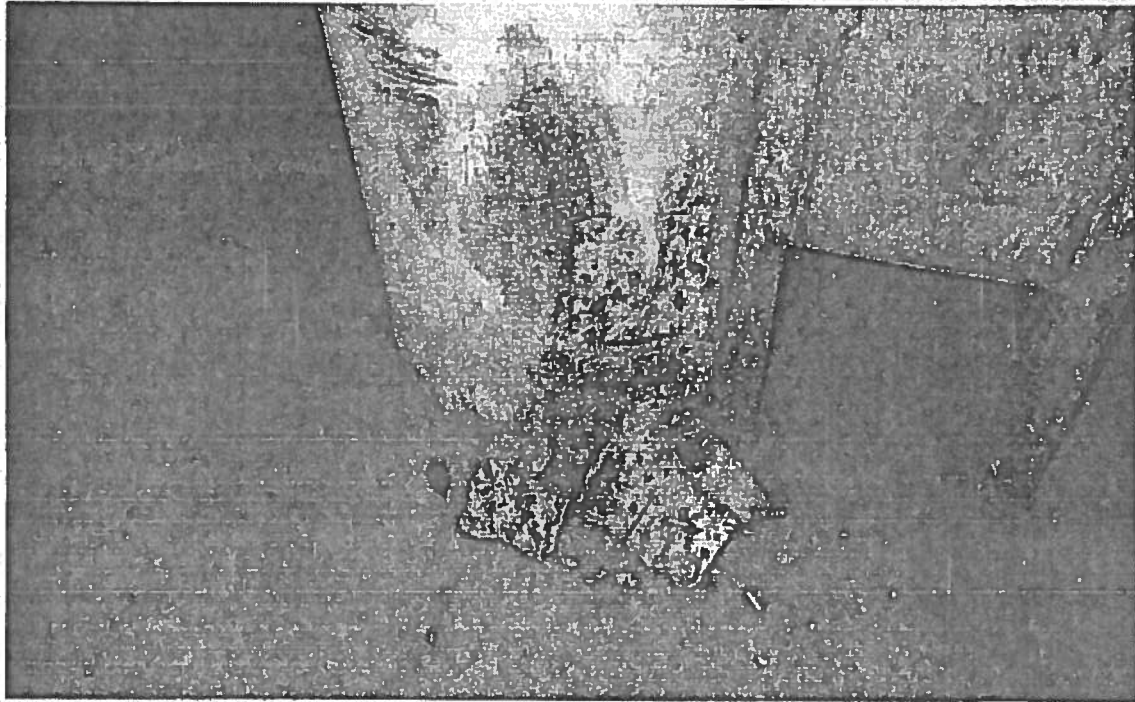
3. Multiple concrete columns located in the garage were observed to have areas of concrete spalling primarily located at the base of the columns (Reference Photos 6-7 and SK-2). Expanding the current scope of repairs to include the columns with the parking garage slab repairs will likely be the most cost-effective option.

Photo 7: Item #3-Typical Column Spall at Base

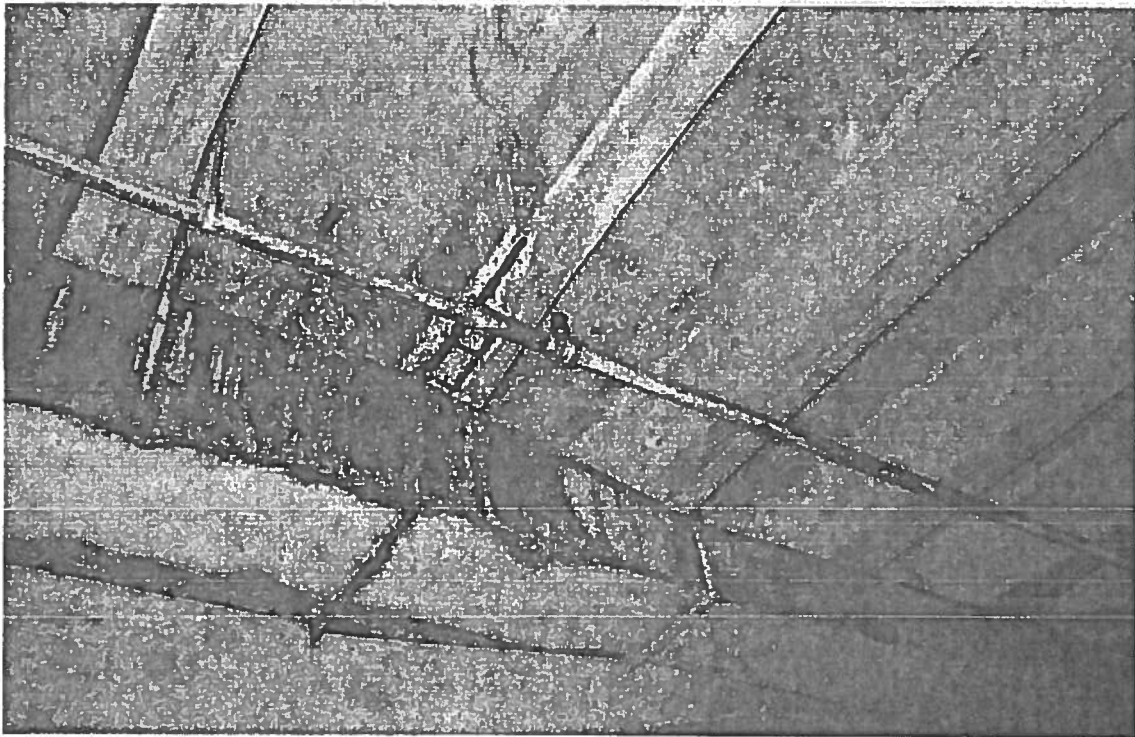
4. Severe spalling was observed at one of the concrete panel ribs located directly adjacent to the plaza beam (Reference Photo 8 and SK-2). Expanding the current scope of repairs to include the panel rib along with the plaza beam repairs will likely be the most cost-effective option.

Photo 8: Item #5-Spall Damage at Panel Rib
