RE: Application for Certificate of Appropriateness

Re: Existing Buildings
319, 321, 323, 325, 327 South New Street
Bethlehem, PA

The Ballina Group, LLC performed an inspection of the buildings referenced above on Tuesday, August 11, 2020. The purpose of this inspection was to document existing conditions and note building deficiencies as they relate to life safety, general building code compliance, and overall building integrity.

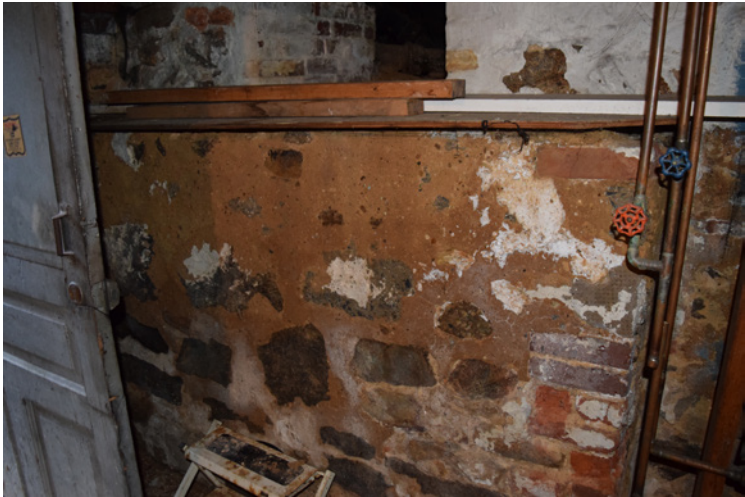
Each basement showed signs of moisture/water intrusion, although no active leaks were present at the time of the inspection. This foundation construction method is historically susceptible to leaks and intrusion which can create air quality and mold issues. The basements are unventilated, which present long term risks to structural framing and overall building and occupant health.

Crumbling Foundation

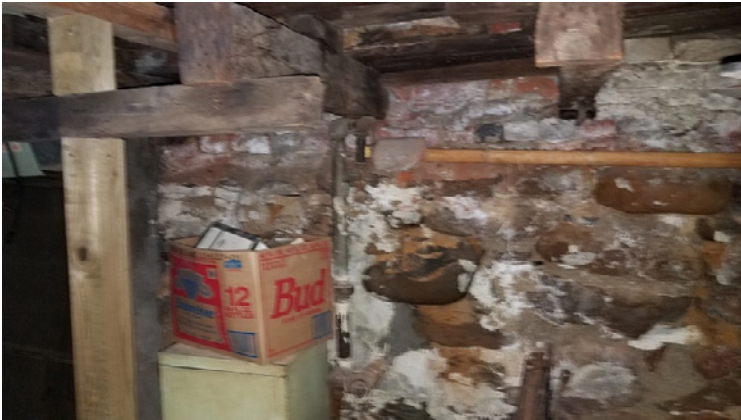
Crumbling Foundation

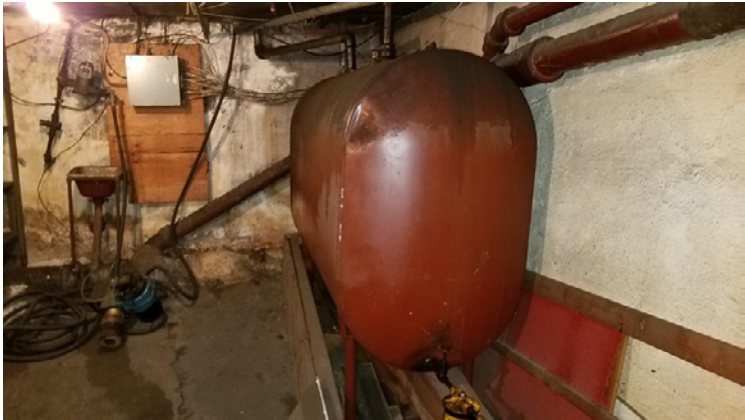
- A total of 850 gallons of oil can be stored in the basements of the buildings at any time (assuming tanks are regularly filled). These fuel tanks are the buildings’ main heat source. In a multi-story/multi-occupant building, the continued presence of these tanks poses a risk of direct surface release in the event of damage or deterioration, which can be harmful to the building materials and occupants.

Oil Tank and Electrical

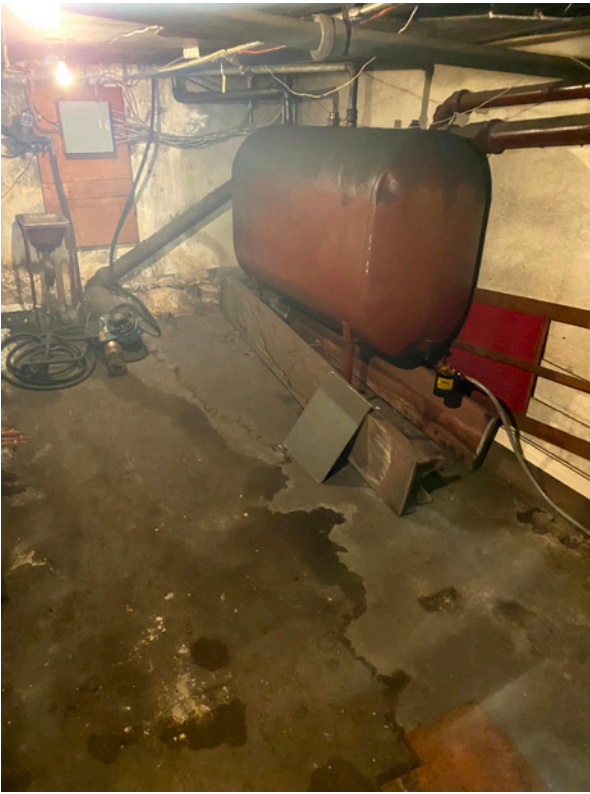
Oil Tank and Concrete Floor

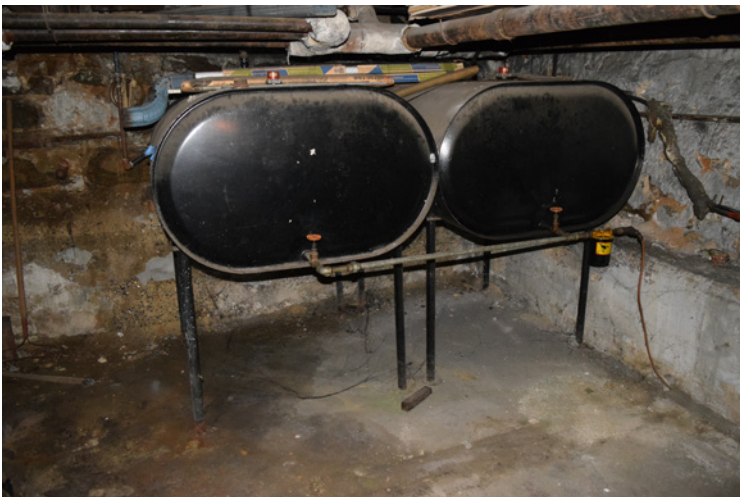
Oil Tanks

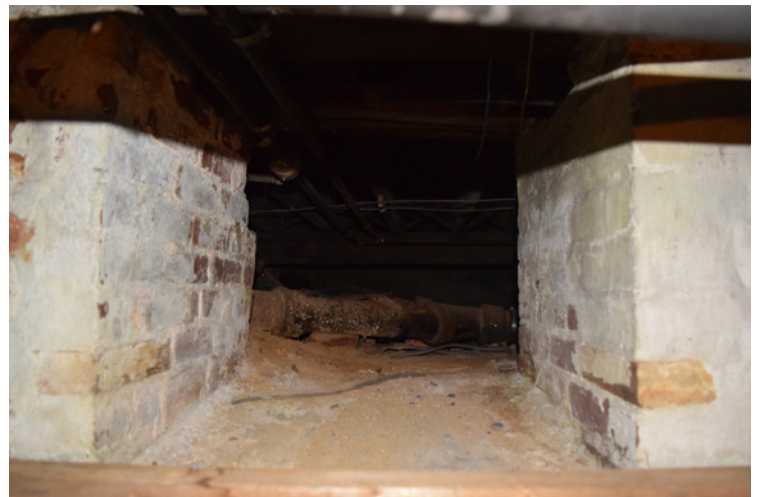
- Unventilated basements can be a breeding ground for mold and other harmful bacteria / organisms.

Unventilated Crawl Space

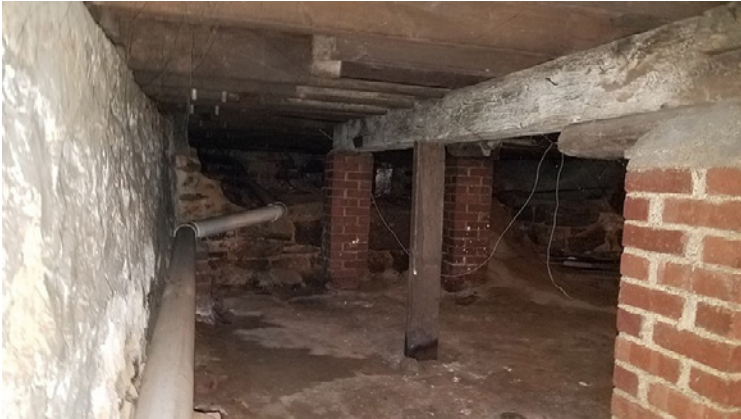
Unventilated Crawl Space

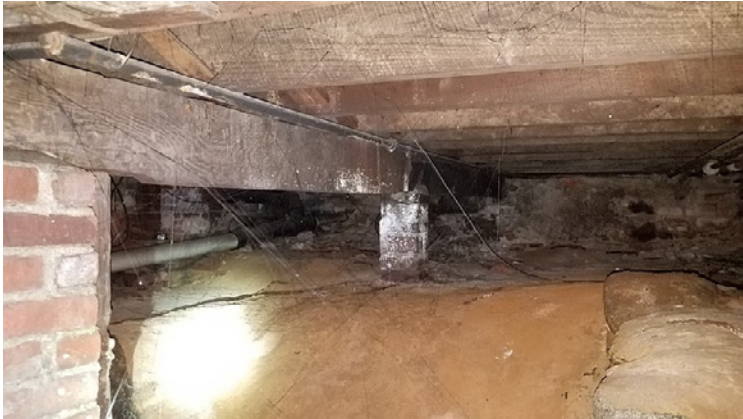
Unventilated Crawl Space

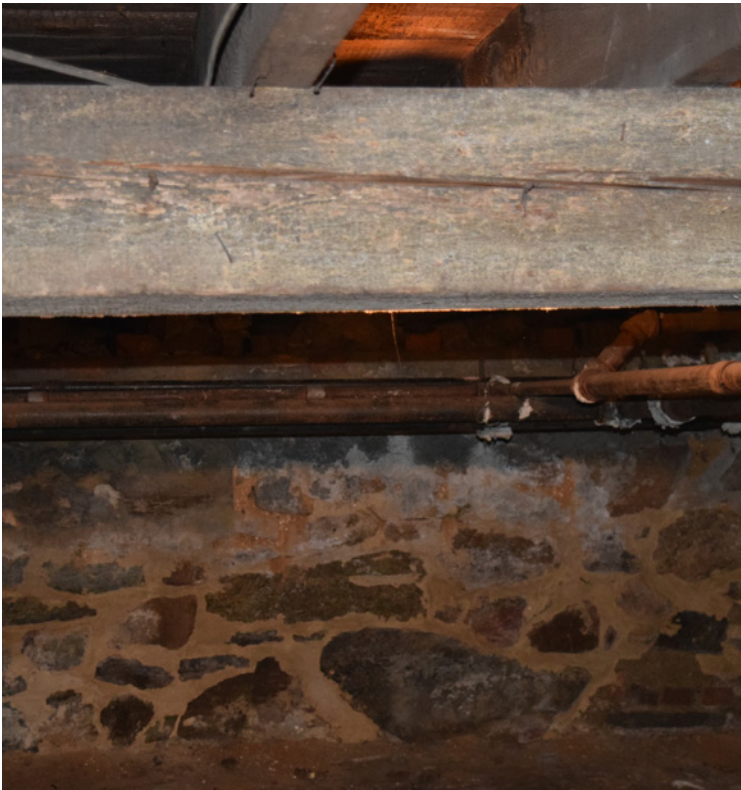
Unventilated Crawl Space with checked beam

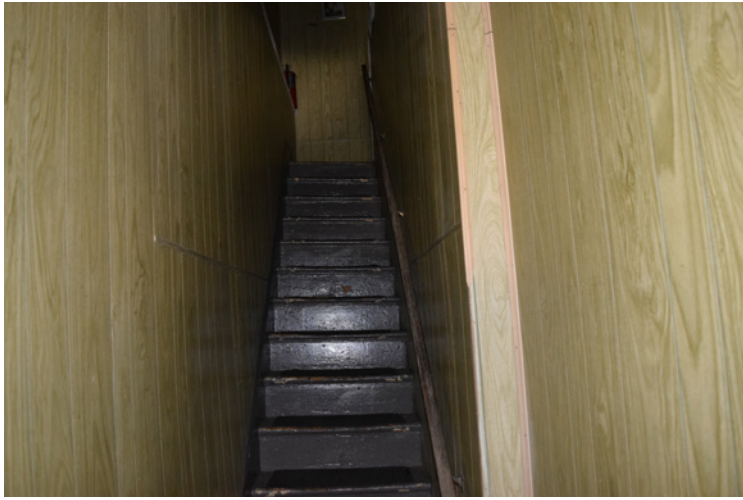
- Exits blocked by tenant usage. In the event of evacuation, this can pose an unnecessary risk.
- Staircases not code compliant. Stairs exceed allowable rise and run permitted by code. Staircase width appears to be too narrow to comply with code.

Narrow, steep staircase

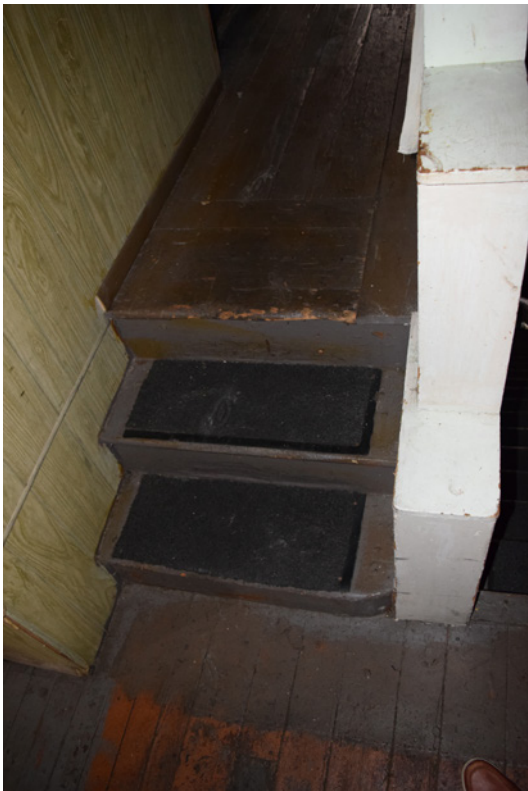
Unsafe split level stair

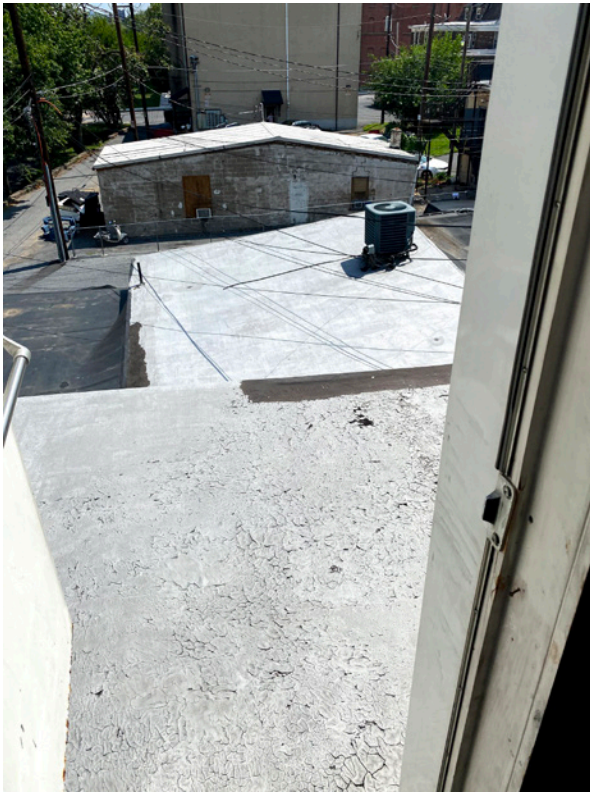
No egress on roof

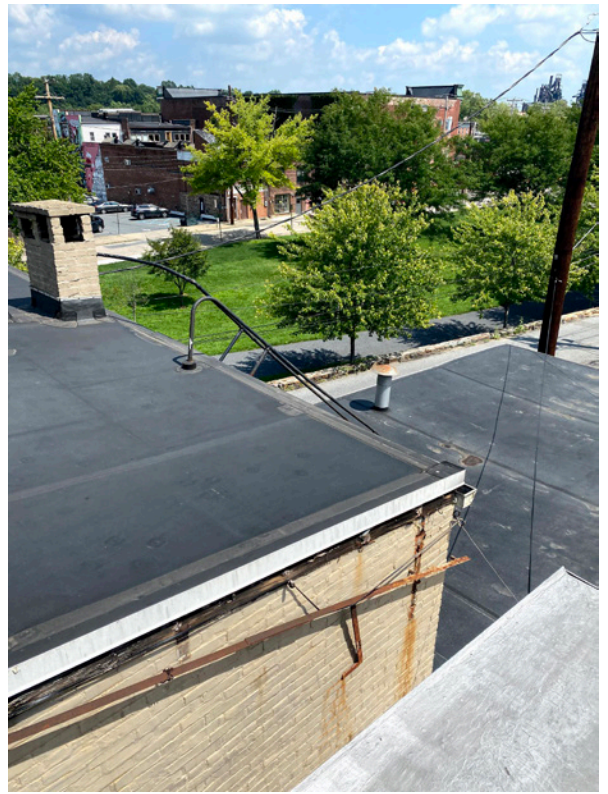
Illegal stair leads to lower roof, no access to grade

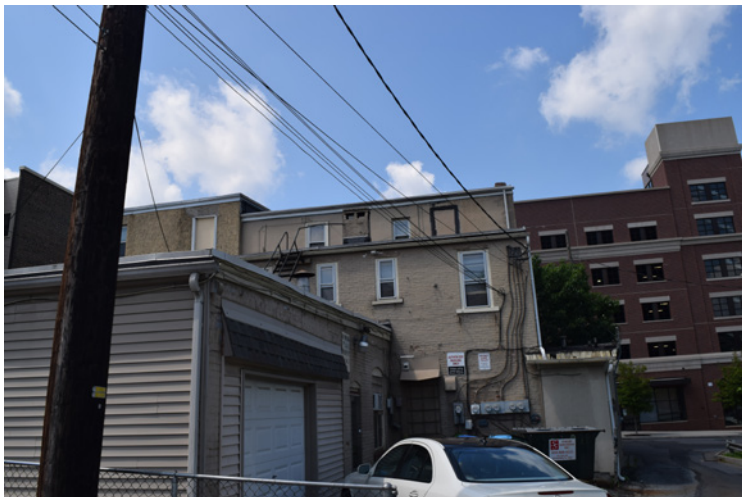
No access to grade

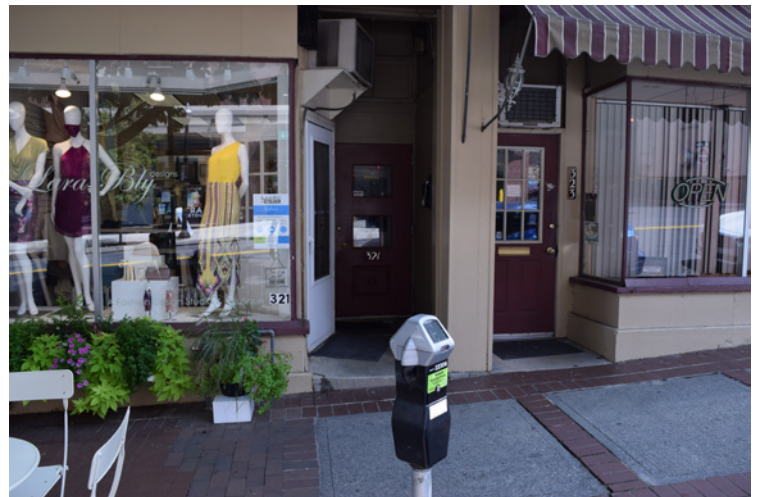
- Building main entrances/exits are not ADA accessible. Given the existing slope of the public way, they are unable to be upgraded appropriately without causing significant disturbance to the public way and limit use to pedestrians.

Existing Entrance, Non-ADA Compliant

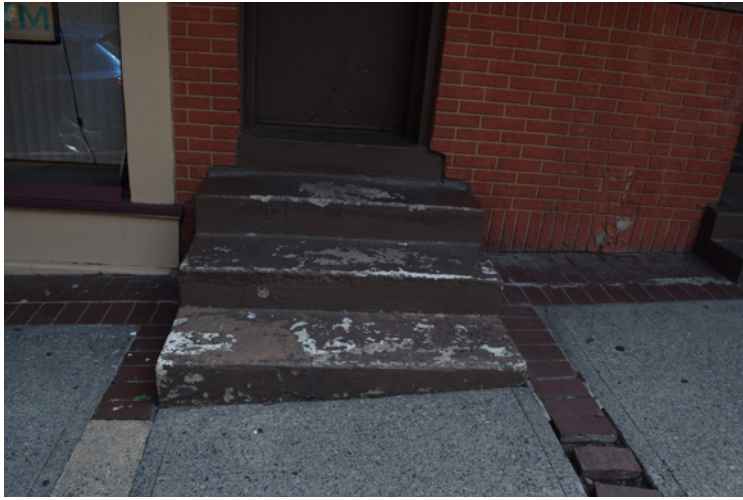
Existing Entrance, Non-ADA Compliant

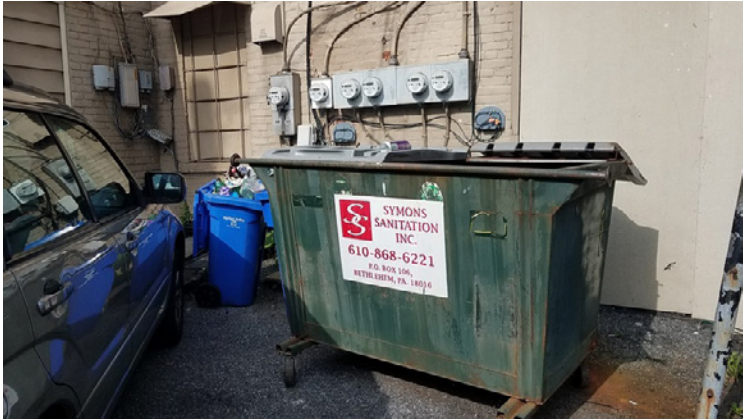
Dumpster against building blocking egress path
