Re: **1304 SPRING STREET  
CONDITIONS ASSESSMENT  
NOVEMBER 8, 2023**

## Holy Family Senior Living – 1304 Spring Street, Bethlehem, PA Condition Assessment

SFA Project. No. P-888

November 9, 2023

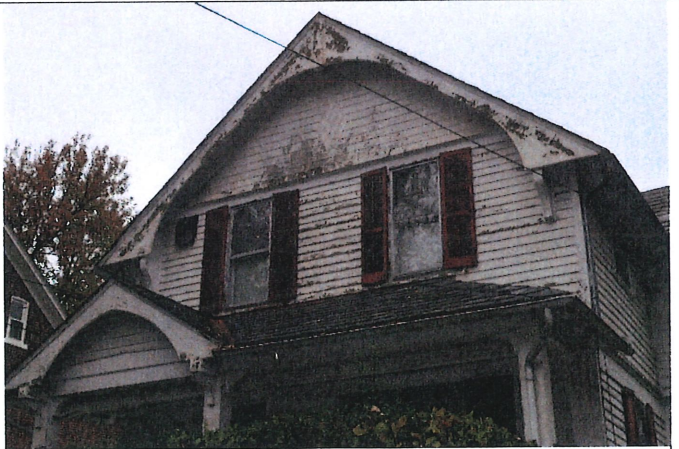
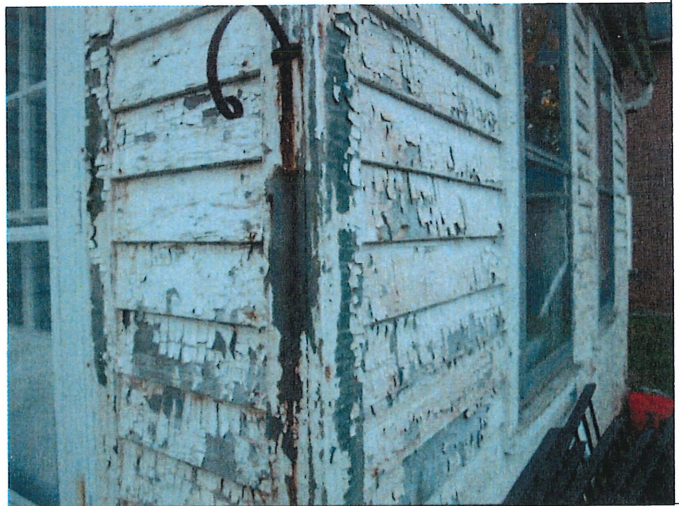
3. The building is a Queen Anne style of architecture.
4. The interior spaces are very damp and mold does exist in the building.
5. The exterior facade is horizontal wood siding which is in fair condition overall but is desperately in need of all new paint. The existing paint is peeling badly and must be removed completely. The existing paint contains lead and must be removed and disposed of properly. There are portions of the wood siding that will need to be repaired or replaced.

| EXTERIOR AND INTERIOR ITEMS | | | | |
|---|---|---|---|---|
| 1 | 1 | G | <p>The existing paint on the exterior of the building is peeling badly. The paint contains lead and must be removed before the building is repainted.</p> <p>Estimated Cost: \$50,000</p> | |

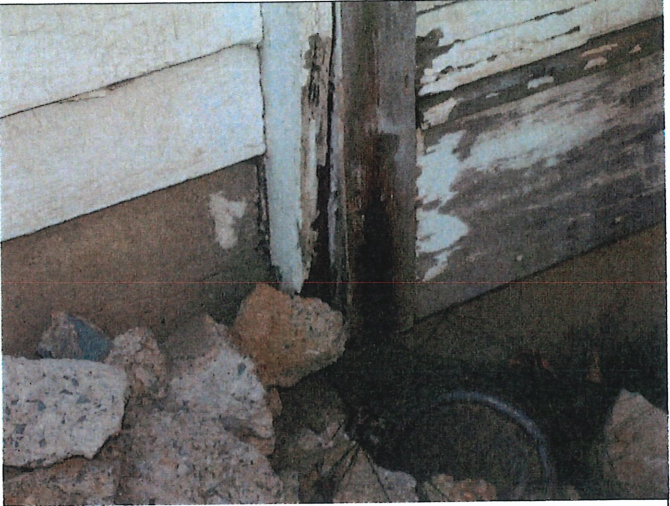
| 2 | 1 | G | <p>There are several areas on the exterior of the home where the wood siding and or trim has deteriorated and must be repaired or replaced.</p> <p>Estimated Cost: \$5,000</p> | |

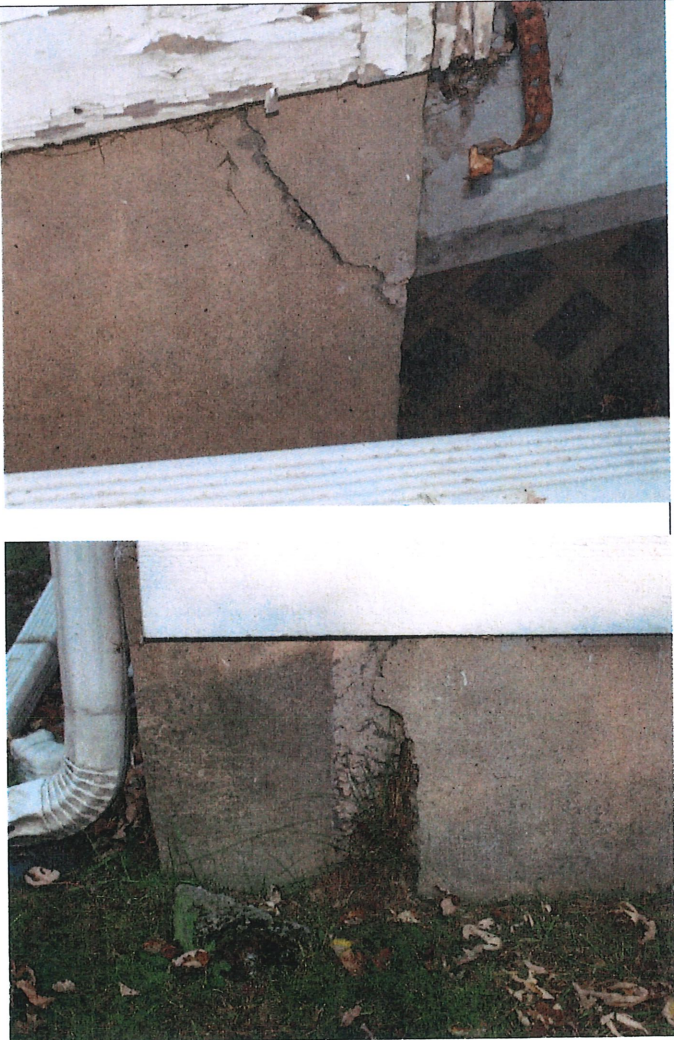
6. The foundation wall is in fair condition but there are a few minor cracks which will need further structural evaluation.
7. The roof is a steep sloped roofing system with the original slate shingles which are in very bad condition and will need to be removed and replaced. There are existing areas on the roof which are allowing water to enter the building. It is obvious that repairs to the roof have been completed in the past. If a new slate roof is provided, there will be a need for some of the existing rafters to be replaced in kind. Previous roof leaks caused will numerous damages to the ceilings on the second floor.

| 3 | 1 | G | <p>The concrete foundation wall has a few minor cracks in it and at the front porch there are two foundation issues that need to be addressed and corrected.</p> <p>Estimated Cost: \$18,000</p> | |

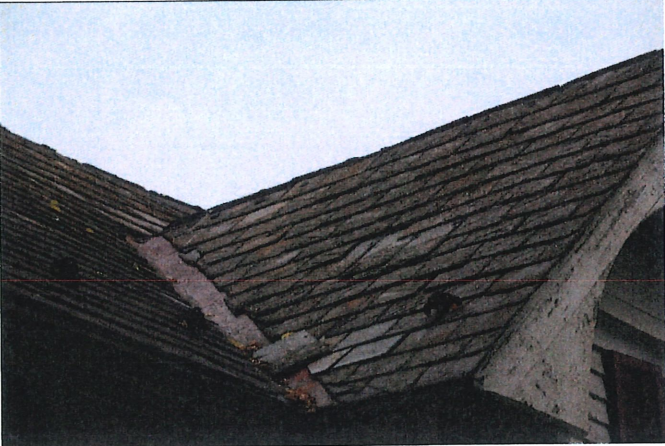
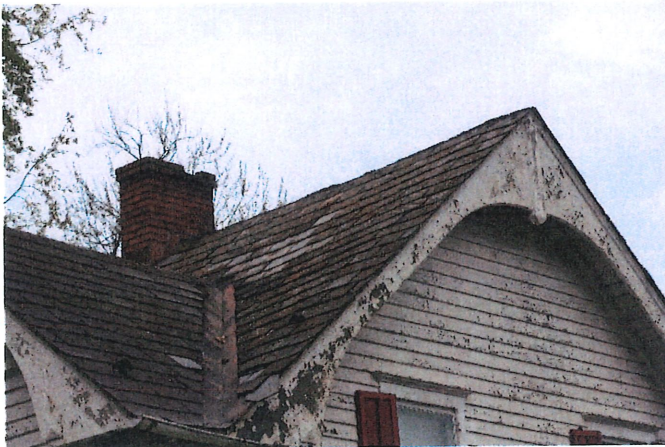
| 4 | 1 | G | <p>The roof is a steep sloped roofing system with the original slate shingles which are in very bad condition and will need to be removed and replaced. There are existing areas on the roof which appear to be allowing water to enter the building. It is obvious that repairs to the roof have been completed in the past. If a new slate roof is provided, there will be a need for repairs to the existing roof rafters.</p> <p>Estimated Cost: \$30,000</p> | |

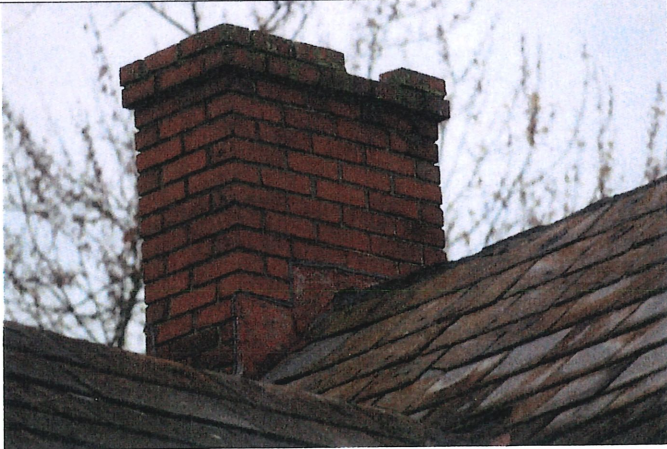
8. The brick chimney is in fair condition but will need to be repaired.
9. The interior walls and ceilings are plaster on a wood lath. A large portion of the plaster walls will need to be removed and replaced due to damages or deterioration from leaks. The plaster was tested for asbestos and the results were negative.

| 5 | 1 | G | <p>The brick chimney will need to be repaired and should have a flue cap installed.</p> <p>Estimated Cost: \$5000</p> | |

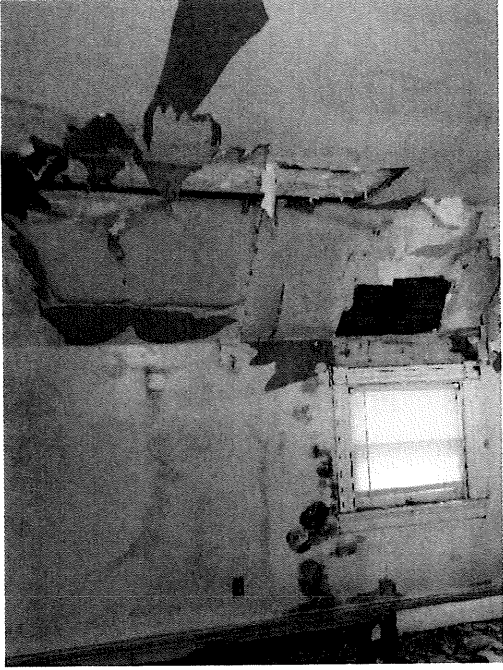
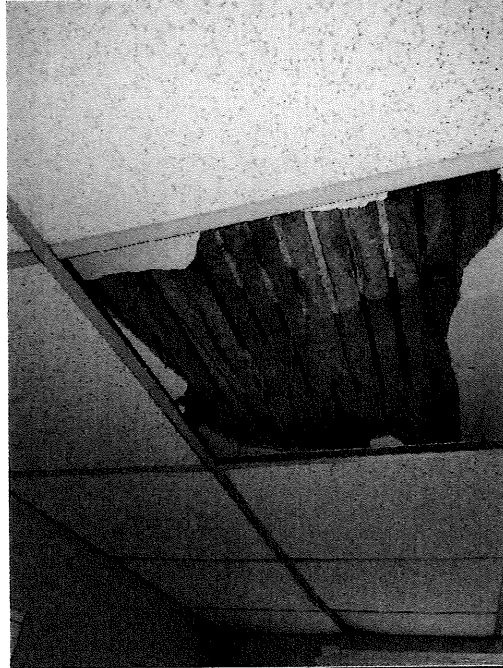
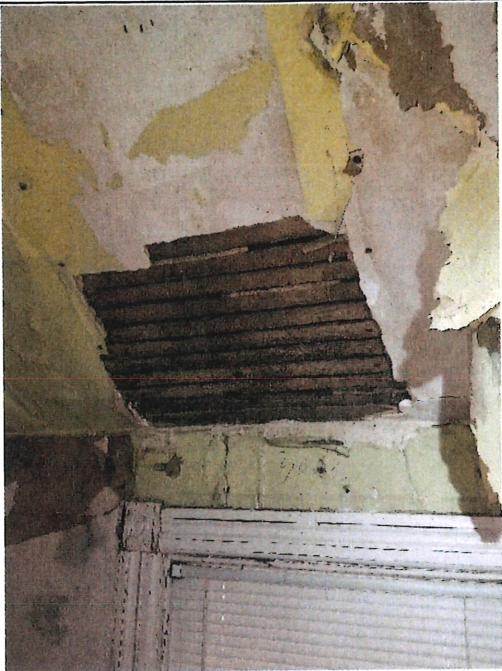
10. The second floor ceilings are damaged beyond any repairs and will need to be completely removed and replaced.
11. The basement floor is very damp as it is apparent that water enters the basement periodically.

| 6 | 1 | G | <p>The interior walls and ceilings are plaster on wood lath. A large portion of the plaster ceilings on the second floor will need to be removed and replaced due to damage or deterioration from leaks.</p> <p>Estimated Cost: \$40,000</p> | |

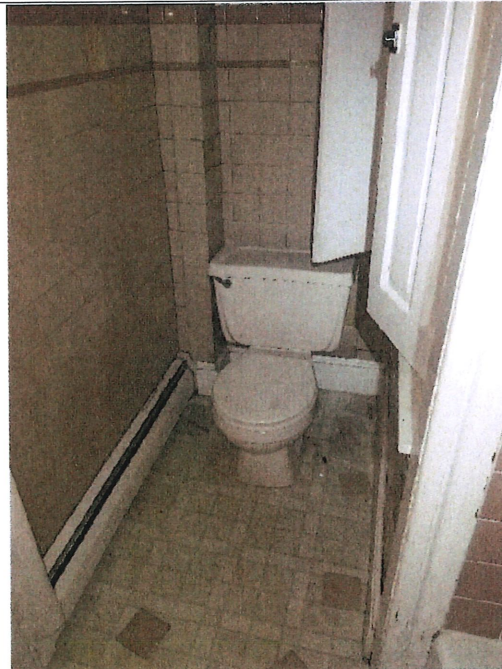
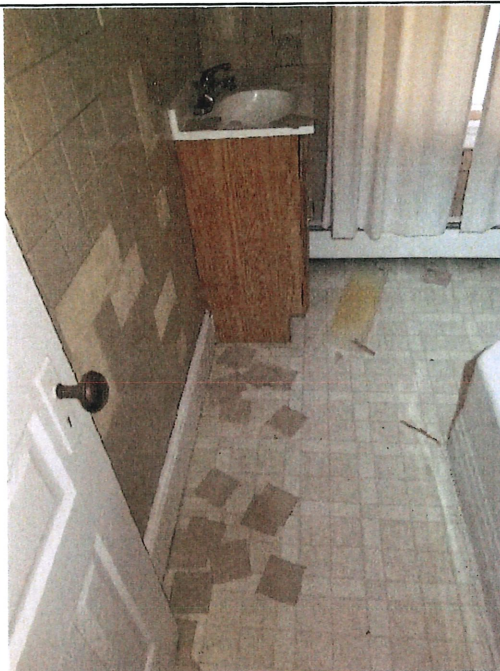
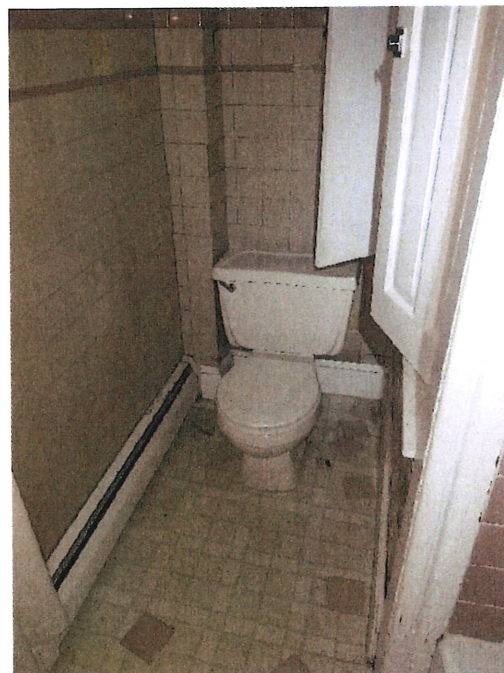
12. The existing bathroom is not code compliant for commercial use and must be completely replaced with new fixtures and altered to be code compliant.
13. The existing windows are the original units and storm windows were added but are in poor condition. Some of the storm windows are missing. The windows do not operate properly in many cases.

| 7 | 1 | B | <p>The existing bathroom is not code compliant for residential use and must be completely renovated with new fixtures and altered to be code compliant.</p> <p>Estimated Cost: \$40,000</p> | |

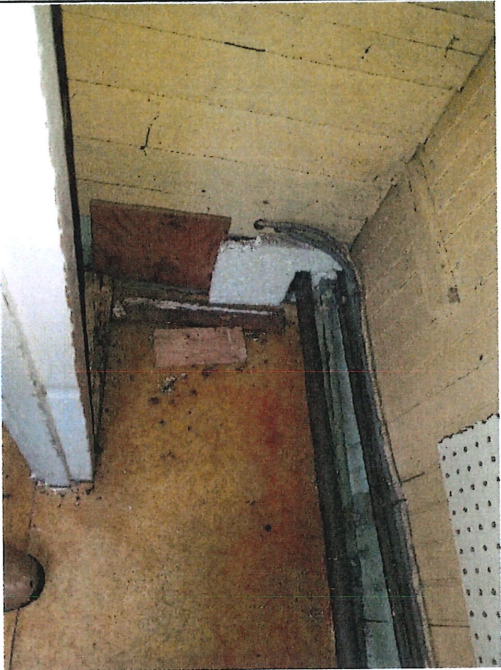
| 8 | 1 | G | <p>The heating system is not operable, and the baseboard units will need to be upgraded and repaired.</p> <p>Estimated Cost: \$15,000</p> | |

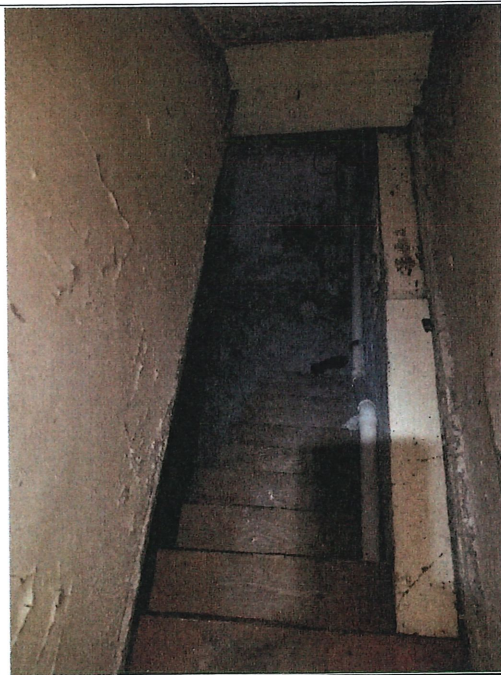
| 9 | 1 | B | <p>The stairs leading to the basement are not code compliant and will need to be replaced.</p> <p>Estimated Cost: \$8000</p> | |

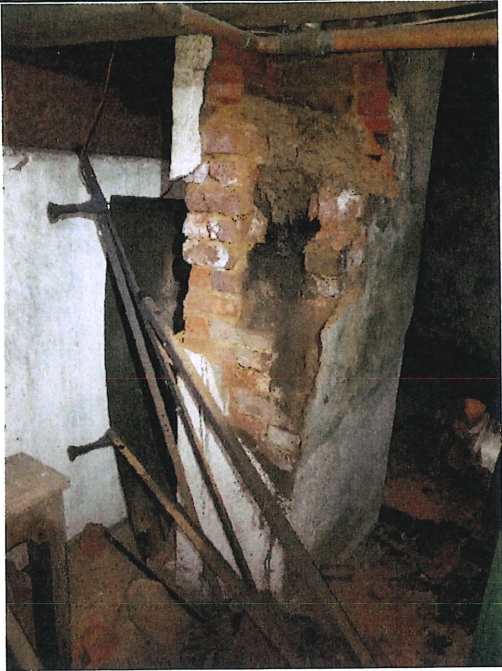
| 10 | 1 | G | <p>The base of the masonry chimney located in the basement has deteriorated badly and must be repaired. It is not operational.</p> <p>Estimated Cost: \$6000</p> | |

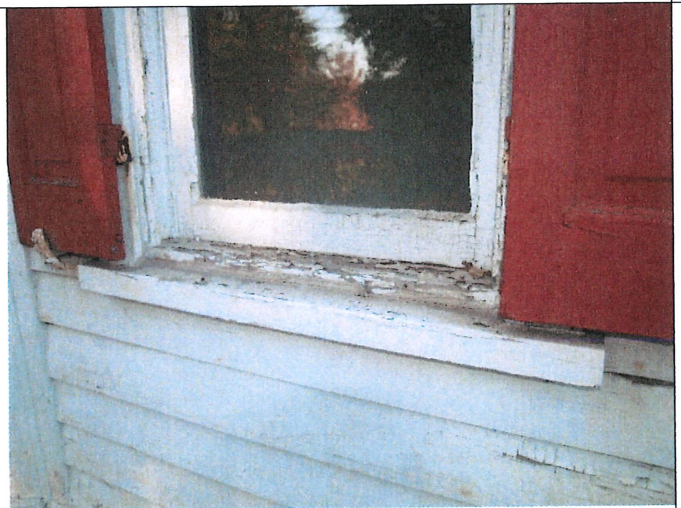
| 11 | 2 | E | <p>A majority of the existing, double-hung wood windows appear to be original and are operating poorly. In addition, they are single pane units. Since the windows are not energy efficient, new storm windows would need to be added.</p> <p>Estimated Cost: \$10,000</p> | |

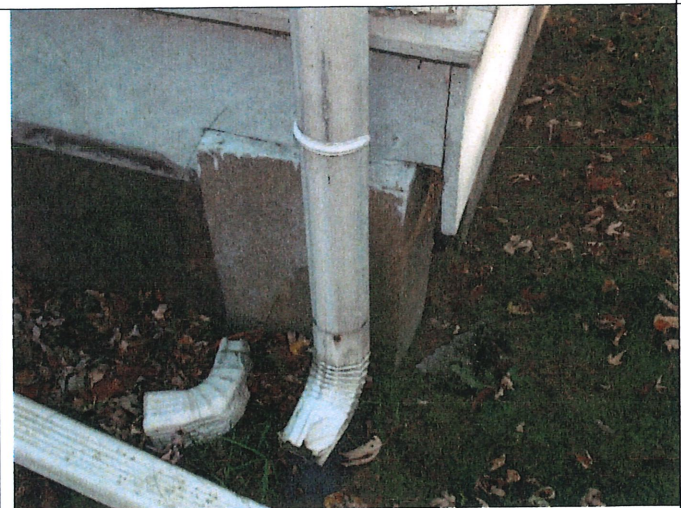
14. The downspouts and gutters are intact and would only need minor repairs.
15. The front porch has some minor structural issues and would need a further evaluation before a repair can be determined.

| 12 | 2 | G | <p>The front porch has some minor structural issues and would need further evaluation before a repair can be determined.</p> <p>Estimated Cost: \$5000</p> | |

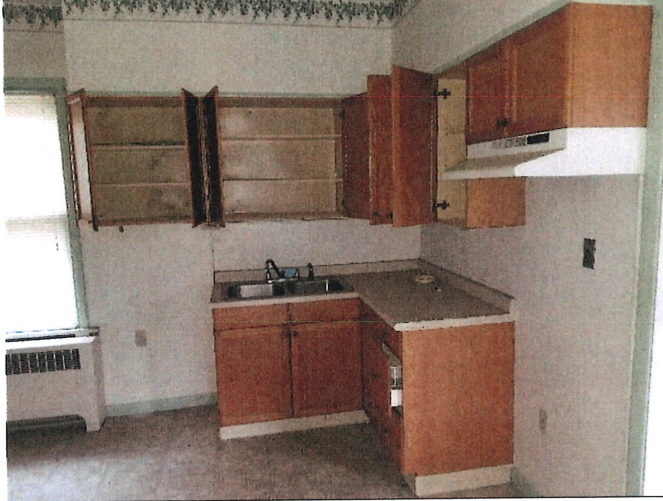
| 14 | 2 | G | <p>All of the kitchen cabinets need to be replaced as they have been damaged by moisture in the building.</p> <p>Estimated Cost: \$25,000</p> | |
