HanoverEngineering

April 23, 2024

RE: Structural Evaluation
330 East Fourth Street
City of Bethlehem, Northampton County
Hanover Project 5161

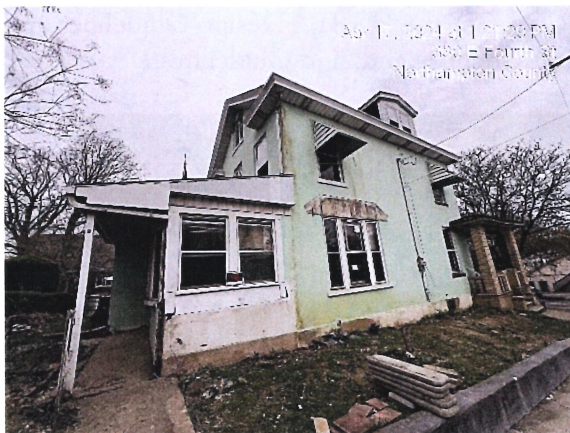
East Elevation

As noted above, the house is three-story. The rear of the house appears to be an addition added to the first floor of the original structure and is composed of two rooms: possibly intended as a kitchen and a “mud room”. However, the entire structure is in very poor condition. Much of the framing is exposed and portions of the supporting masonry, including brickwork and the rubble stone foundation is in serious distress. The detached garage is extremely damaged and can only be addressed by full demolition.

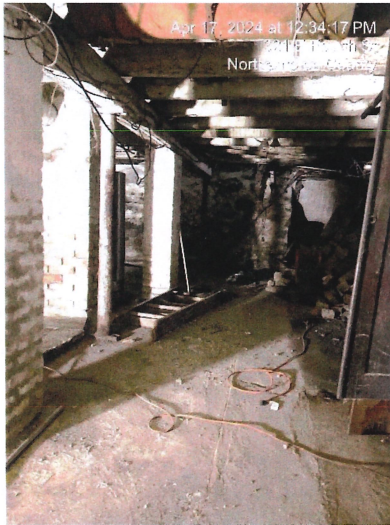
Main Basement

The basement is divided into two areas, a main, larger, area and a smaller front room. In general, this front room is in better condition. The basement is full under most of the house but does not extend to under the back rooms of the first floor. Though the basement walls perform the primary function of retaining exterior fill, they do not exclude all surface water – much of which appears to have puddled on the main floor of the basement. The basement beams supporting the joists of the first floor appear to have suffered distress, and their supporting posts are not in good condition. However, the joists themselves appear sound, although their connection to and support by the basement walls is of inconsistent quality. At the southwest of the main basement, there is a depressed “cistern” structure. This part of the structure, composed of masonry and some timbers, is in poor condition – its actual original purpose is unknown.

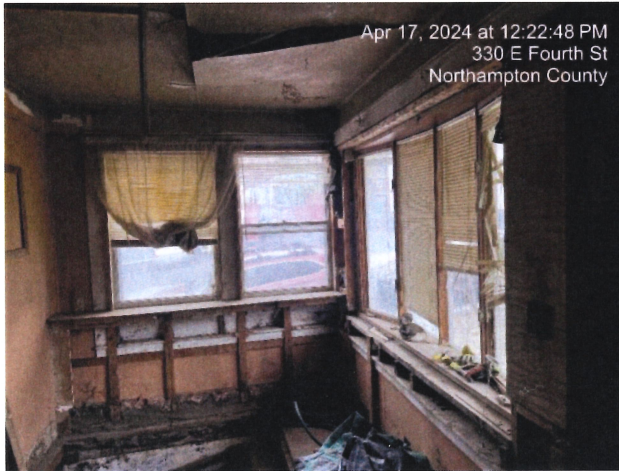
1st Floor “Mud Room”

The first floor is in fair condition – the distressed condition of the floor joists underneath has not produced unevenness in the walking surface; but as previously noted, the underlying joists are not entirely trustworthy – either in design capacity or in construction. The condition of the back rooms (the addition to the first floor) is not satisfactory. The access to the basement is via a hatch in the floor of the “mud room” in this area.

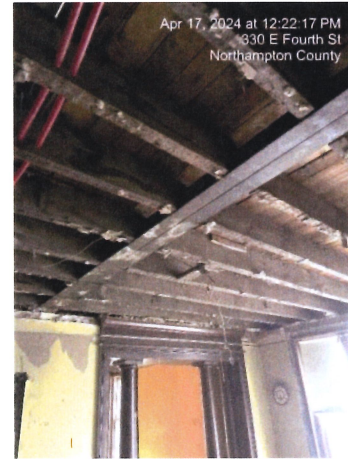
Exposed Joists in Ceiling of “Dining Room” – note also Steel Bearing Beam

Also of concern is the distress of the second-floor joists, visible in the “dining room” of the first floor. The suspended ceiling in this room has been removed, revealing this framing – which includes a conventional steel beam running north-south. Although the framing appears sound, it is unclear if it adequately supports current standard loadings; the timber joists are especially suspect. The suspended ceiling of the “living room”, immediately to the north, is still in place, but it is assumed that the concealed floor framing in this area is similar, with similar misgivings. The front hall, exposed and not supporting the upper floors, is framed more adequately, and appears to be in better overall condition.

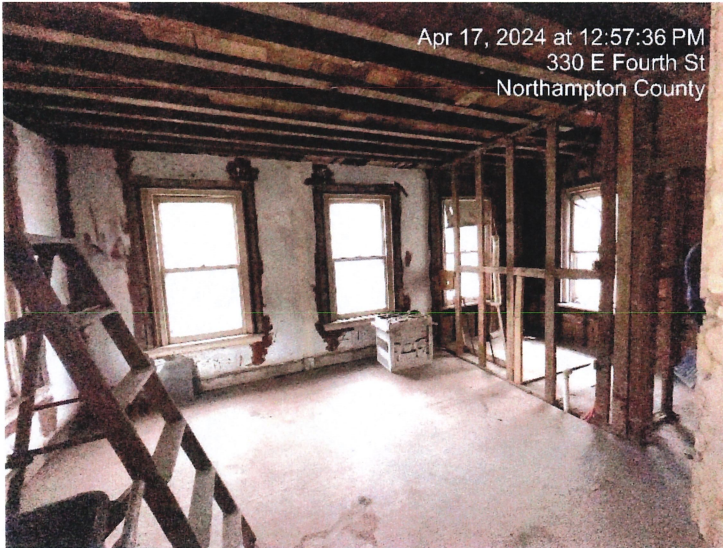
The second floor is accessed via a standard staircase from the first floor and appears to be in similar condition to the first floor. However, the curtain wall separating the two rear rooms looks to be inadequately supported by the first-floor framing, and the joists at the northwest are embedded into a failing brick wall.

Back Room of 2nd Floor and Suspect Curtain Wall

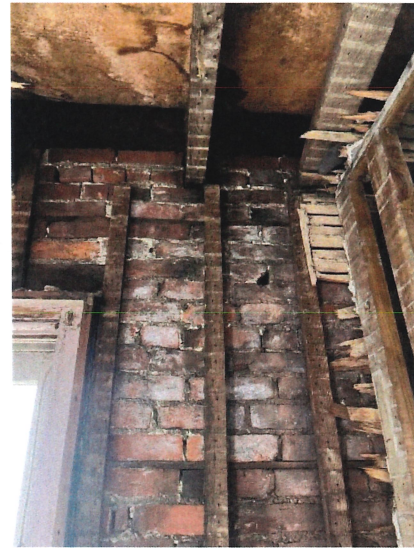
Typical Exposed Brickwork

The exterior of the structure has been covered in stucco, but appears to originally have been brick, some of which is visible inside the house.

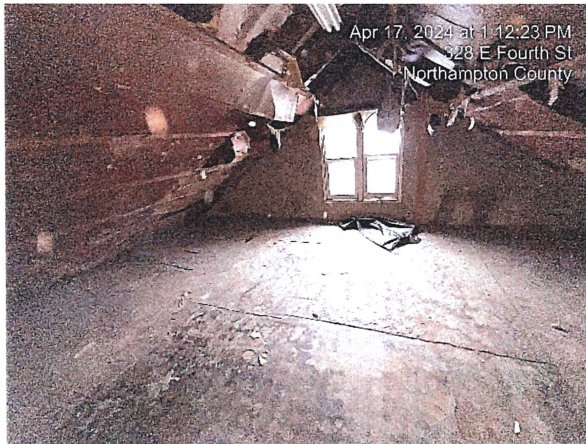
3rd Floor Attic

The third floor is also reached by a standard staircase in good condition. This floor is separated into an attic with exposed rafters, no collar ties, and a floor of uncertain stability at the north end. The south portion at this level seems to be living space, of limited overhead clearance. The roof in this southern third floor varies from the standard A-frame seen in most of the structure, but appears to be in similar good condition, and is composed of conventional timber framing.

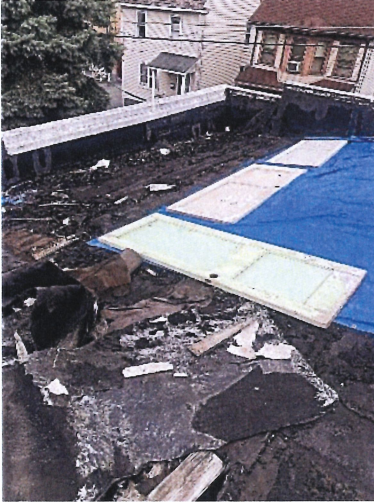
Garage Roof

There is a garden shed like out-building, in poor condition, located in the middle of the backyard. This structure appears to have been erected more recently than the main structure. As noted above, another detached building is the garage at the far north end of the property. This building is heavily distressed, and currently unsafe to enter. The roof has largely failed, as have most portions of the interior floor and all interior walls. The brickwork composing the east and west sides is generally failing, displaying gaps in the masonry and some vegetation ingress.
