Re: **1304 SPRING STREET
CONDITIONS ASSESSMENT
NOVEMBER 8, 2023**

Holy Family Senior Living – 1304 Spring Street, Bethlehem, PA Condition Assessment

SFA Project. No. P-888

November 9, 2023

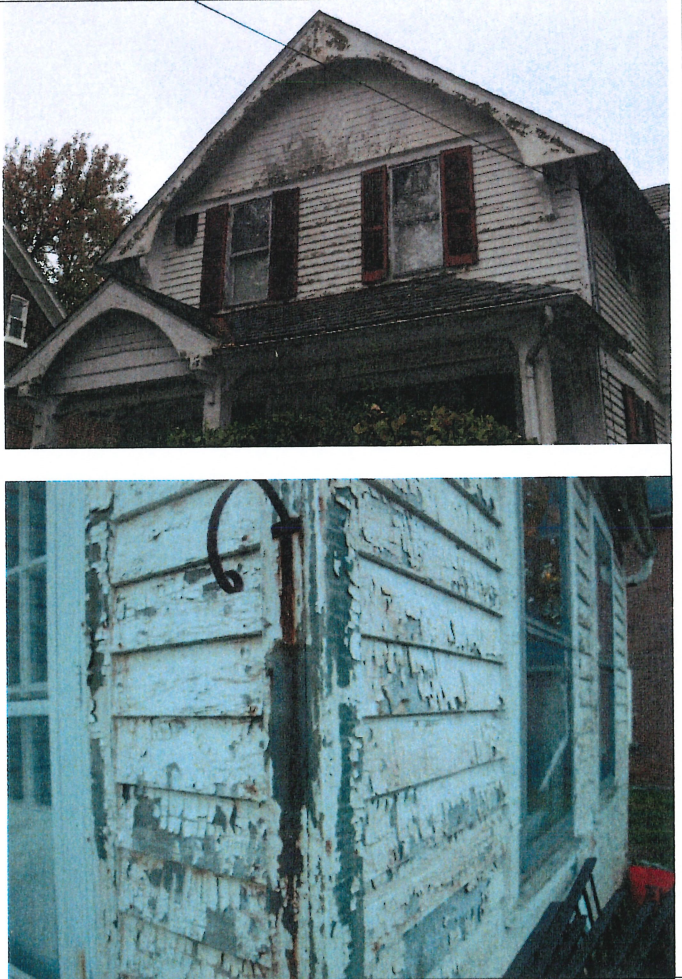
ITEM No.	PC	DC	DESCRIPTION	IMAGE
1	1	G	<p>The existing paint on the exterior of the building is peeling badly. The paint contains lead and must be removed before the building is repainted.</p> <p>Estimated Cost: \$50,000</p>

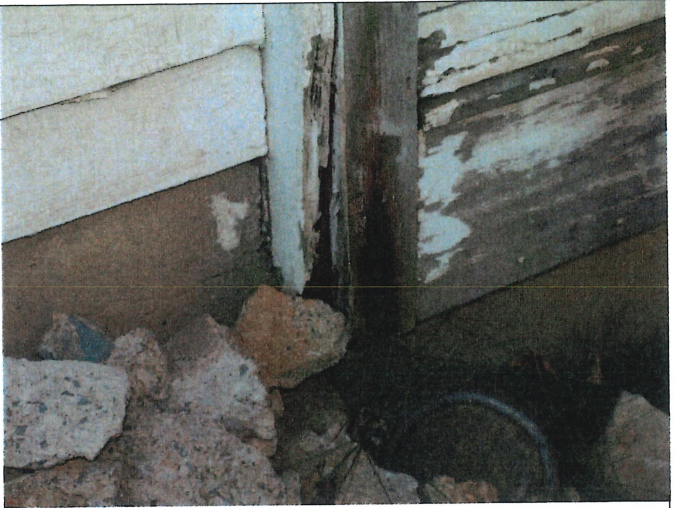
2	1	G	<p>There are several areas on the exterior of the home where the wood siding and or trim has deteriorated and must be repaired or replaced.</p> <p>Estimated Cost: \$5,000</p>

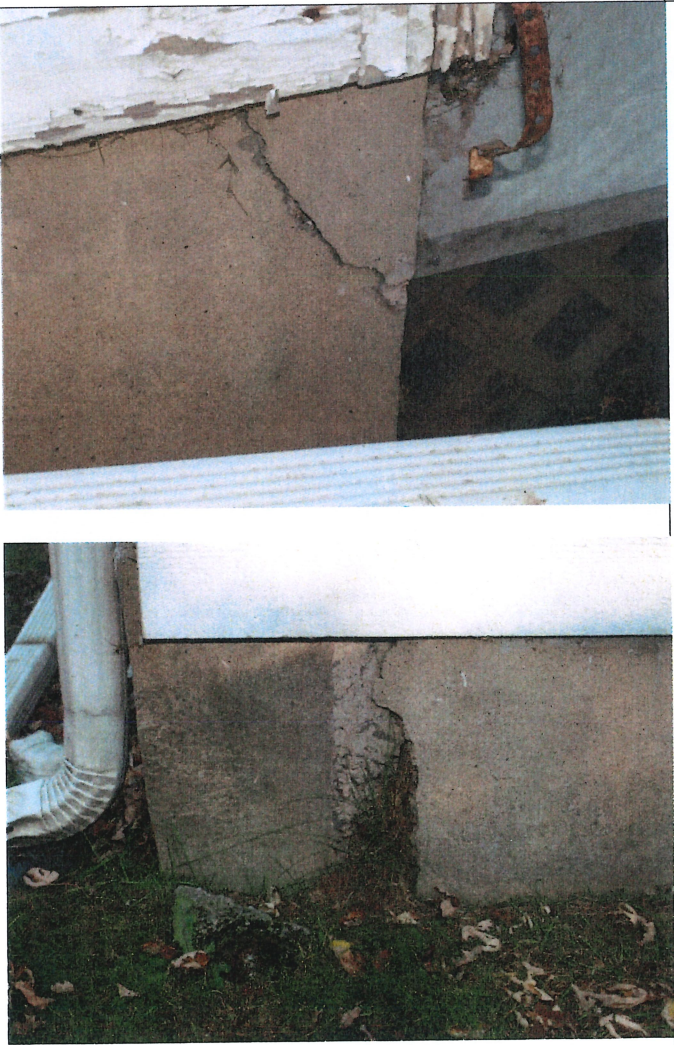
3	1	G	<p>The concrete foundation wall has a few minor cracks in it and at the front porch there are two foundation issues that need to be addressed and corrected.</p> <p>Estimated Cost: \$18,000</p>

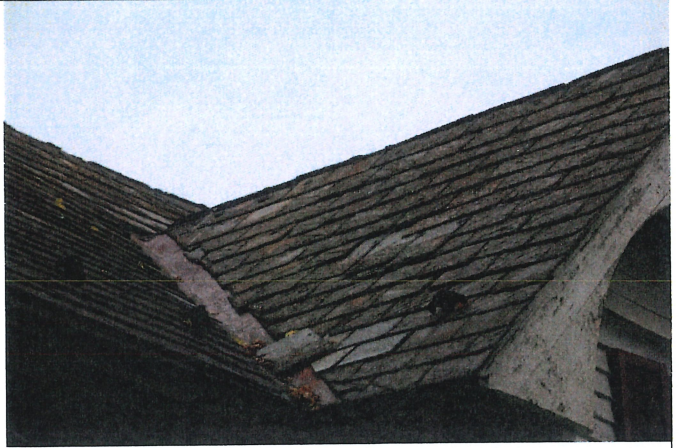
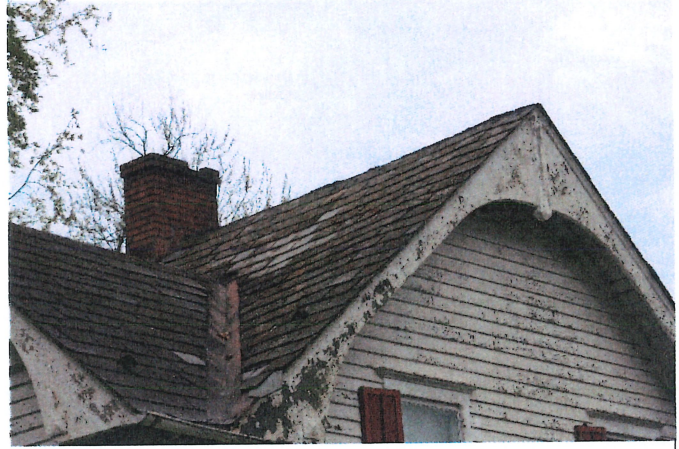
4	1	G	<p>The roof is a steep sloped roofing system with the original slate shingles which are in very bad condition and will need to be removed and replaced. There are existing areas on the roof which appear to be allowing water to enter the building. It is obvious that repairs to the roof have been completed in the past. If a new slate roof is provided, there will be a need for repairs to the existing roof rafters.</p> <p>Estimated Cost: \$30,000</p>

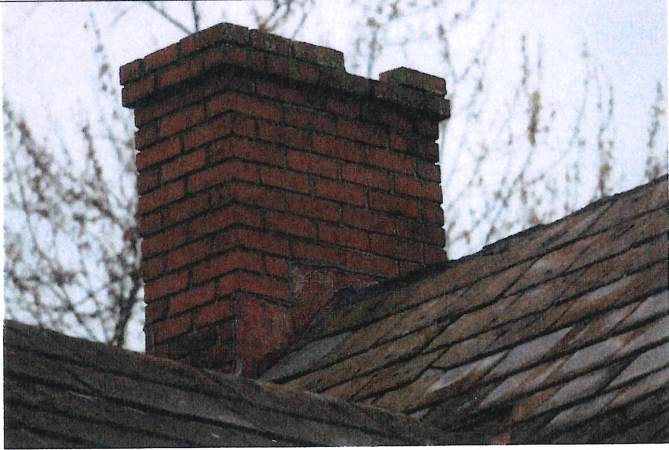
5	1	G	<p>The brick chimney will need to be repaired and should have a flue cap installed.</p> <p>Estimated Cost: \$5000</p>

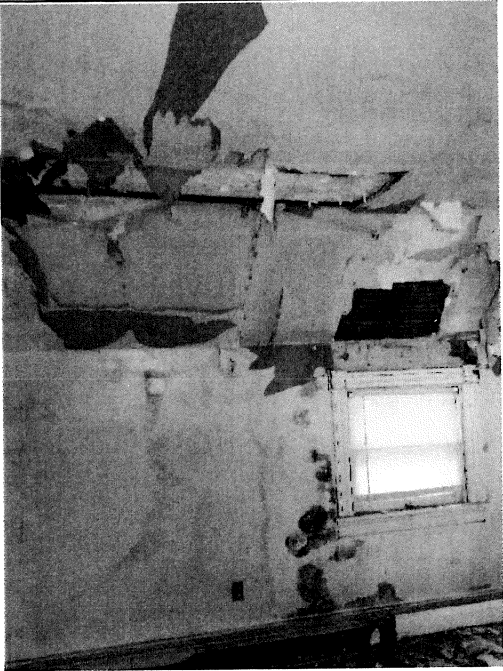
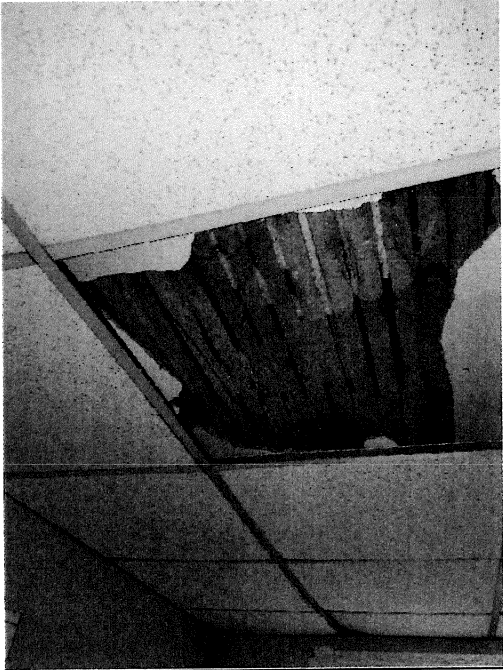
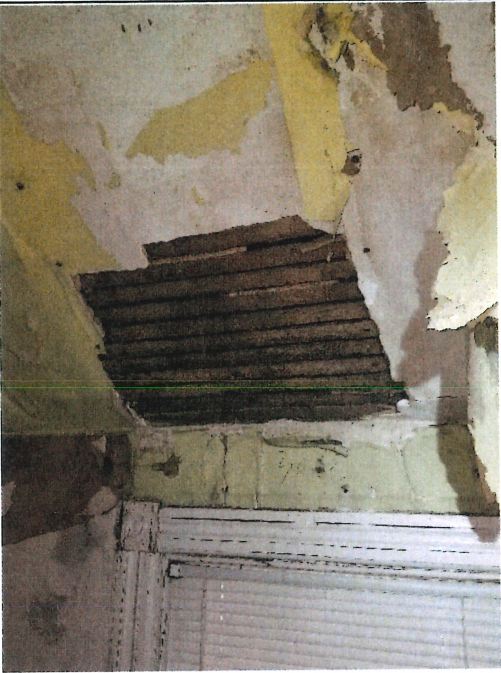
6	1	G	<p>The interior walls and ceilings are plaster on wood lath. A large portion of the plaster ceilings on the second floor will need to be removed and replaced due to damage or deterioration from leaks.</p> <p>Estimated Cost: \$40,000</p>

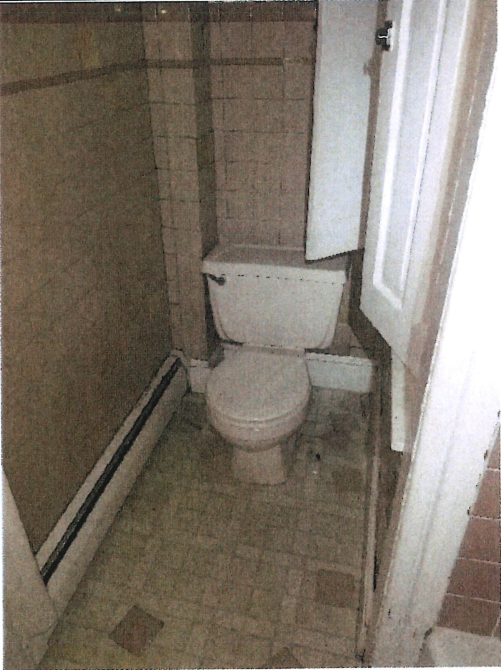
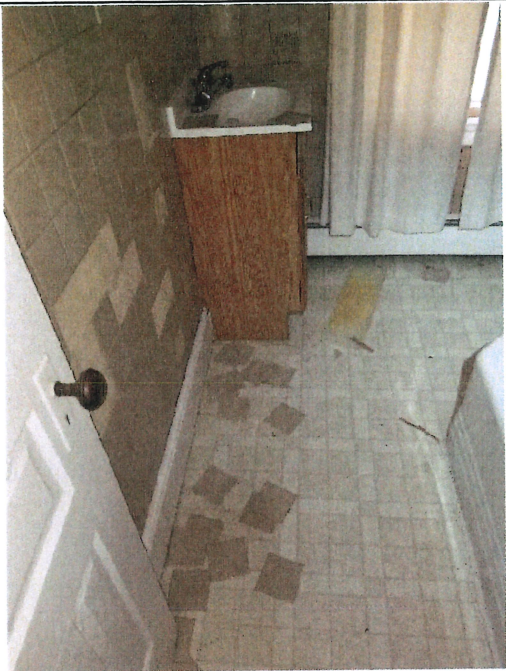
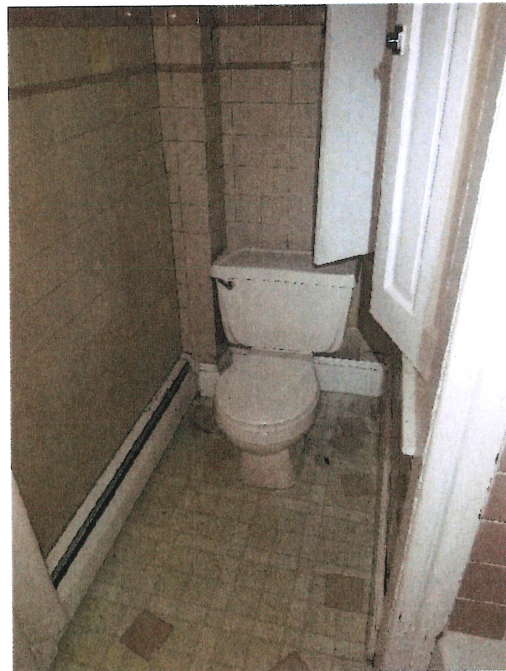
7	1	B	<p>The existing bathroom is not code compliant for residential use and must be completely renovated with new fixtures and altered to be code compliant.</p> <p>Estimated Cost: \$40,000</p>

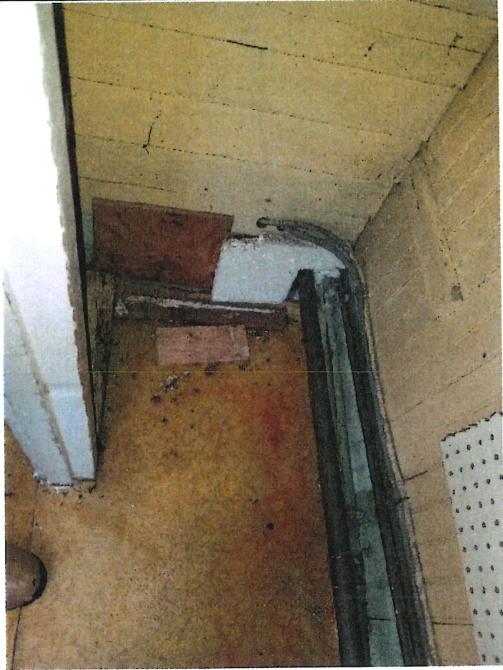
8	1	G	<p>The heating system is not operable, and the baseboard units will need to be upgraded and repaired.</p> <p>Estimated Cost: \$15,000</p>

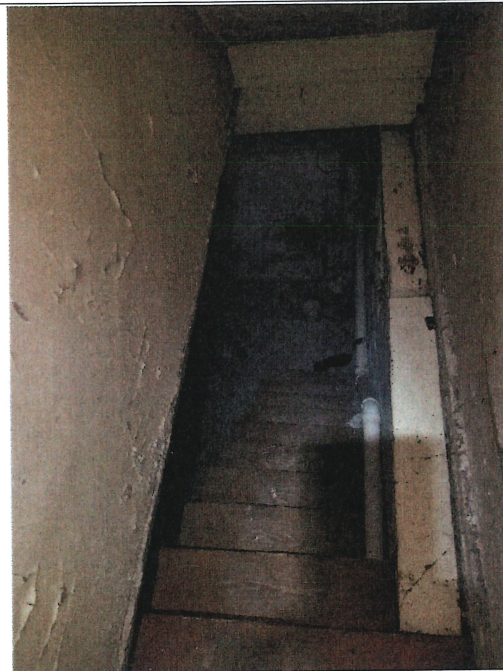
9	1	B	<p>The stairs leading to the basement are not code compliant and will need to be replaced.</p> <p>Estimated Cost: \$8000</p>

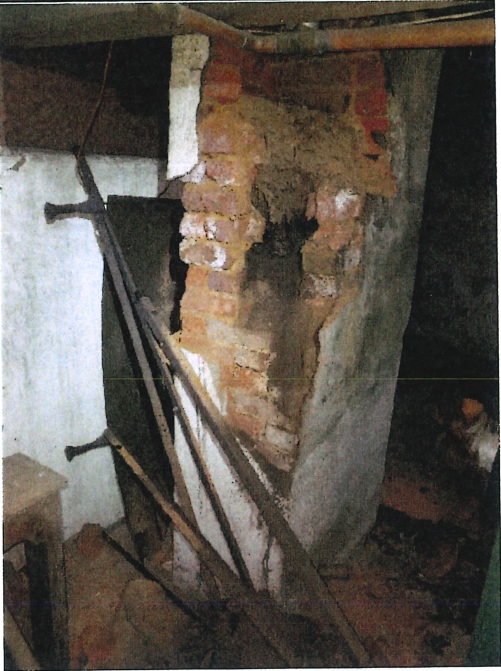
10	1	G	<p>The base of the masonry chimney located in the basement has deteriorated badly and must be repaired. It is not operational.</p> <p>Estimated Cost: \$6000</p>

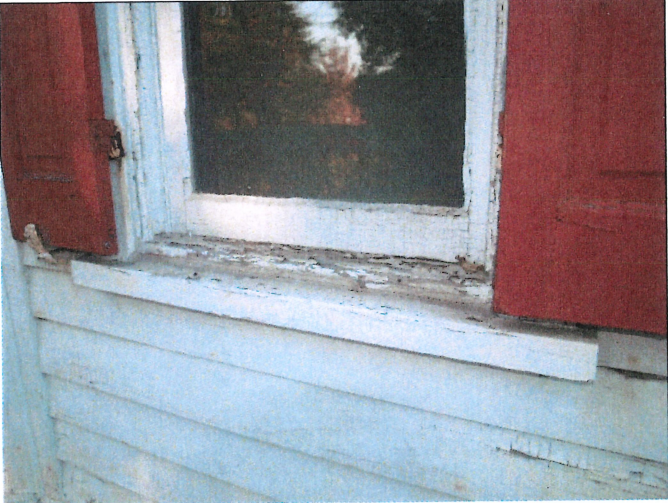
11	2	E	<p>A majority of the existing, double-hung wood windows appear to be original and are operating poorly. In addition, they are single pane units. Since the windows are not energy efficient, new storm windows would need to be added.</p> <p>Estimated Cost: \$10,000</p>

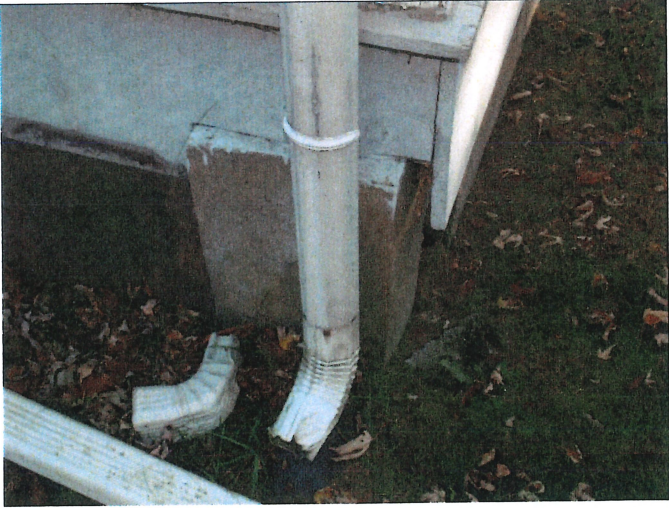
12	2	G	<p>The front porch has some minor structural issues and would need further evaluation before a repair can be determined.</p> <p>Estimated Cost: \$5000</p>

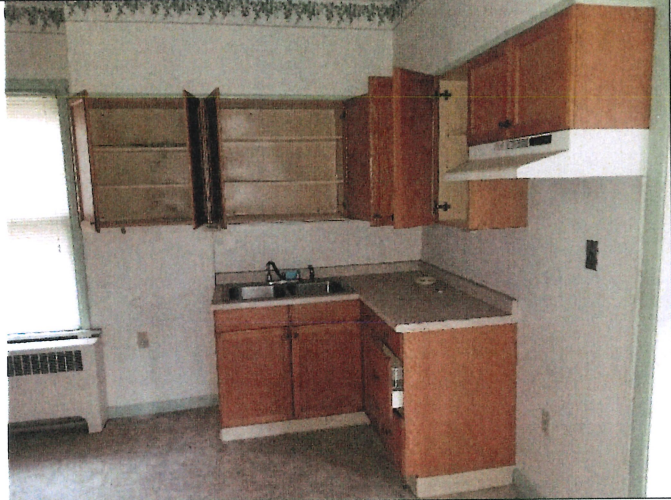
13	1	G	<p>Is has been reported that the existing sanitary piping and drain to the street was poor and need to be repair and cleared. Further evaluation is needed to determine the full extent of the assessment.</p> <p>Estimate Cost: \$5000</p>	
14	2	G	<p>All of the kitchen cabinets need to be replaced as they have been damaged by moisture in the building.</p> <p>Estimated Cost: \$25,000</p>
