Subject: 14-18 West Third Street Properties
Re: Request and reasoning for demolition – attached to the COA

We are requesting that HARB approve the demolition of these properties for future development based on the demonstrated lack of structural integrity of the properties, the minimal amount of retained historic importance of the two properties, and the prohibitive cost required to repair these buildings, to allow for an improved economic and aesthetic impact a new development will have on this critical area of South Bethlehem and provide an appropriate neighbor to the approved development immediately to the east on Third Street.

As you know, back in 2016 I did an investigation of the building at 14-18 West Third Street in Bethlehem, PA, specifically about the west exterior wall. The following is a resulting letter I issued previously:

Thank you for asking me to provide structural engineering services pertaining to the building at 14-18 West Third Street, Bethlehem, PA. The purpose of my investigation was to evaluate the structural impact of damage to the west exterior wall.

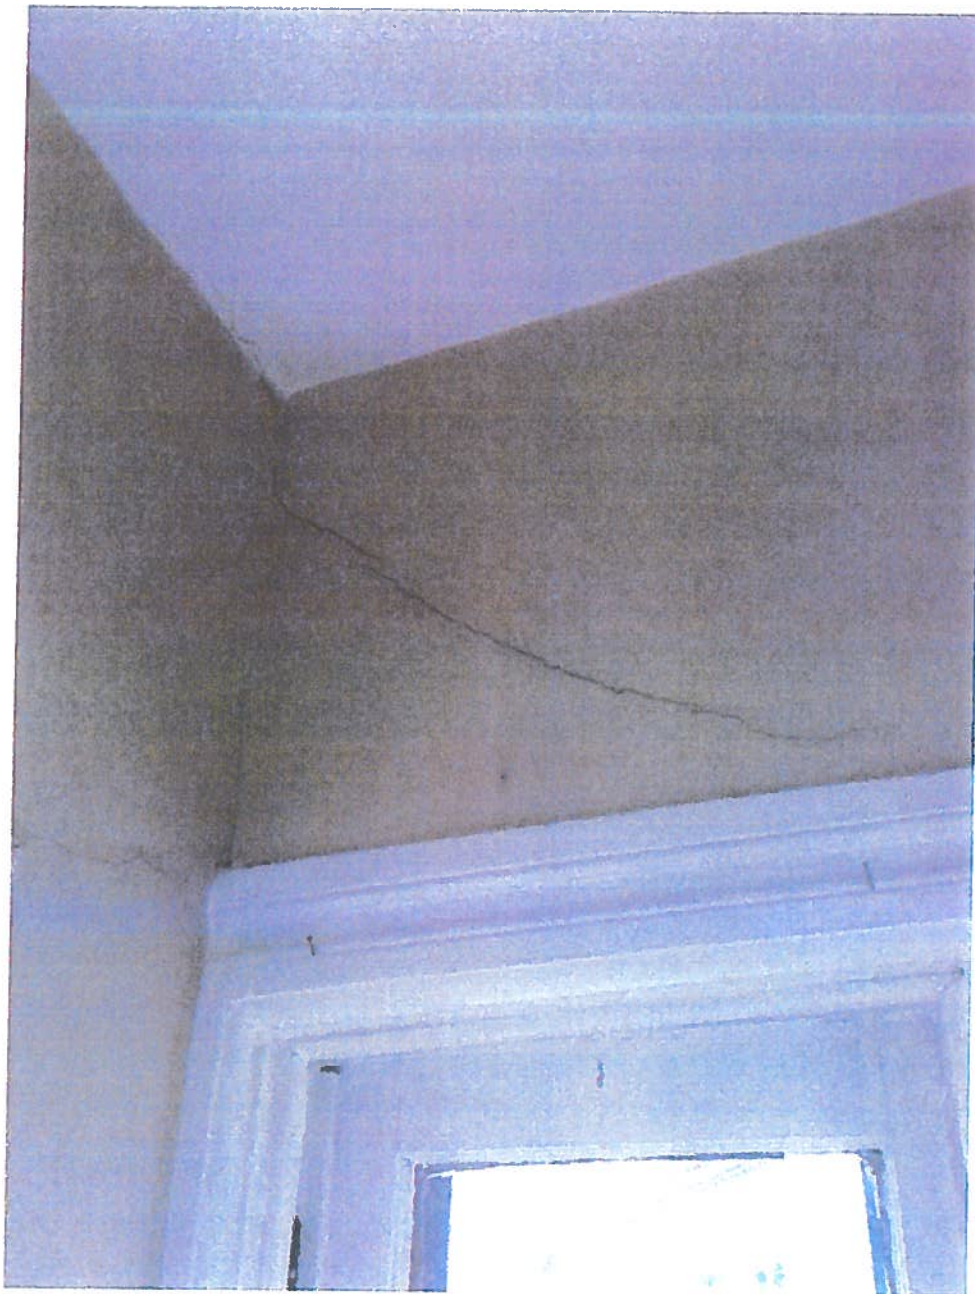
interior wall cracking

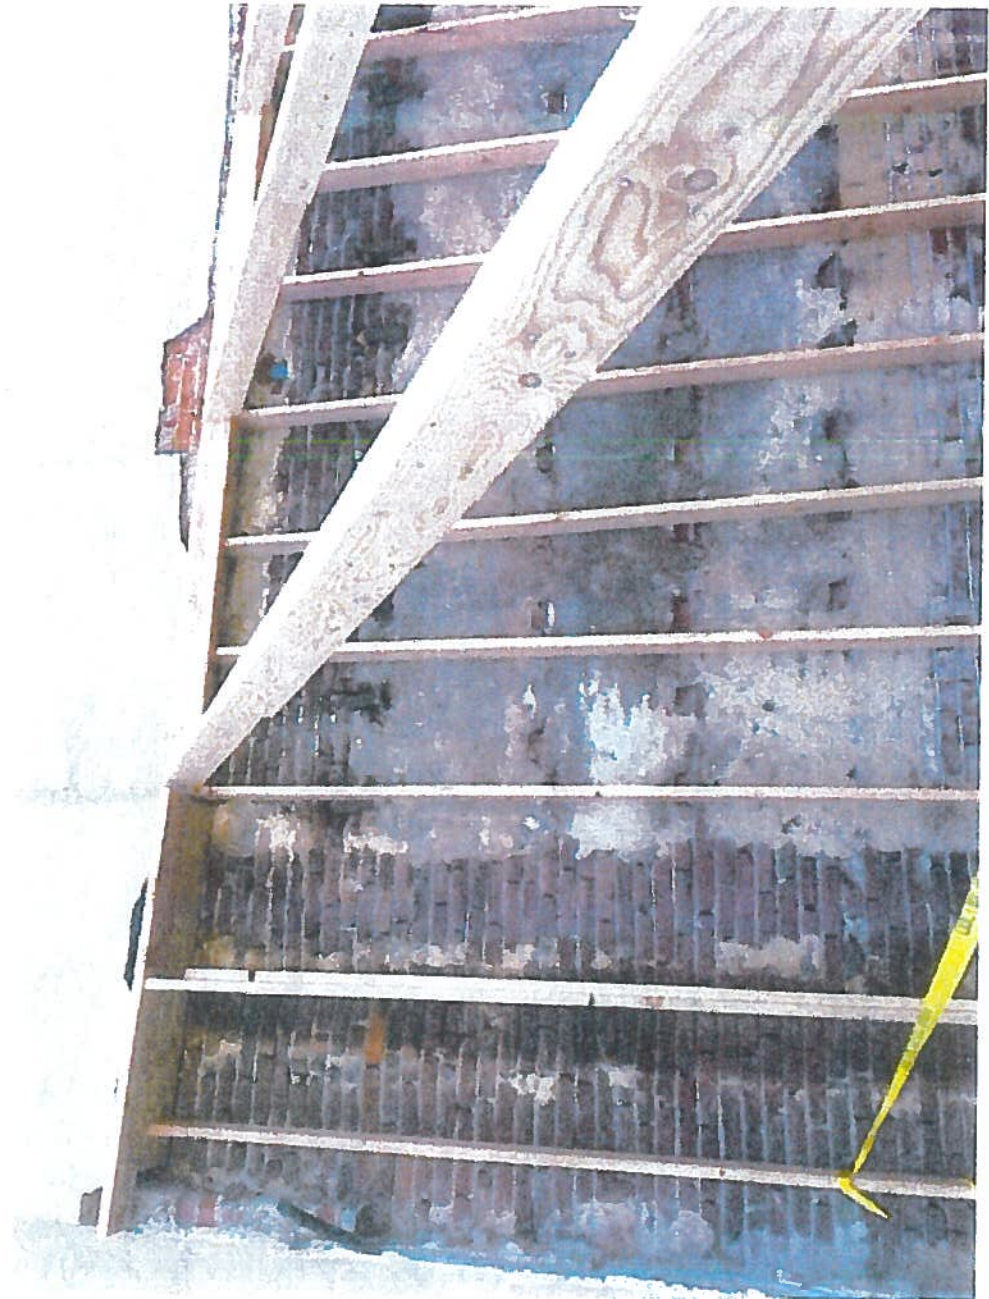
temporary support at
collapsed wall

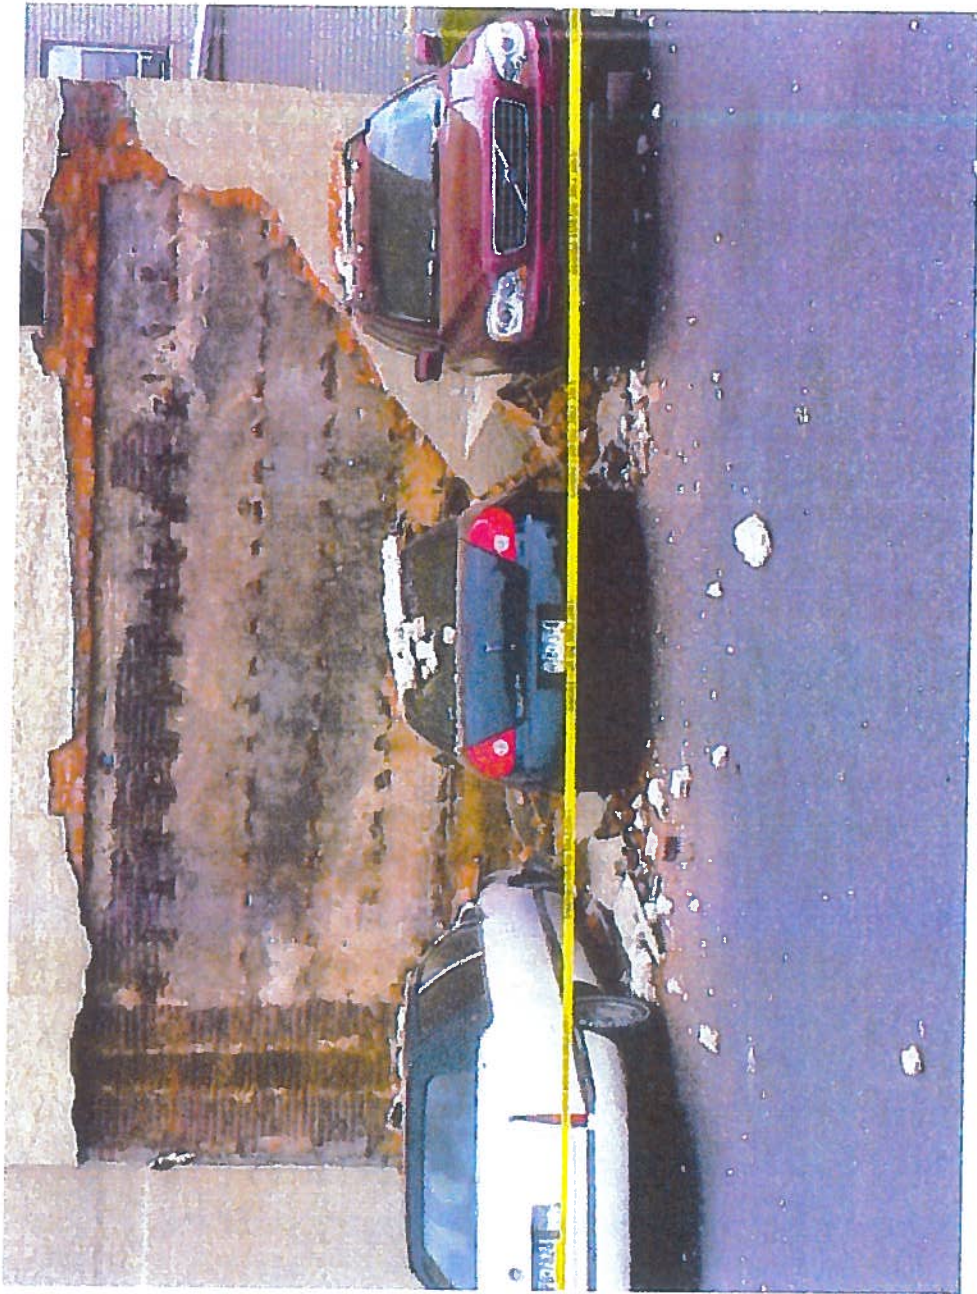
collapsed side wall

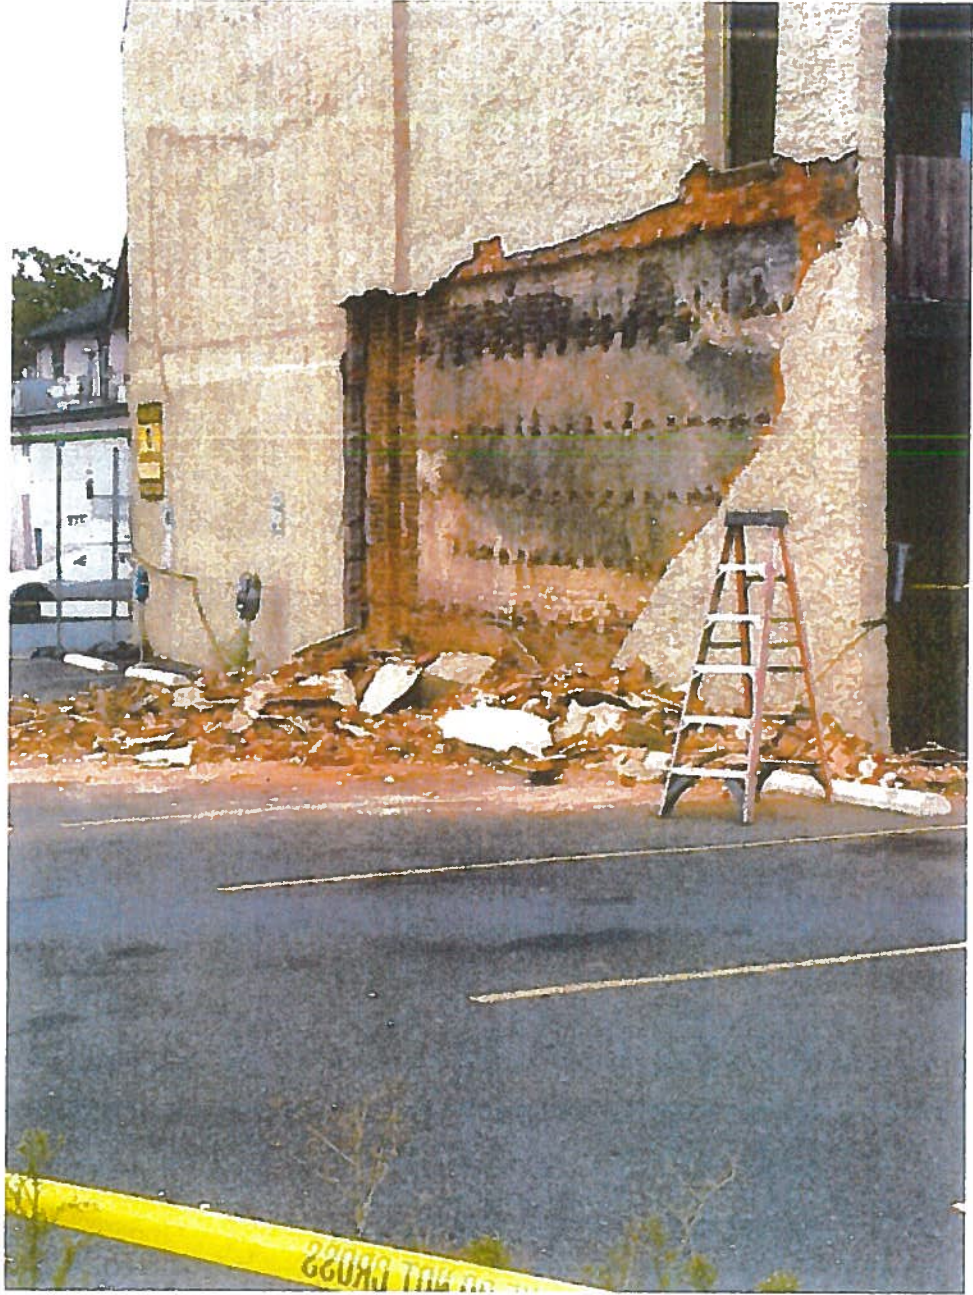
collapsed side wall

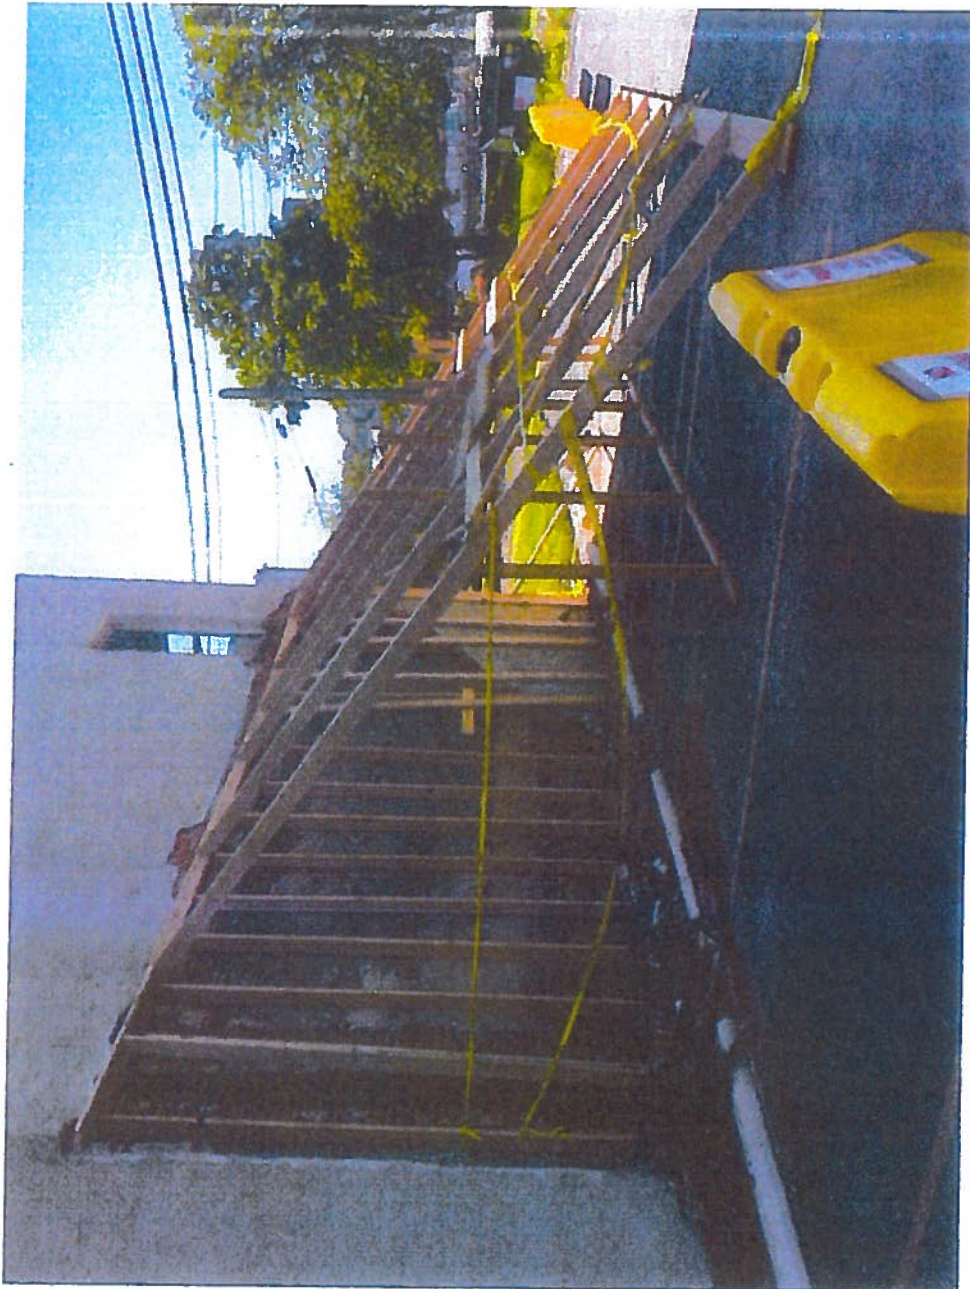
temporary support
-for side walk.

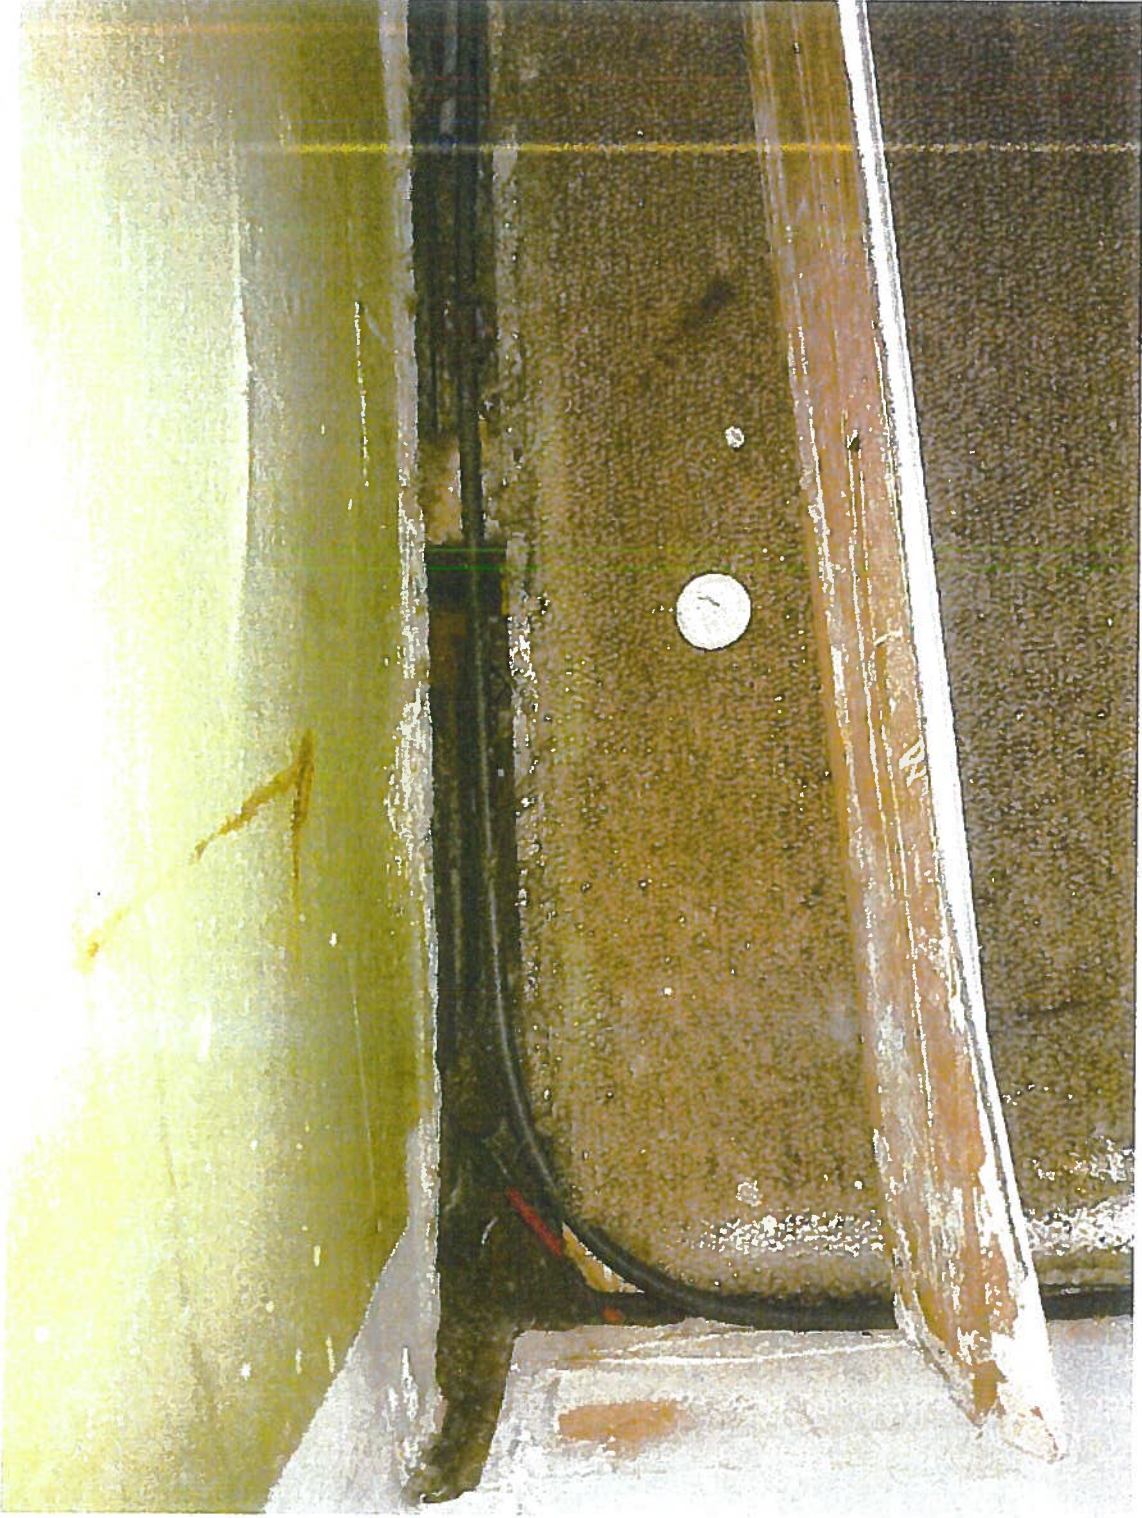
gap at wall/floor intersection

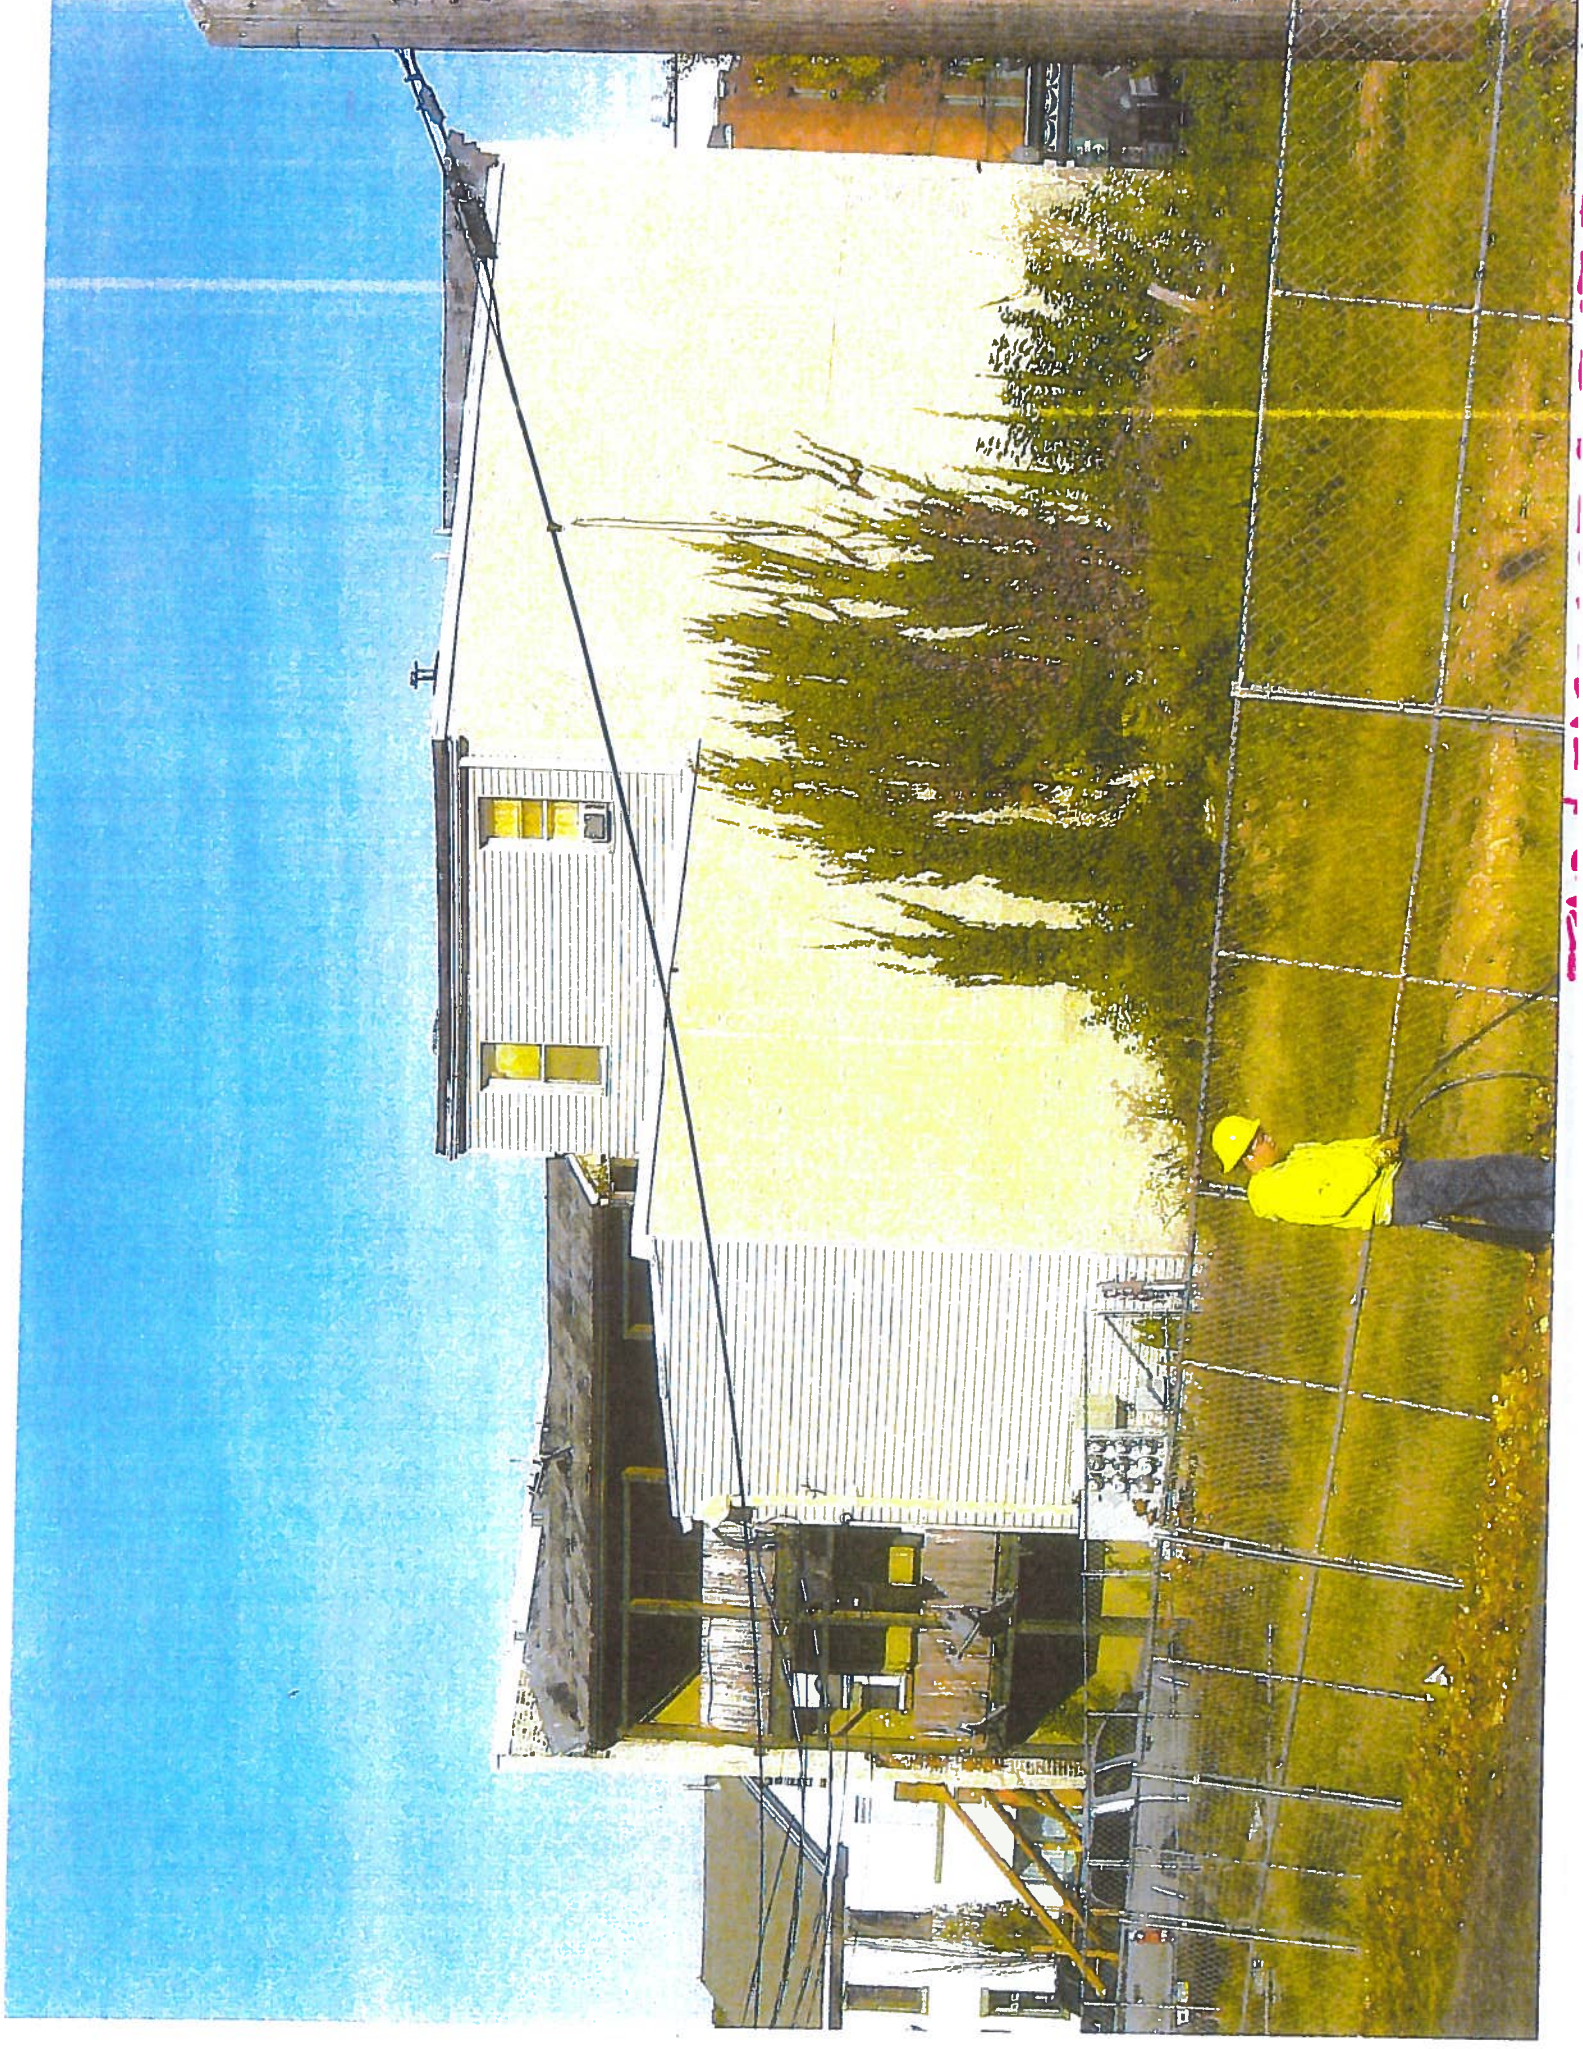
COLLAPSED WALL
