**APPLICATION FOR CERTIFICATE OF APPROPRIATENESS (COA)**

**MORAVIAN UNIVERSITY**  
**THE BRETHREN'S HOUSE - WINDOW REPLACEMENT**  
November 17, 2021

## Description of Proposed Work

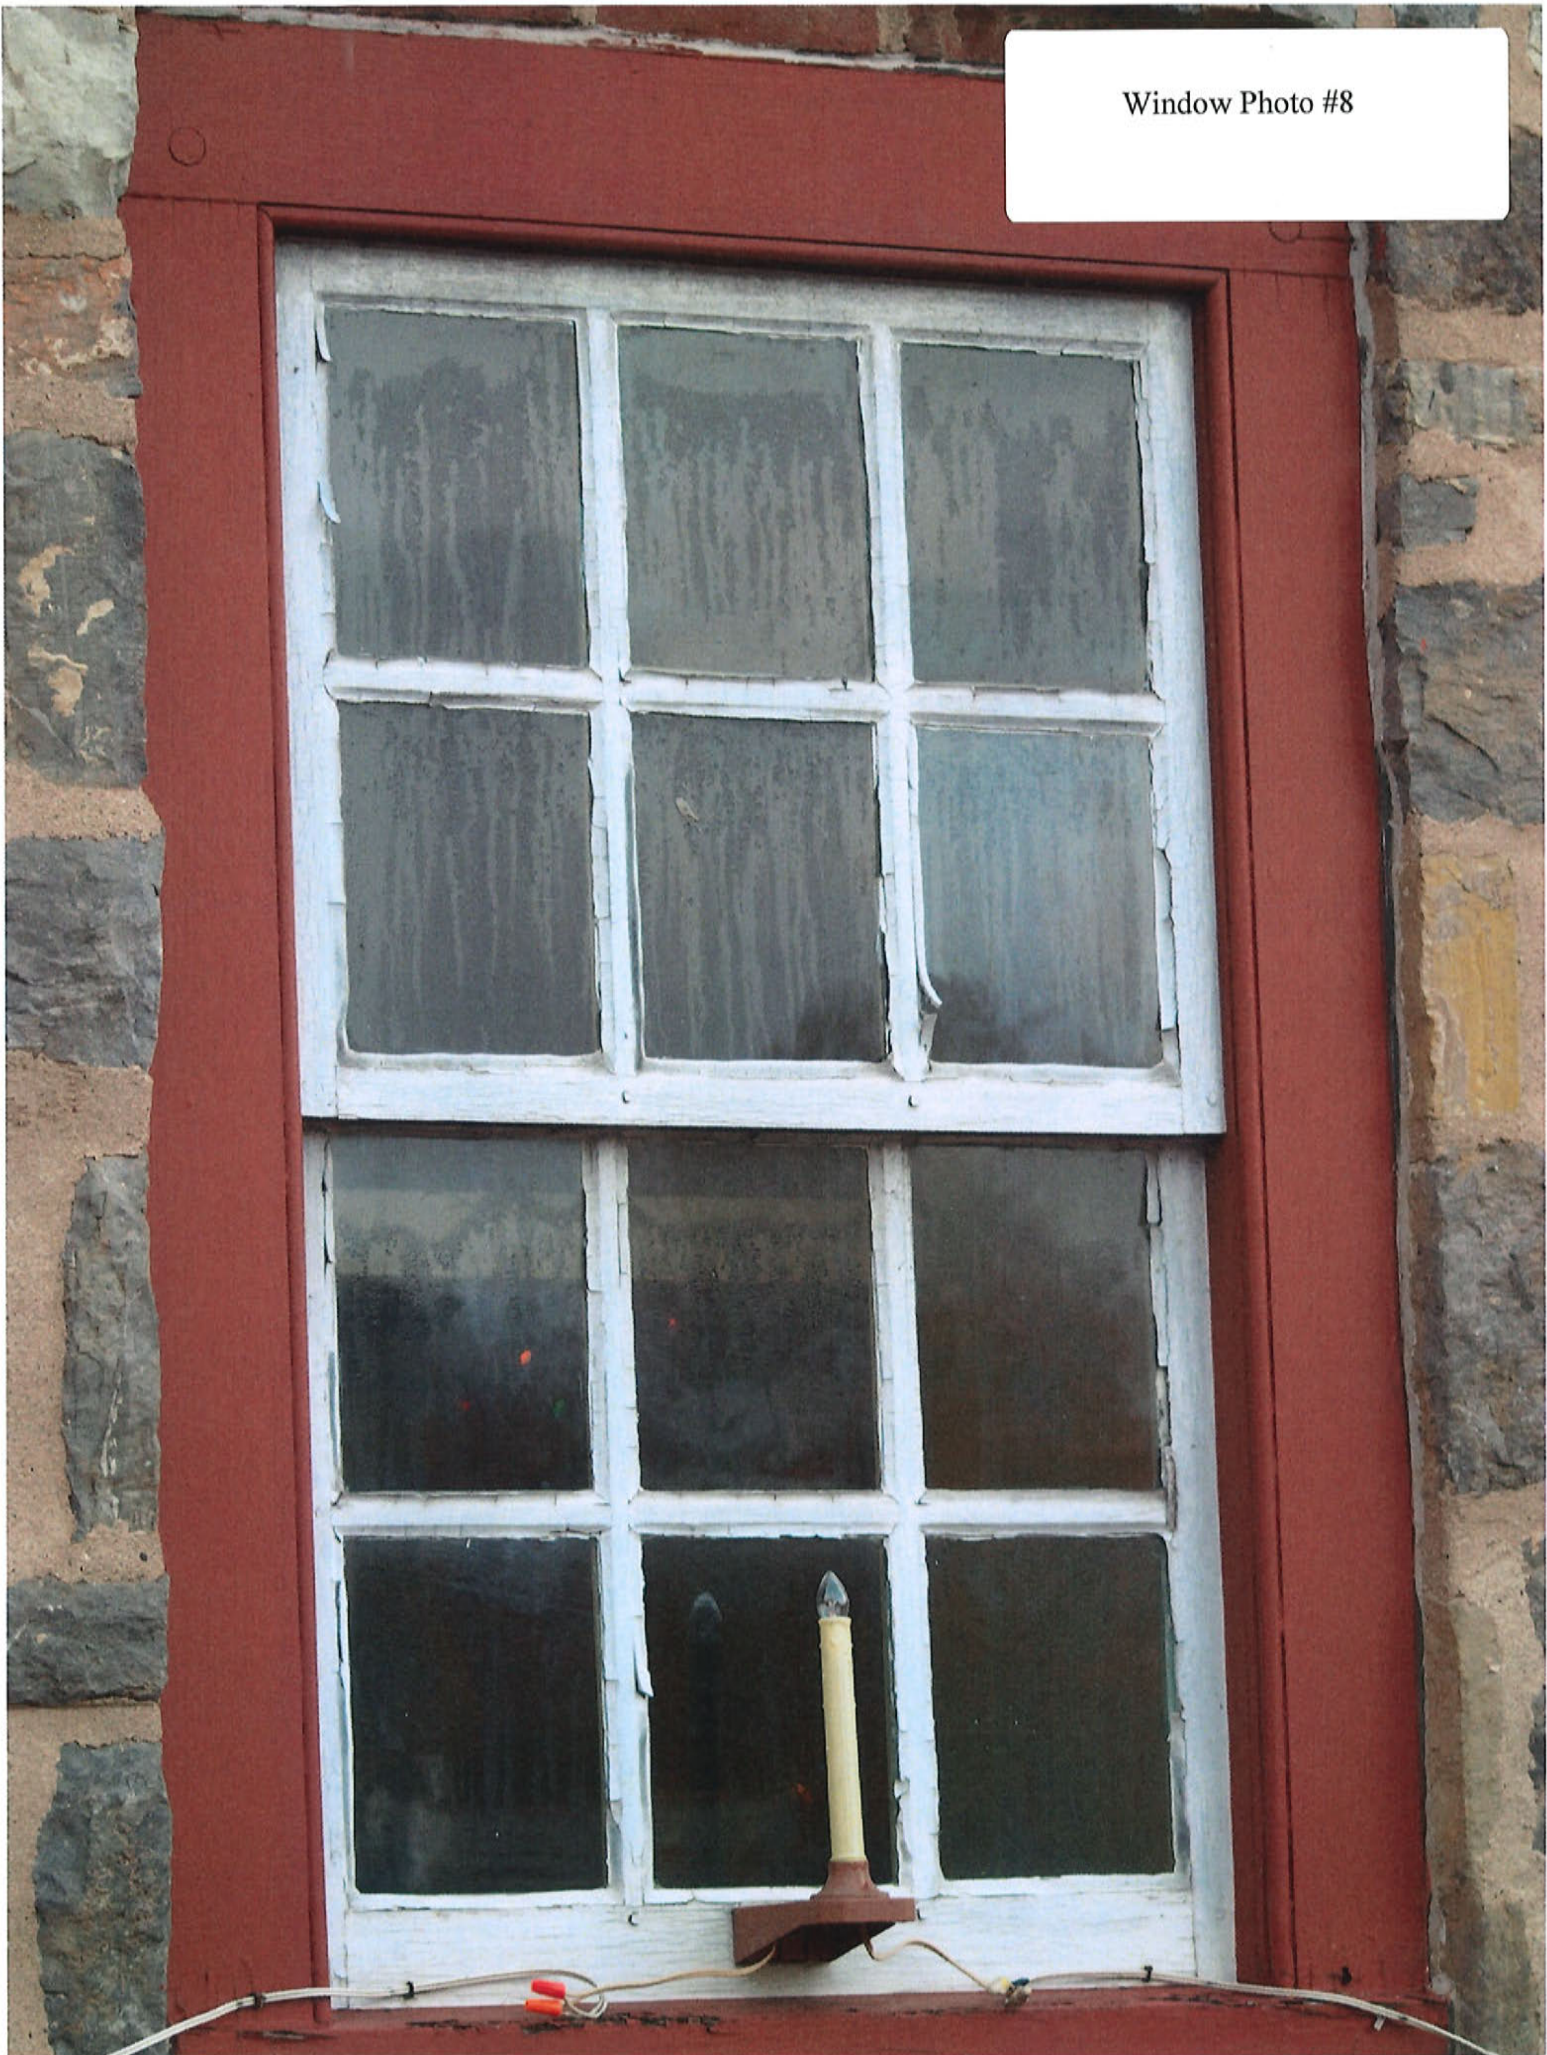
Window Photo #8

6. The existing glazing in the windows are single pane glass. This type of glazing experiences interior condensation which accelerates the deterioration of the wood windows. The use of insulated glass is a much desired feature and will eliminate the condensation issues. (Reference Window Photo #8) . We propose to use true-divided, insulated glass which in our opinion will not detract from the historical integrity of the appearance. The proposed glass shall be clear with no Low-E coating applied.

We propose to replace the existing wood windows with a closely matched wood replica of the existing units. Attached are photos of the existing windows and conditions. In addition, the University has purchased a full size mock up of the proposed window unit as an example to review and compare. (This full size unit will be brought to the scheduled HARB meeting.)
