APPRAISAL OF

330 E. 4th Street Bethlehem, PA 18015

Teresa A. Riggs PA State Cert.Residential Appraiser

1004 APPRAISAL REPORT - AS IS VALUE

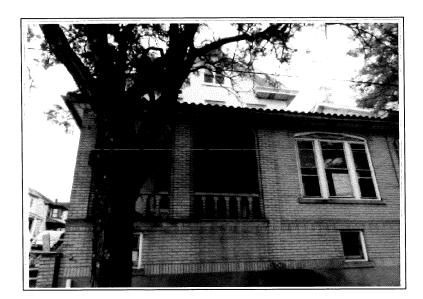
FRONT VIEW OF SUBJECT PROPERTY

The subject is a colonial style home situated on a publicly maintained street. The exterior of the home is stucco with an asphalt/fiberglass shingle roof. The home offers a covered front porch, enclosed rear porch with access to the basement and enclosed front porch. There is a detached garage containing approx. 1440 sf. The garage was not given value as it needs to be torn down due to condition. There is a shed/outbuilding in the rear yard which also needs to be torn down due to condition.

The subject is in poor condition and not considered habitable. A structural evaluation was completed on the subject on 4/23/2024 by Hanover Engineering. A copy of this report was provided by owner reviewed and relied on for confirmation of observed deficiencies. The detached garage is dilapidated and complete demolition is suggested as the structure is unsafe to enter. The subject dwelling has serious issues with exposed framing, settlement and deterioration of foundation walls and support beams show evidence of distress as do 2nd floor joists. The structural evaluation has been included in this report.

The interior shows exposed lathe, deteriorated brick walls with missing mortar, exposed floor joists, crumbling plaster and soft floors on the first floor. The subject is not habitable. The entire dwelling needs complete rehab and structural reinforcement. The potential buyer segment is extremely limited due to the extent of rehab required and cash to purchase requirement. Typical conventional, FHA or VA financing would not be viable. Once required repairs are fully realized, it may be more economically prudent to demolish the structure and rebuild.

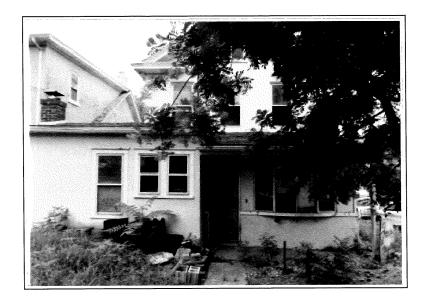
REAR VIEW OF SUBJECT PROPERTY

The home is on a full, unfinished basement. Dampness and settlement is evident in the basement and per structural report may not be sufficient for load support of the structure. The subject needs new electrical, plumbing and HVAC. The interior shows exposed lathe, deteriorated brick walls with missing mortar, exposed floor joists, crumbling plaster and

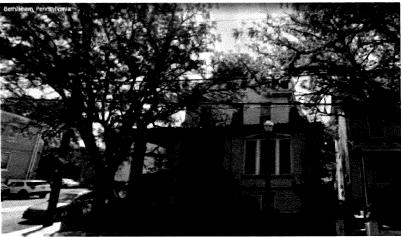
Front of Residence (North Elevation) (from google earth)

As noted above, the house is three-story. The rear of the house appears to be an addition added to the first floor of the original structure and is composed of two rooms: possibly intended as a kitchen and a "mud room". However, the entire structure is in very poor condition. Much of the framing is exposed and portions of the supporting masonry, including brickwork and the rubble stone foundation is in serious distress. The detached garage is extremely damaged and can only be addressed by full demolition.
