ROOF REPLACEMENT PROPOSAL FOR MAIN PORTION OF ROOF CURRENTLY SLATE

Proposal for Exterior Painting of 442 High St

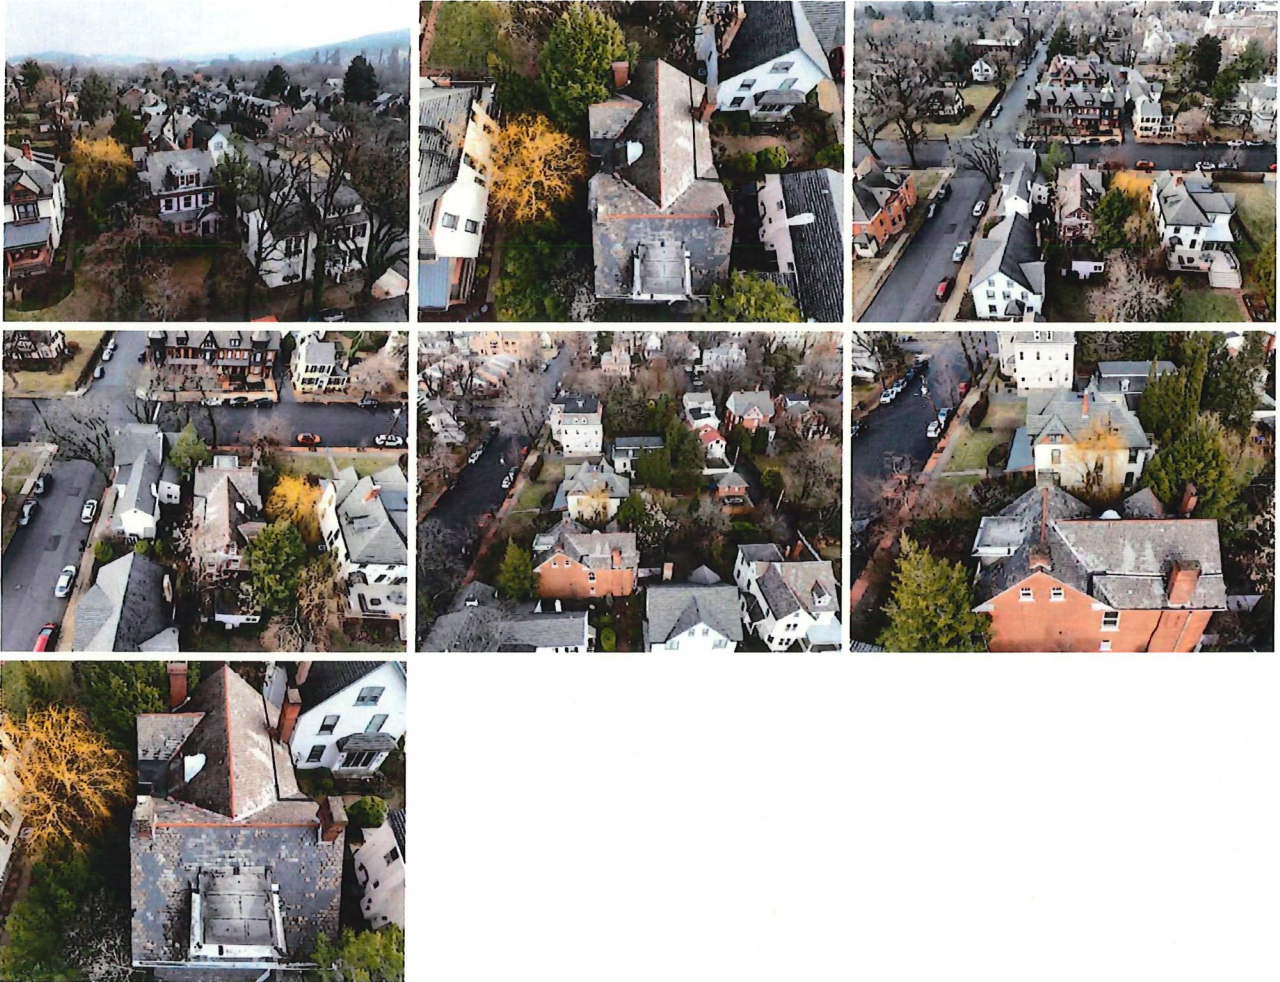
Slate Roof

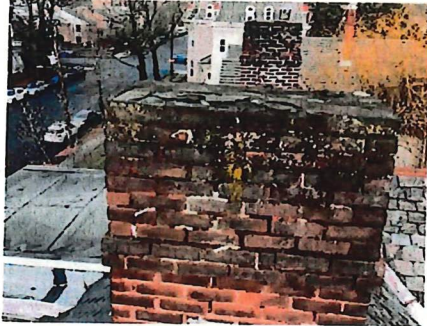
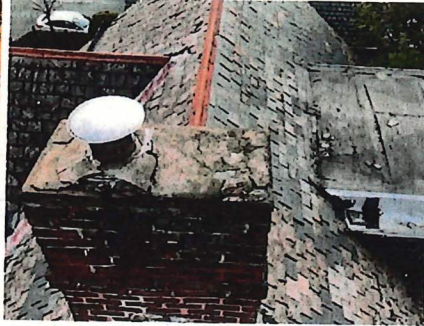
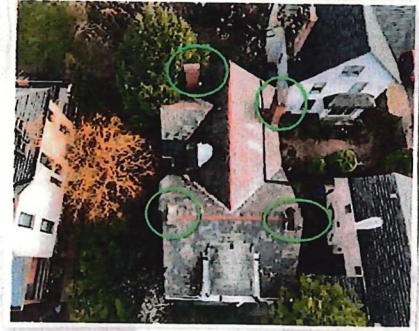
North Chimney

CHIMNEY - DETERIORATED BRICK/MORTAR

Dismantle chimney up until a stable base of bricks is reached to begin re-laying of bricks

Re-build chimney using lime mortar and reusing bricks, if possible, otherwise new bricks will need to be used²

Pour lime mortar crown around flue of chimney

Re-flash chimney

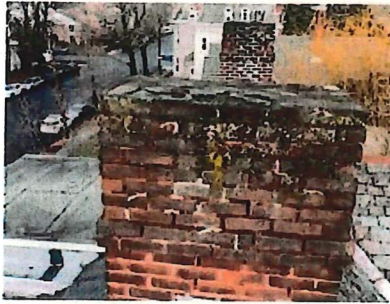
Rear of House Chimneys

needs for repairs.

there does not appear to be any urgent

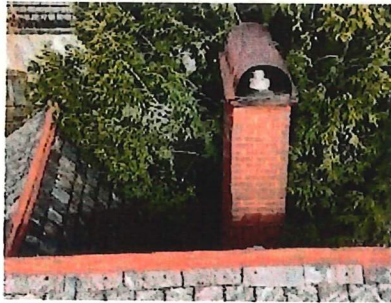
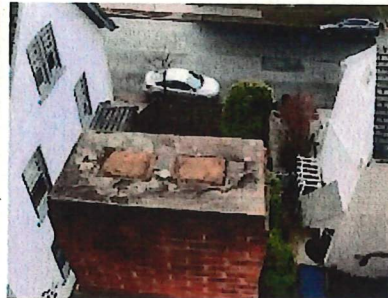
Brick & Mortar Repairs

****Many areas, as noted in inspection report, of brick spalling and mortar deterioration. The inspection report noted that the source of deterioration of bricks could be moisture, but upon masons inspection, it is likely in conjunction with improper Portland mortar use that was observed from previous repairs.**

1. For best match of mortar and brick, wash brick with an appropriate cleaner for older bricks to reveal original/more uniform color of brick
2. Remove as much Portland cement mortar, as possible, through grinding of mortar joints (especially in areas where bricks are already spalling)
3. Repoint bricks using lime mortar blended to match existing
4. Remove and replace heavily eroded bricks
5. Re-surface deteriorated bricks using repair mortar, specifically formulated for brick repairs and blended to match original brick color (such as Lithomex)

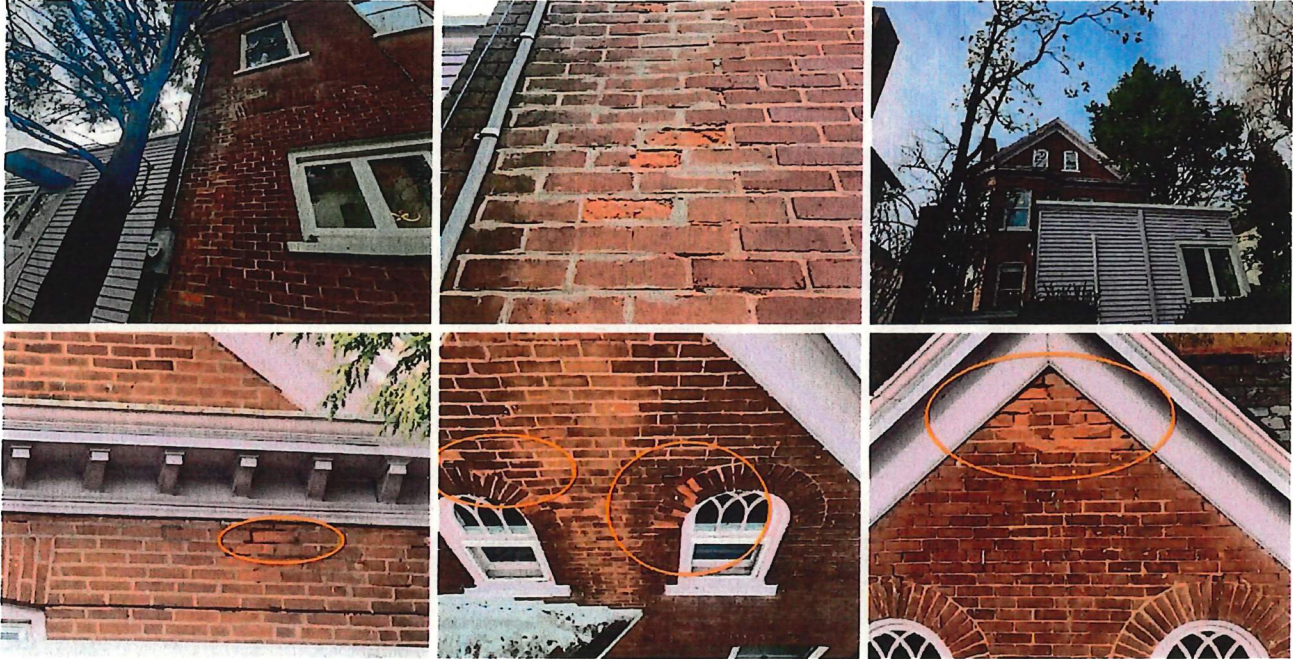
SIDING BRICK - SPALLING

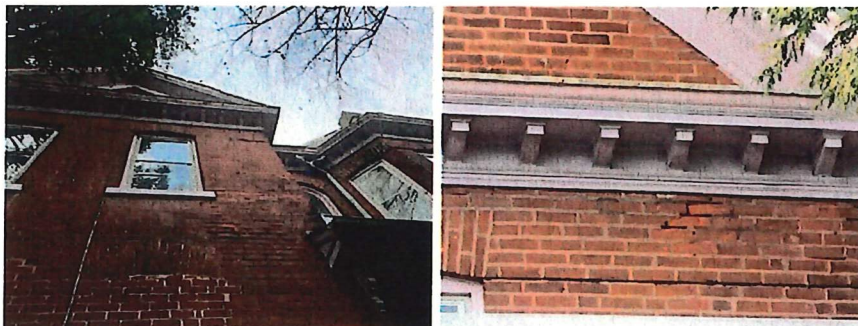
SIDING MORTAR DAMAGED

During the inspection, areas of missing damaged mortar were observed in the siding. This includes sections where the mortar is cracked, crumbling, or missing.

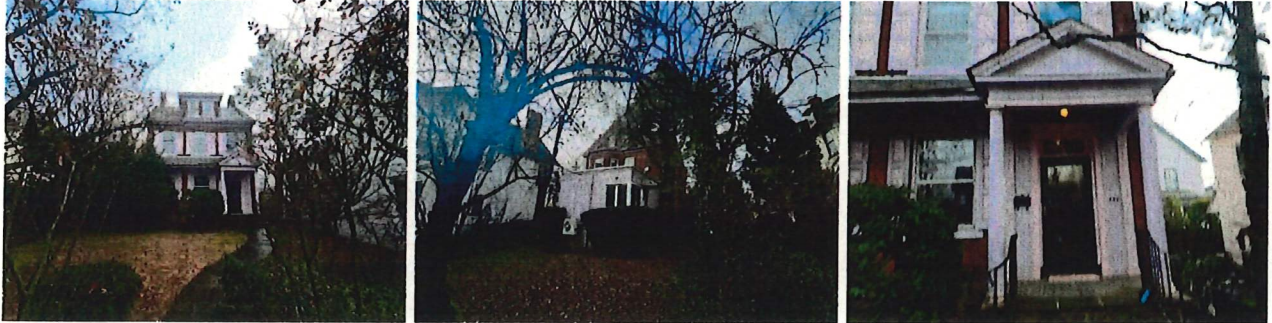
TRIM - MAINTENANCE/REPAIRS

Areas of the paint and caulking on the exterior are in need of repairs/maintenance.

- Scrape and sand loose and peeling paint
- Caulk gaps and putty cracks and holes as needed
- Replace loose and missing window glazing on wood window sashes
- Clean glass on exterior of wood window sashes
- Repair damaged and rotten wood
