HanoverEngineering

April 23, 2024

RE: Structural Evaluation
330 East Fourth Street
City of Bethlehem, Northampton County
Hanover Project 5161

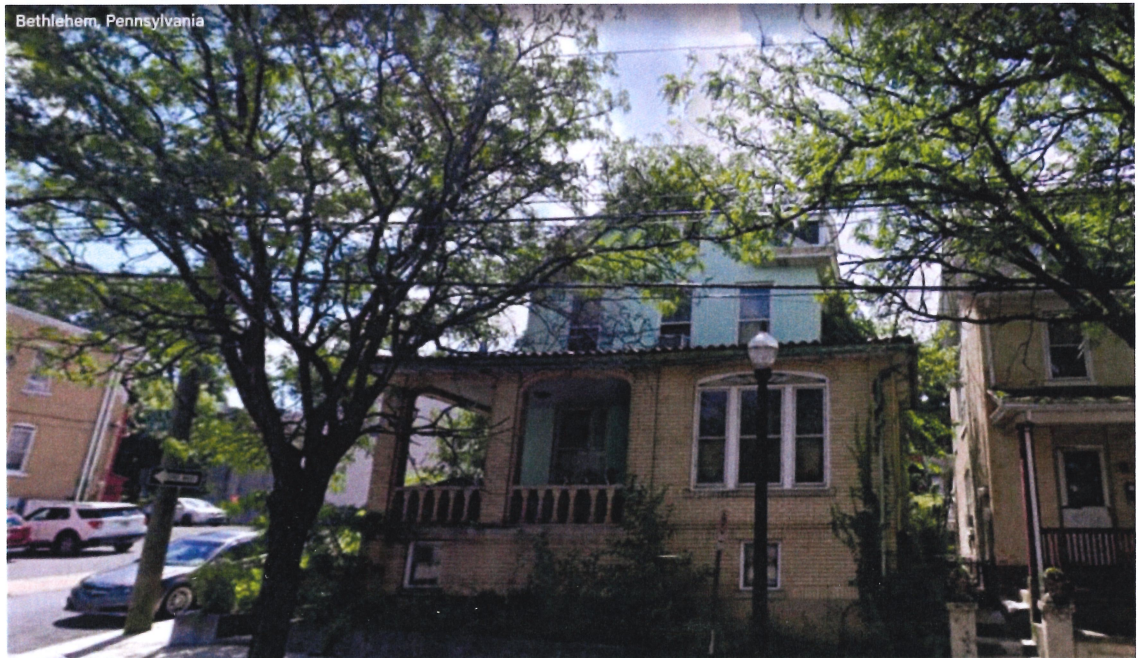
Front of Residence (North Elevation) (from google earth)

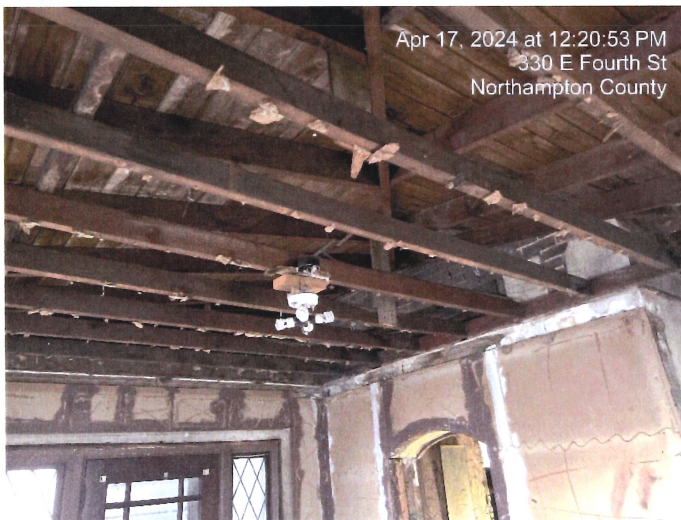
Front Hall

Also of concern is the distress of the second-floor joists, visible in the “dining room” of the first floor. The suspended ceiling in this room has been removed, revealing this framing – which includes a conventional steel beam running north-south. Although the framing appears sound, it is unclear if it adequately supports current standard loadings; the timber joists are especially suspect. The suspended ceiling of the “living room”, immediately to the north, is still in place, but it is assumed that the concealed floor framing in this area is similar, with similar misgivings. The front hall, exposed and not supporting the upper floors, is framed more adequately, and appears to be in better overall condition.

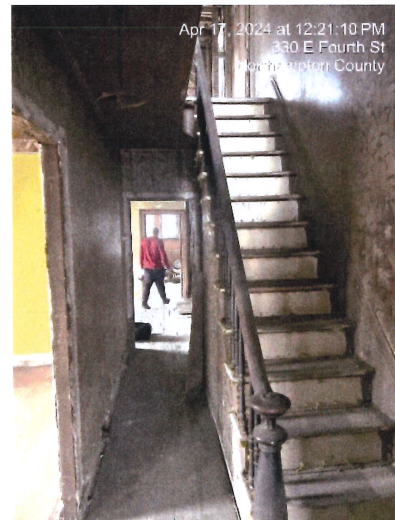
Staircase 1st to 2nd Floor

The second floor is accessed via a standard staircase from the first floor and appears to be in similar condition to the first floor. However, the curtain wall separating the two rear rooms looks to be inadequately supported by the first-floor framing, and the joists at the northwest are embedded into a failing brick wall.
