Subject: 14-18 West Third Street Properties
Re: Request and reasoning for demolition – attached to the COA

We are requesting that HARB approve the demolition of these properties for future development based on the demonstrated lack of structural integrity of the properties, the minimal amount of retained historic importance of the two properties, and the prohibitive cost required to repair these buildings, to allow for an improved economic and aesthetic impact a new development will have on this critical area of South Bethlehem and provide an appropriate neighbor to the approved development immediately to the east on Third Street.

As you know, back in 2016 I did an investigation of the building at 14-18 West Third Street in Bethlehem, PA, specifically about the west exterior wall. The following is a resulting letter I issued previously:

Thank you for asking me to provide structural engineering services pertaining to the building at 14-18 West Third Street, Bethlehem, PA. The purpose of my investigation was to evaluate the structural impact of damage to the west exterior wall.

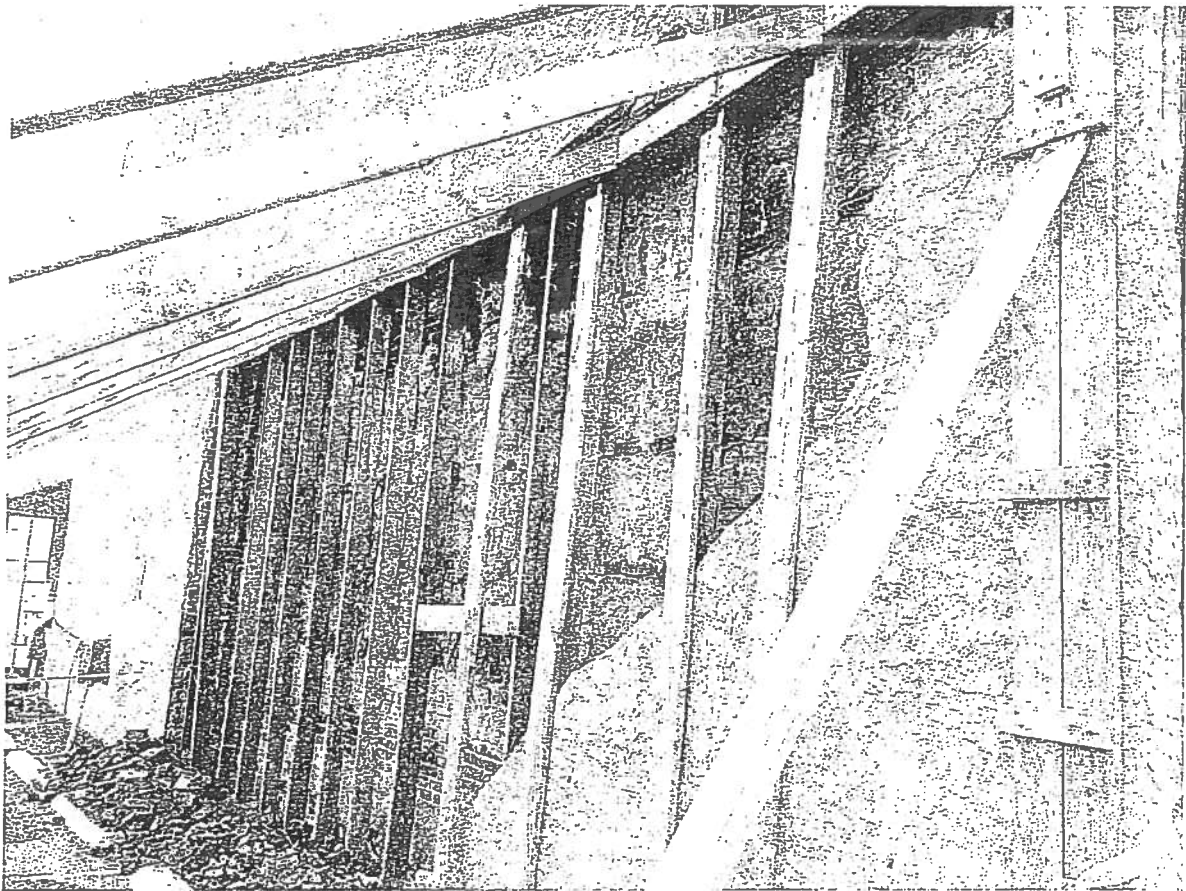
PHOTO 1

3. During the visit, it was noted that a significant portion of the brick wall, from the chimney toward the back, from the ground up to above the second floor framing has partially collapsed, leaving one wythe of brick (approximately 4" thick) to support the second floor framing, the third floor framing, and the weight of the remaining brick wall above. In my opinion this is structurally unacceptable. Even if the remaining single wythe is of sound, firm brick and mortar, it is not acceptable in my opinion to rely on it to support load. It is too thin and brittle.

I recommend evacuating the tenants on that end of the building immediately, installing

temporary shoring inside the building to support the floor framing, and having the wall demolished and replaced with a structurally sound wall.
